Description: PAIR OF SEMI DETACHED PROPERTIES

Location: 20 VERNON ROAD, WORSBROUGH

# Permit to Enter or Disturb Coal Authority Mining Interests

| Client | Drawing Name: Borehole Location Plan | |

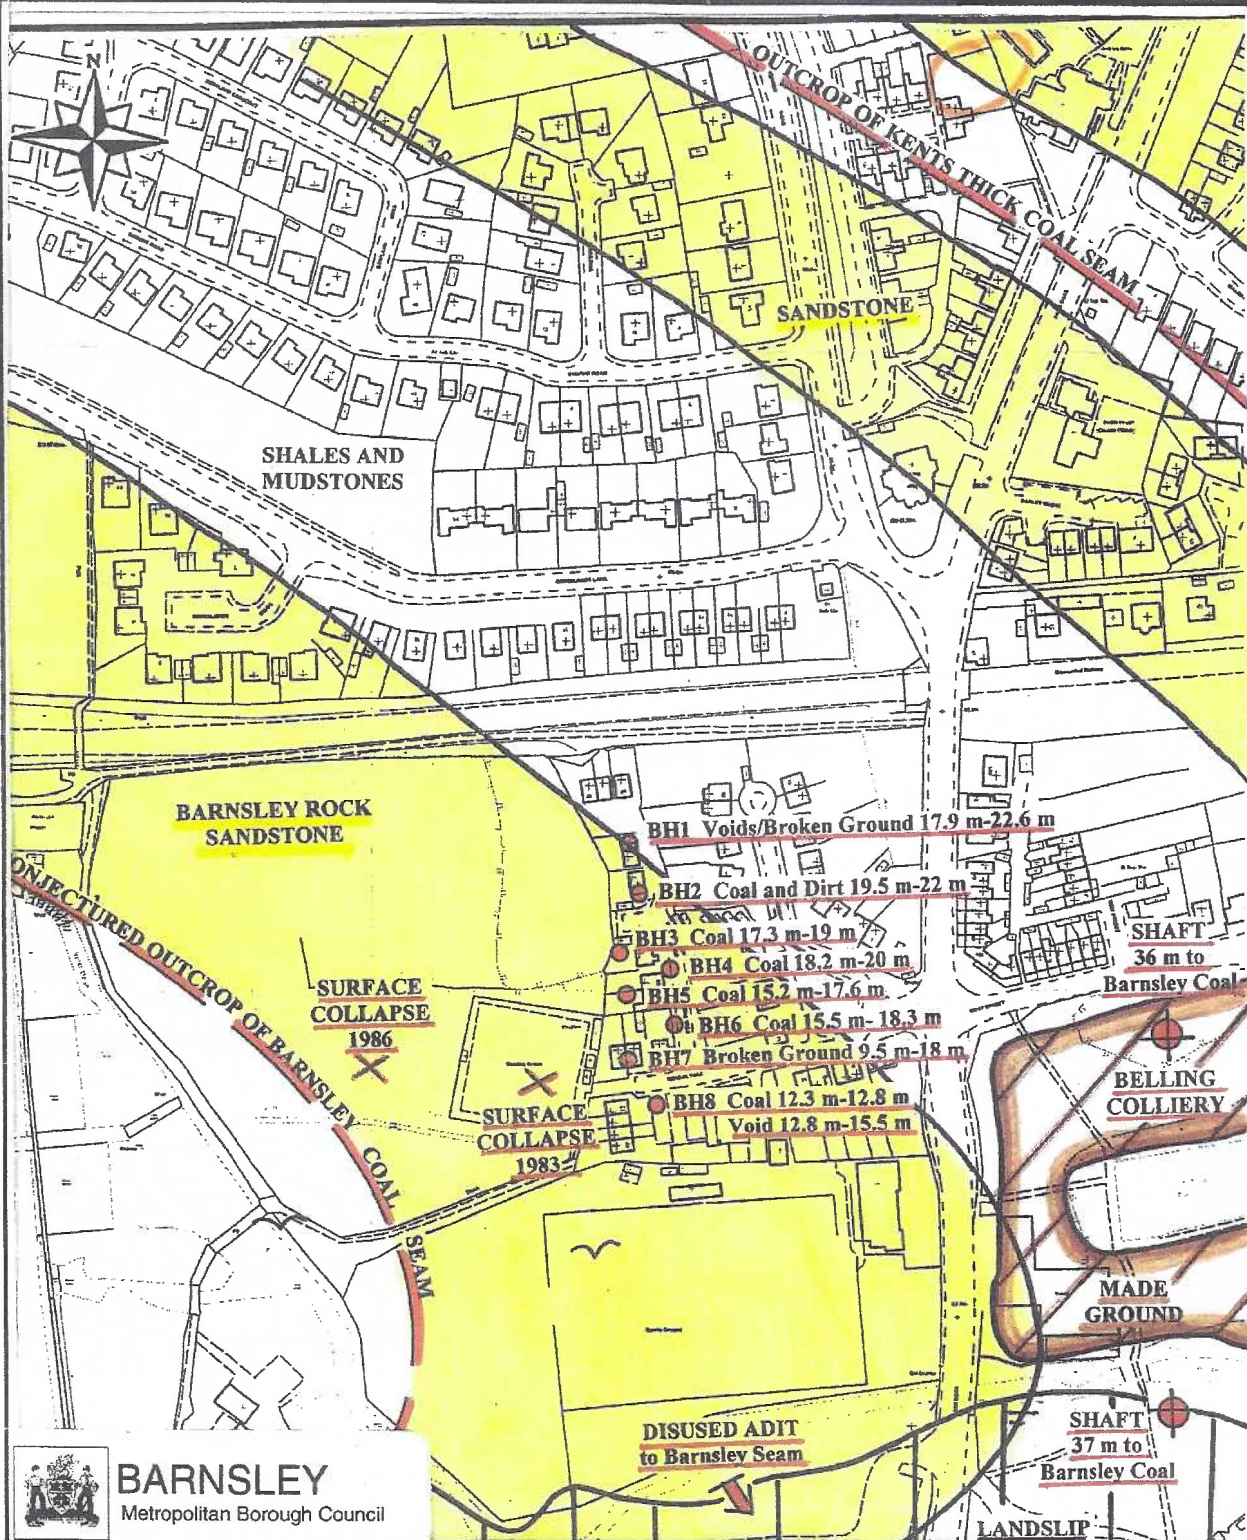
16/07/12/BR

| The coal seam shown on the plan may be under the proposed development at a shallow depth. | A6<br>✓ |
| Shallow mineworkings in the coal seam marked on the attached plan may be present under the site. | A7<br>✓ |

| A site investigation should be carried out to check the possible presence of shallow workings/broken ground. Boreholes to a depth of 15m would be recommended in this instance.<br>(Prior consultations with the Coal Authority would be required). | B4<br>✓ |
| Although it is not a consideration of the A2(b) requirement all the usual safety precautions and monitoring procedures in respect of fugitive gases (associated with shallow coals, mine entries, made ground or landfill) should be employed. | B9<br>✓ |
