**Site Sensitivity Map - Segment A13**

1 Midland Road, Royston, BARNSELY, South Yorkshire, S71 4QN

# CON29M Non-Residential Mining Report

MIDLAND ROAD  
ROYSTON  
BARNESLEY  
SOUTH YORKSHIRE

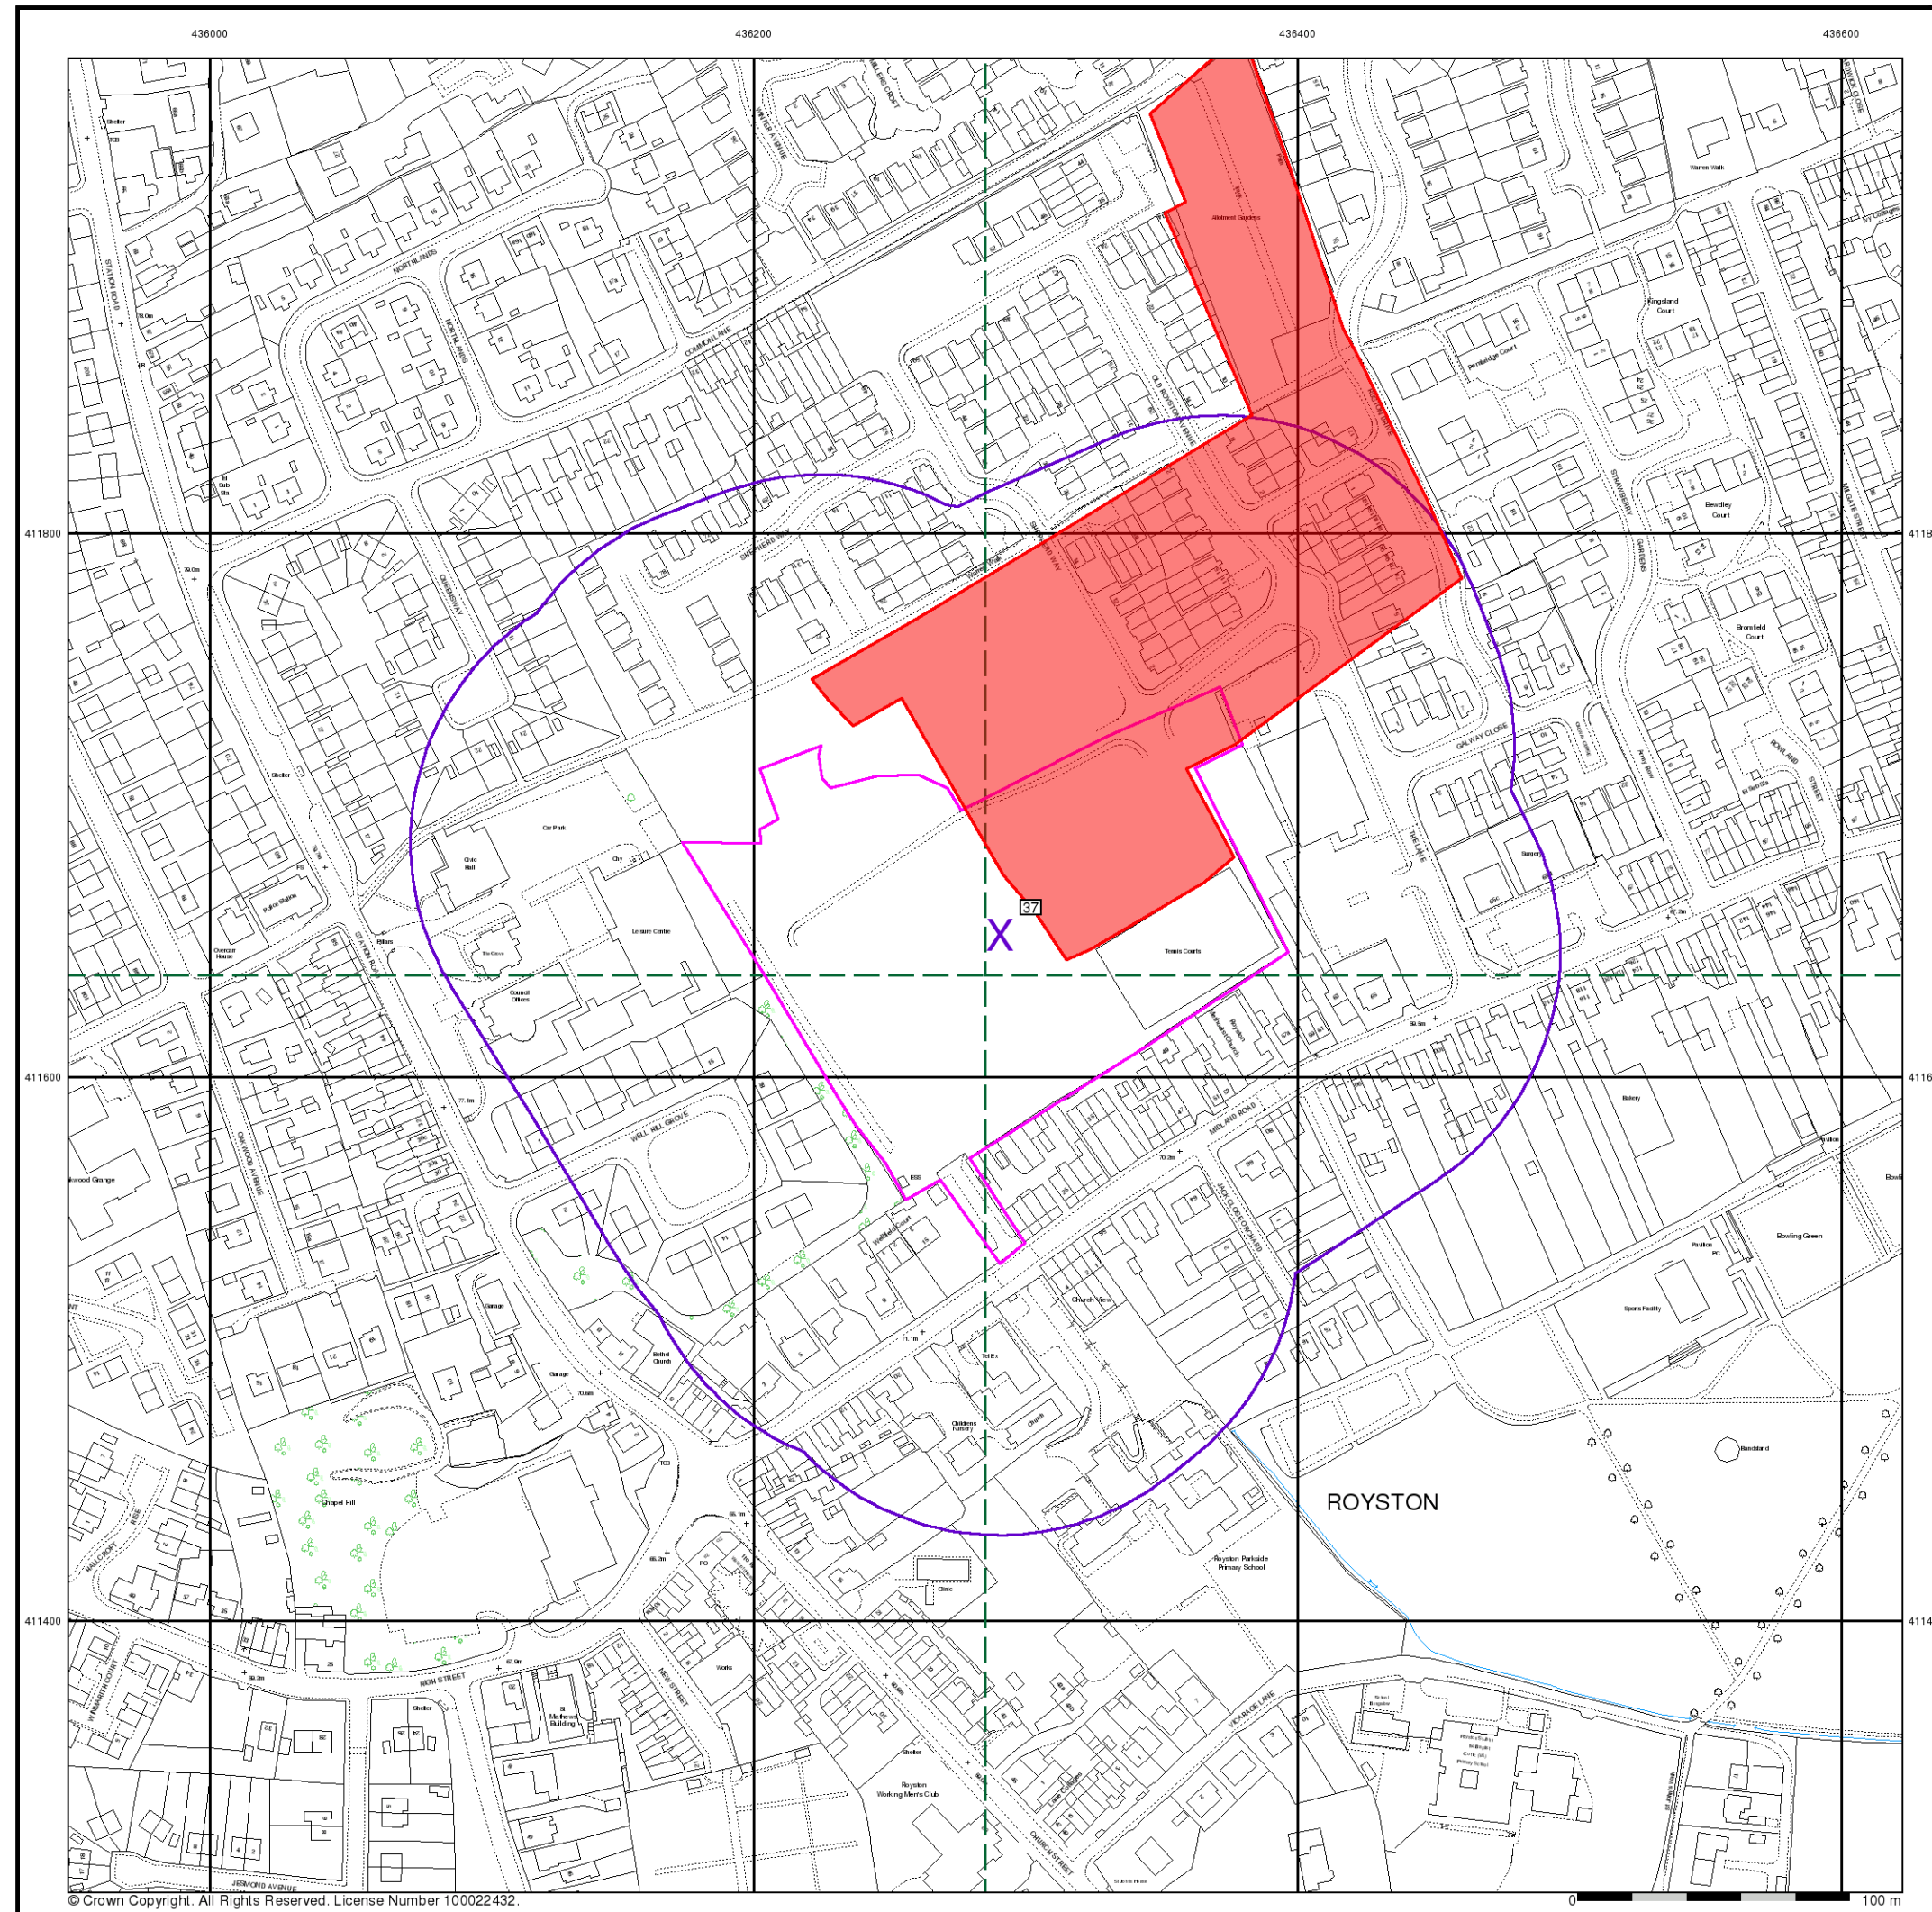
- General**
- Specified Site
  - Specified Buffer(s)
  - Bearing Reference Point
  - Map ID
  - Several of Type at Location
  - Pylon
  - Overhead Transmission Line

- Agency and Hydrological**
- Contaminated Land Register Entry or Notice (Location)
  - Contaminated Land Register Entry or Notice
  - Discharge Consent
  - Enforcement or Prohibition Notice

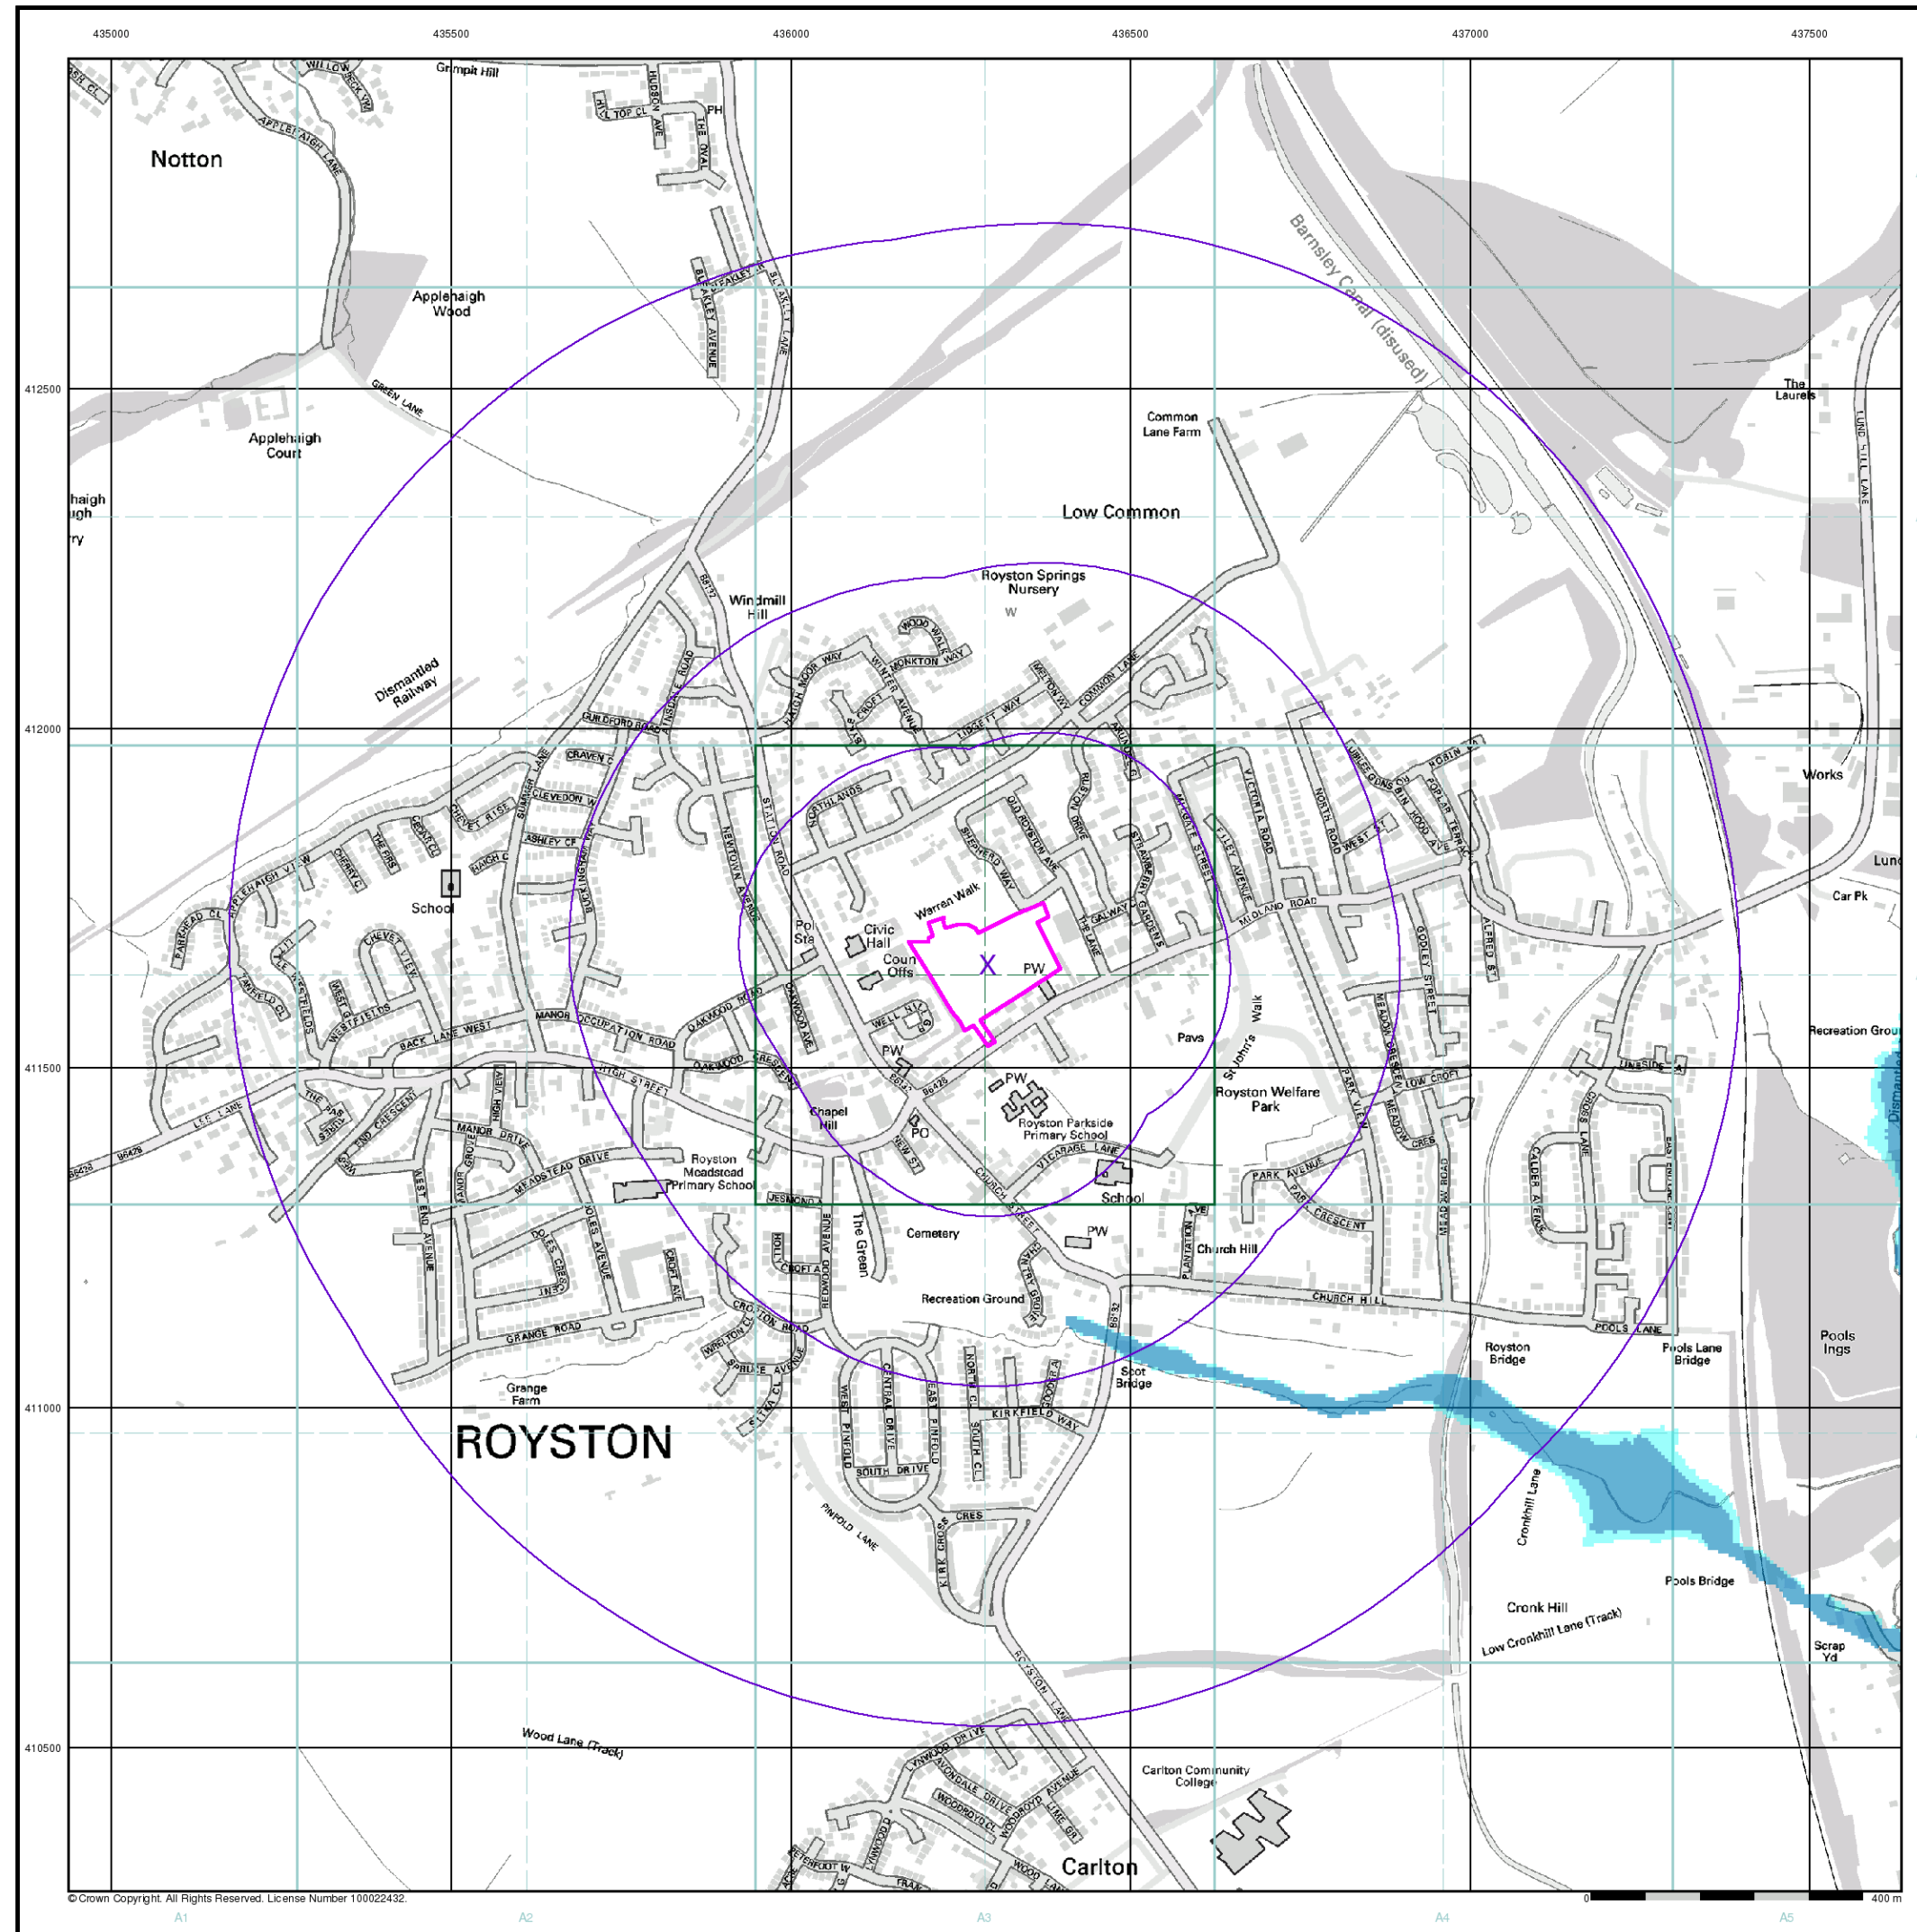
**Flood Map - Slice A**

- Extreme Flooding from Rivers or Sea without Defences (Zone 2)
- Flooding from Rivers or Sea without Defences (Zone 3)
- Area Benefiting from Flood Defence
- Flood Water Storage Areas
- Flood Defence
