PERCOLATION REPORT

Pantry Hill, Barnsley

25930-PR-001

DART
ENGINEERS LTD
CIVIL AND STRUCTURAL
ENGINEERING

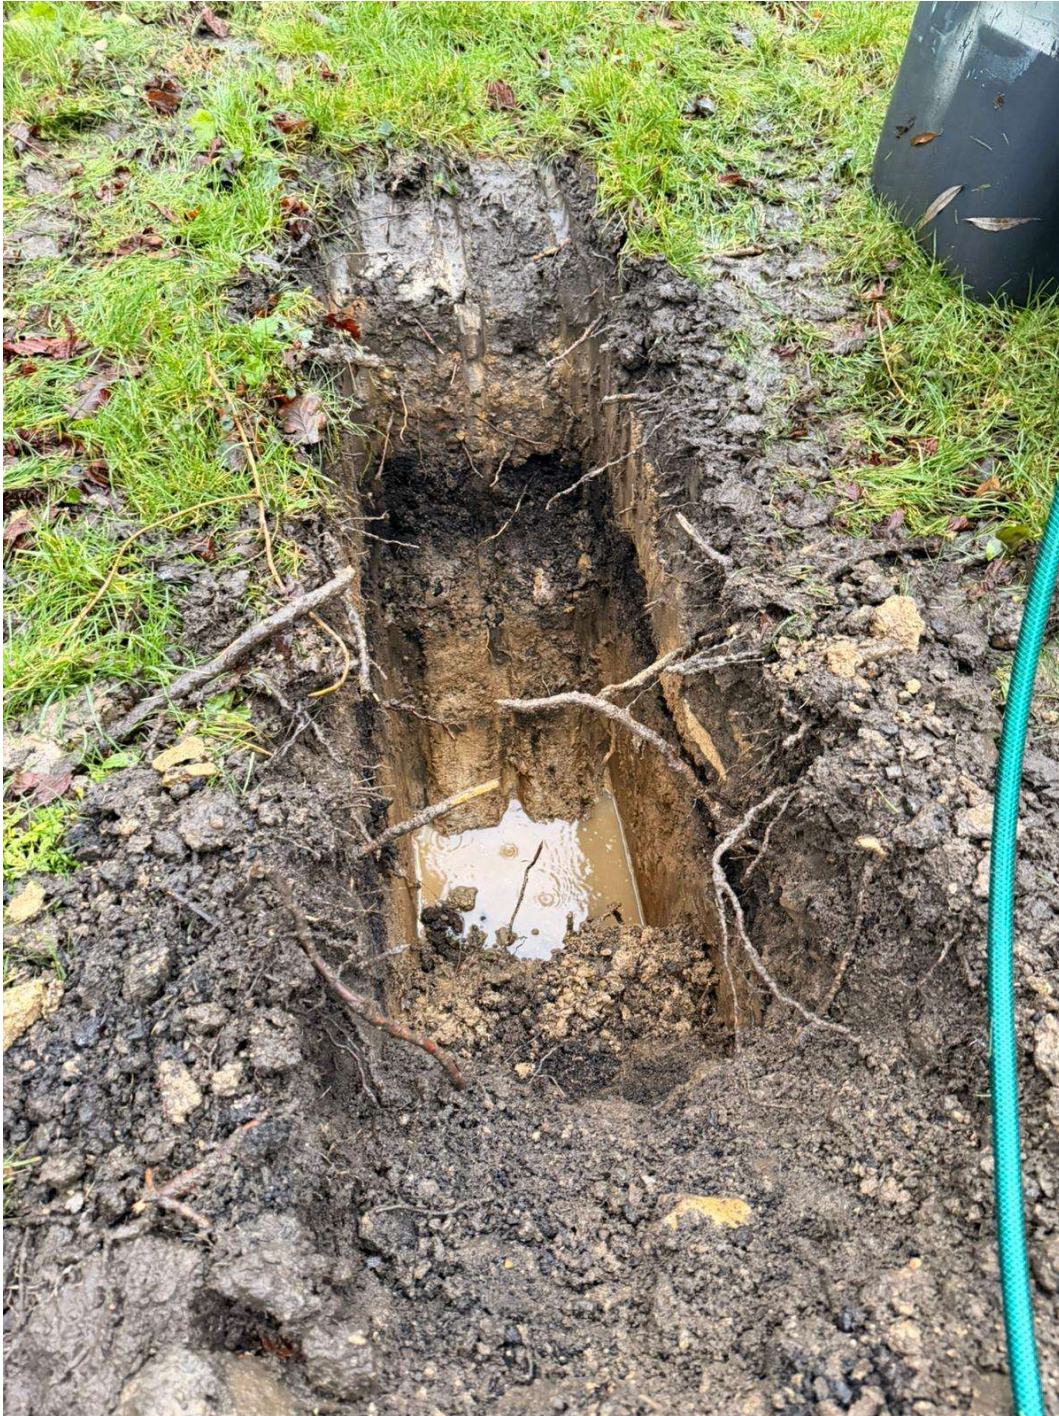
Trial Pit 1

For Test 1 (Test Pit 1), Groundwater was encountered at the base of the excavation at an approximate depth of 1.00m below ground level. In accordance with the requirements of BRE Digest 365, the presence of groundwater prevented valid percolation testing from being undertaken.

Calculation sheet 1 shows that the infiltration rates are not high enough and do not satisfy BRE 365 requirements. Therefore, Infiltration methods of drainage will not be viable for this site and strategy.

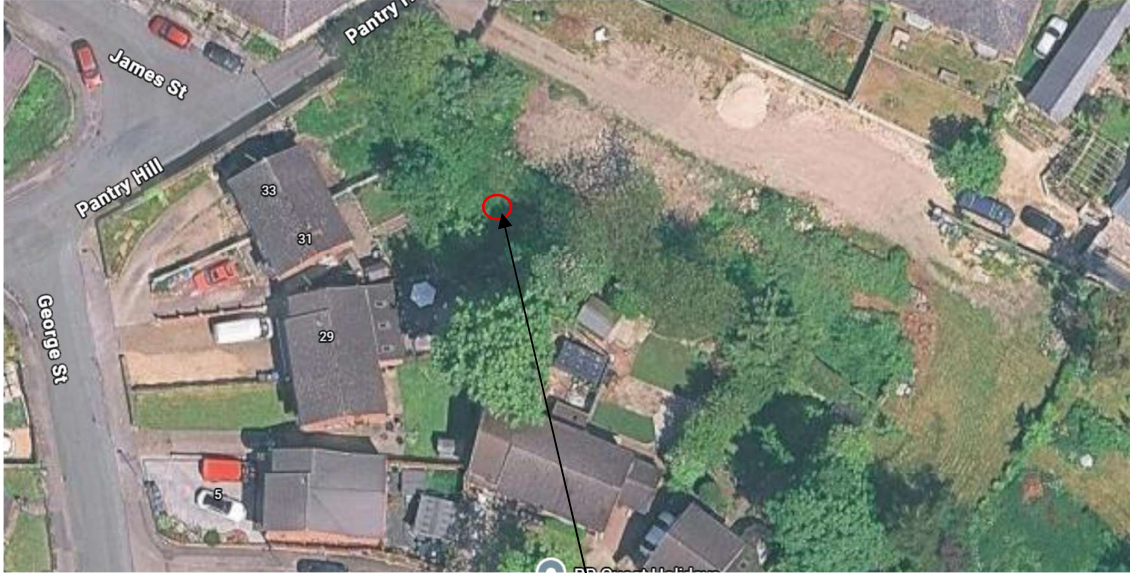
Trial Pit 1 Location

Trial Pit 1 was
formed here
