M Booth Design Ltd

P17-00360-Met-RP-GE-001

Darley Grove

Phase I Desk Study

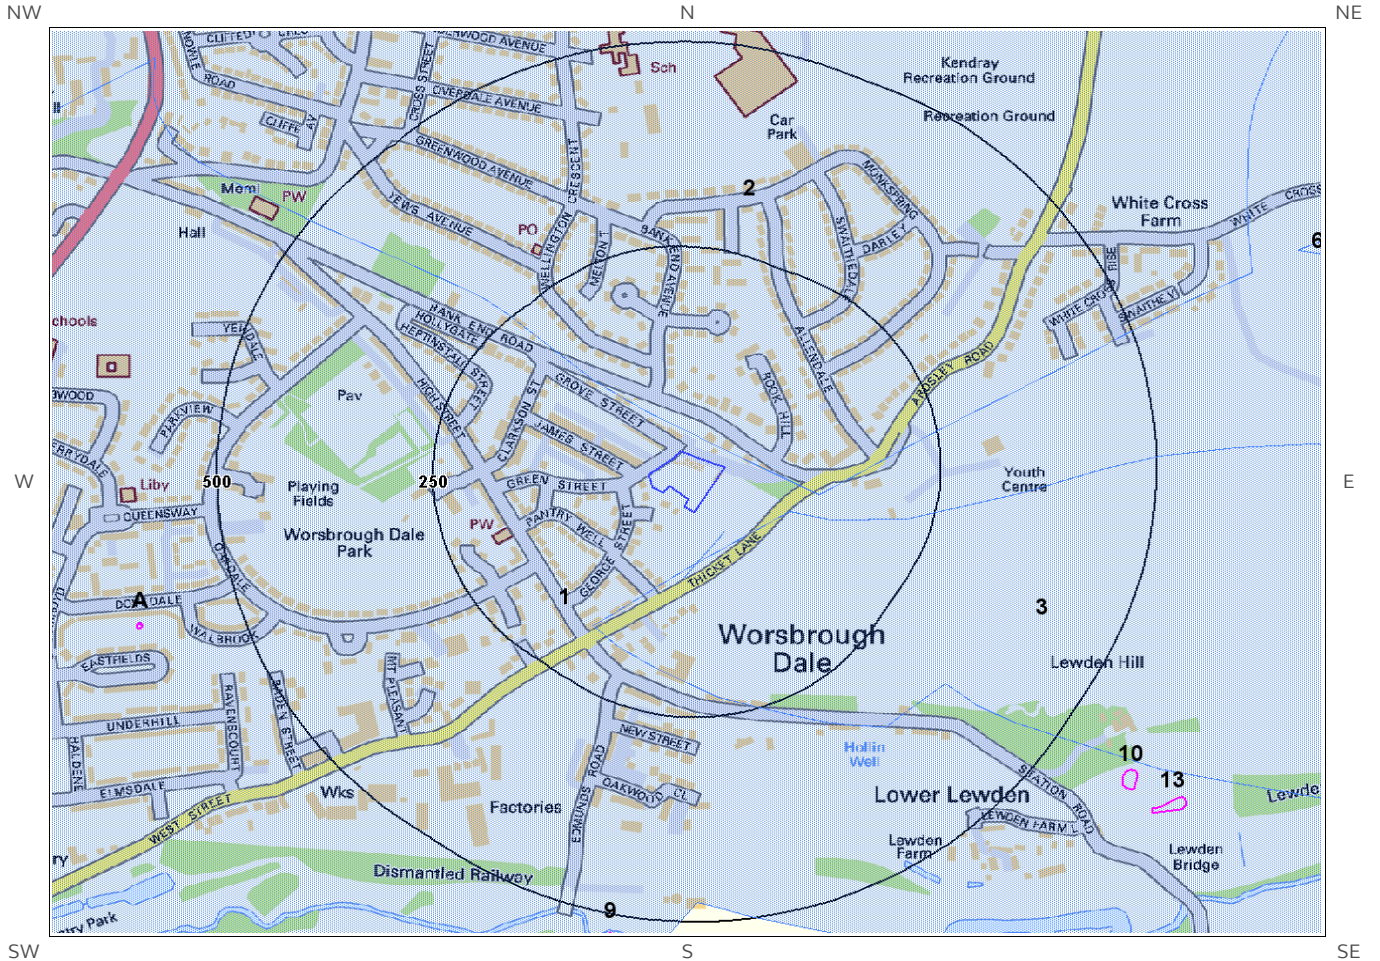
5 Mining, Extraction & Natural Cavities Map

ID	Distance (m)	Direction	Name	Commodity	Assessment of likelihood
1	0.0	On Site	Not available	Iron Ore (Bedded)	Localised small scale underground mining may have occurred. Potential for difficult ground conditions are unlikely or localised and are at a level where they need not be considered
2	20.0	NE	Sheffield Area	Vein Mineral/Iron ore	Localised small scale underground mining may have occurred. Potential for difficult ground conditions are unlikely or localised and are at a level where they need not be considered
3	54.0	SE	Sheffield Area	Vein Mineral/Iron ore	Localised small scale underground mining may have occurred. Potential for difficult ground conditions are unlikely or localised and are at a level where they need not be considered
Not shown	558.0	S	Sheffield Area	Vein Mineral/Iron ore	Localised small scale underground mining may have occurred. Potential for difficult ground conditions are unlikely or localised and are at a level where they need not be considered
