**15 and 17 Garden Cottages  
Pontefract Road  
Cudworth**

**Pre-development Arboricultural Report**

**07 August 2020**

**By  
Ian Kennedy  
Wharnccliffe Trees and Woodland Consultancy**

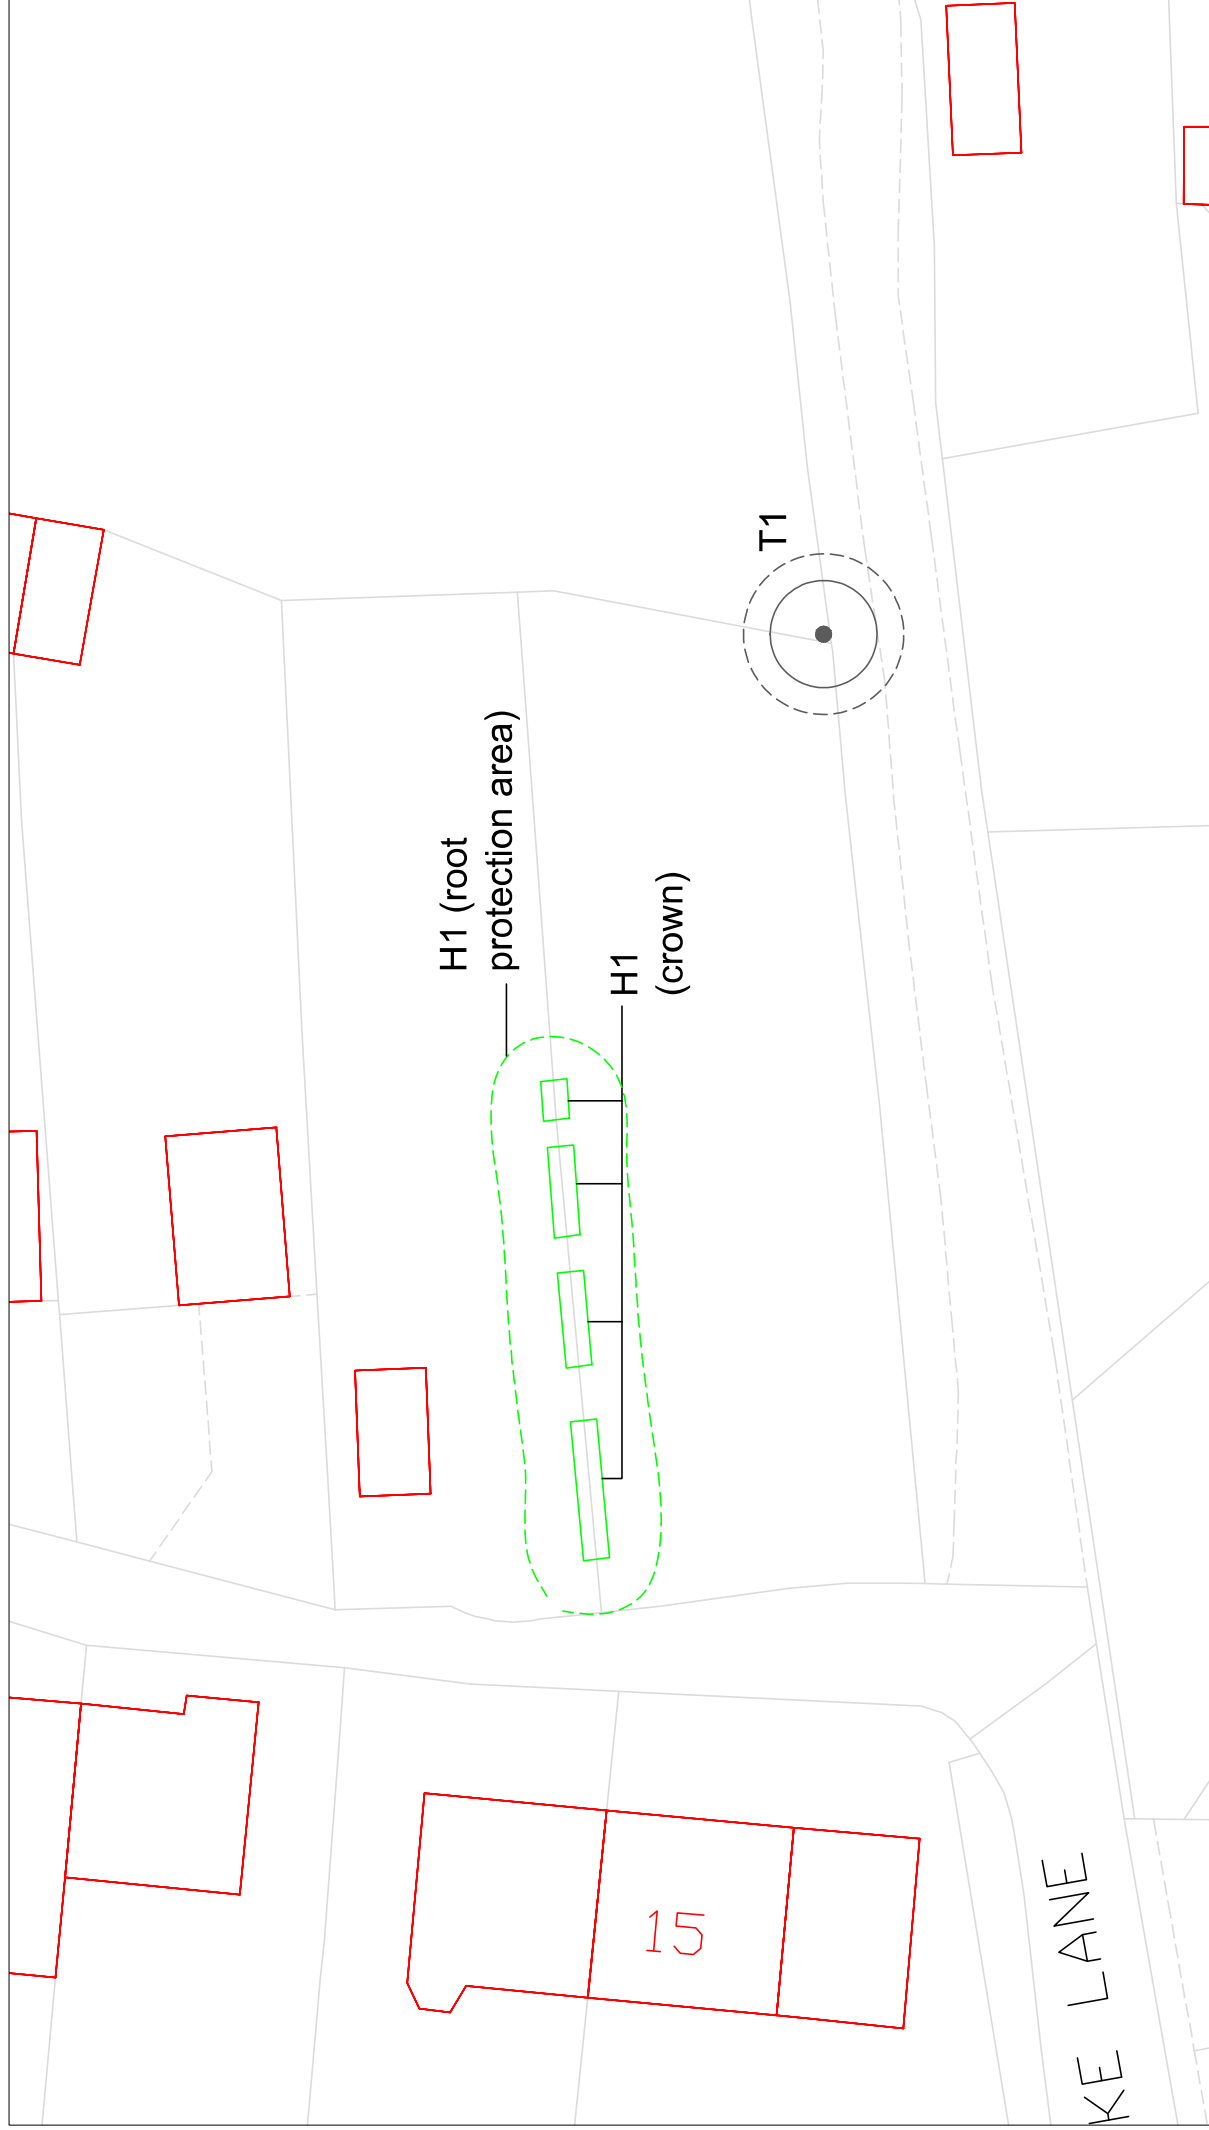
Plan 1 Tree constraints plan showing the existing layout

The approximate location of one hedge and one tree are recorded on Plan 1 that shows the existing site layout.

There is one small hawthorn tree just outside the north west corner of the site and a conifer hedge along part of the boundary between the two gardens. The tree is included in the lowest retention category C because it is small and has very limited value. Hedges cannot be attribute retention categories.

This section of the report considers the impact that the proposed layout will have on the trees that are included in Table 1 and shown on Plan 1; *Tree Constraints Plan showing the existing layout*.

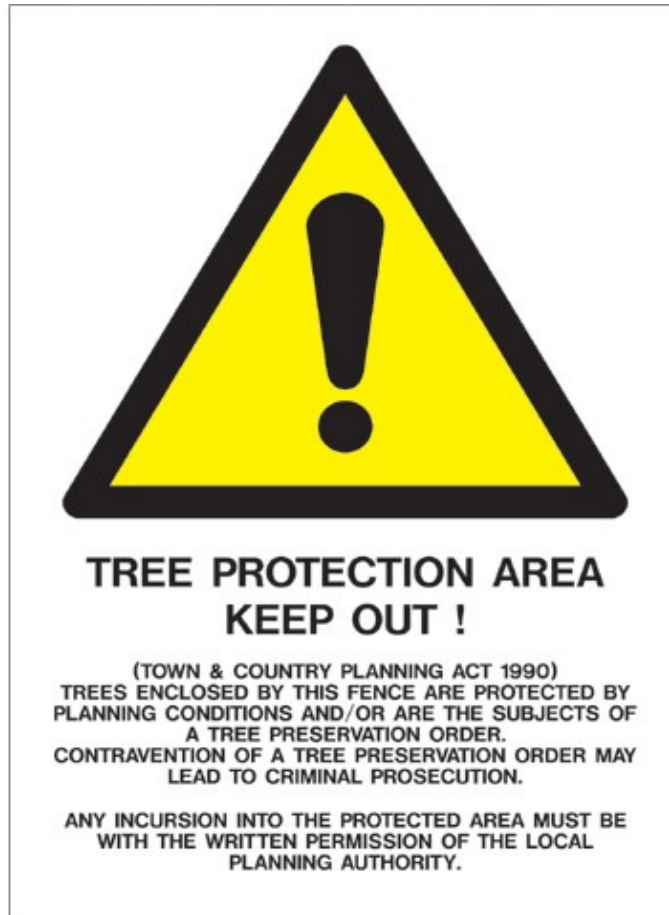
### Example of a sign to attach to tree protective fencing

Appendix 5 is an example of a sign that should be attached to fencing to advise onsite staff of the reasons and importance of the fencing.
