**CAPE SITE SERVICES  
COAL MINING & GEOTECHNICAL  
CONSULTANCY**

**COAL MINING RISK INTERPRETATION REPORT – FOLLOWING THE SITE  
INVESTIGATION FOR PROPOSED RESIDENTIAL DEVELOPMENT AT FORMER GARAGE SITE,  
FEARN HOUSE CRESCENT, HOYLAND, BARNSLEY S74 0BA**

## 5.2 Borehole Location Plan No. 00254/B

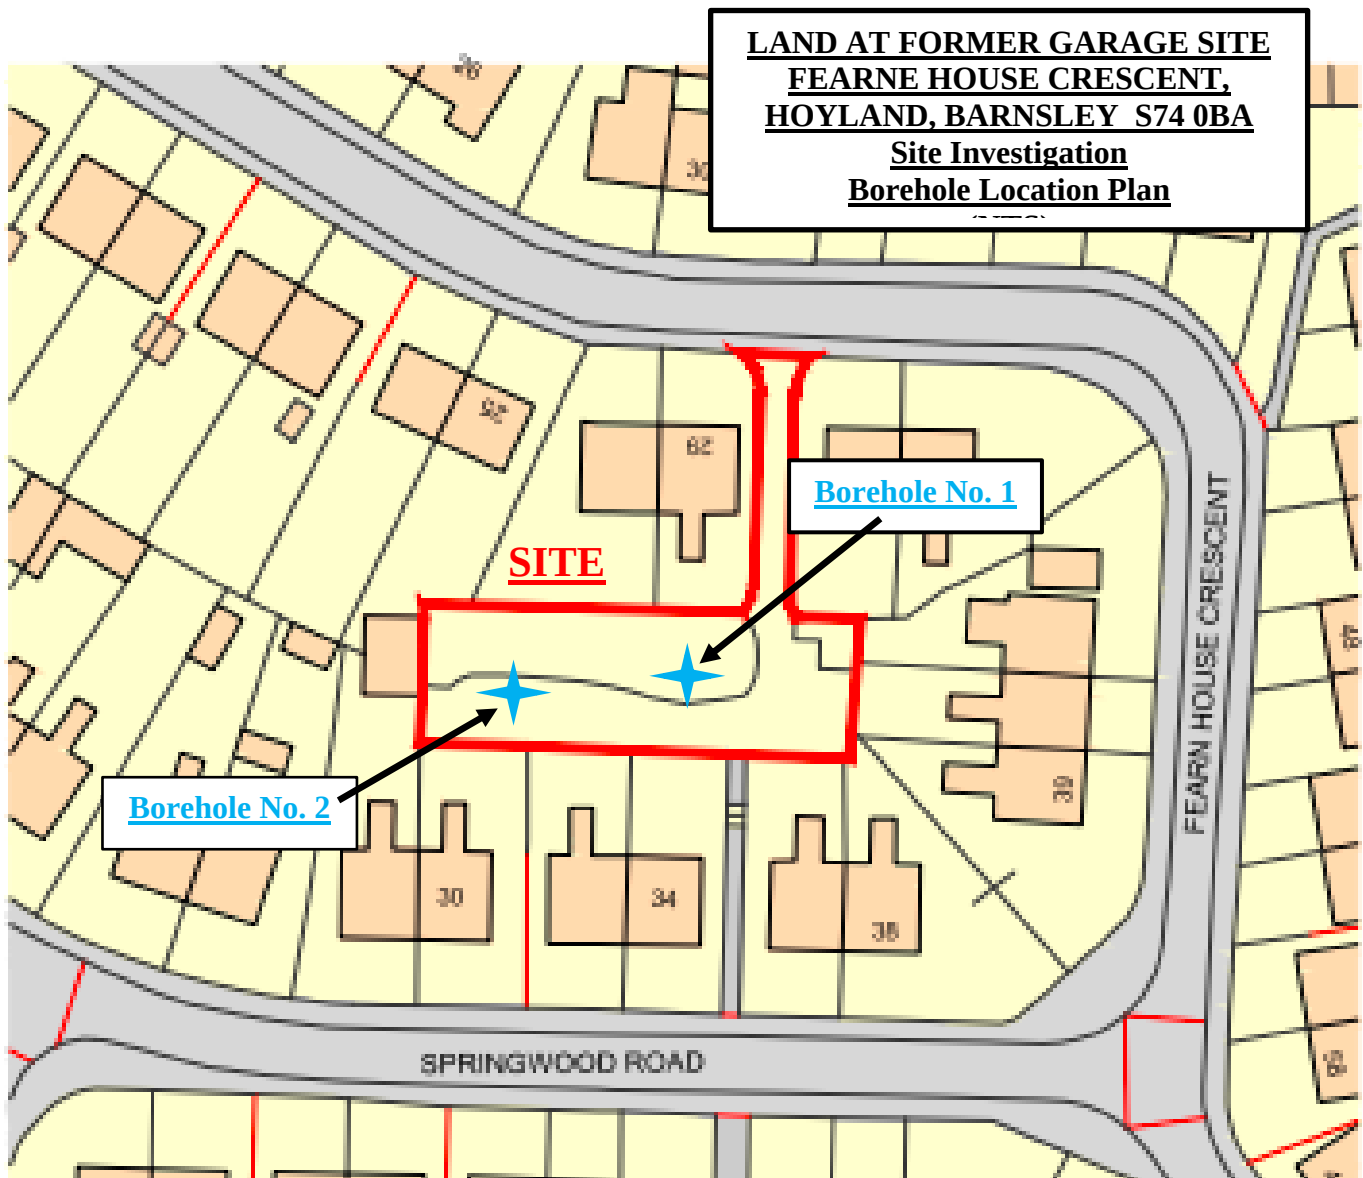
Planning permission is being considered for the development of a detached dwelling at the above location subject to the mining legacy risks been fully realised and mitigated from on site, if necessary. Cape Site Services has now undertaken this work via an intrusive site investigation of 2 boreholes, the location of which is outlined on plan no. 00254/B – as attached and illustrated in appendix 5.2.

Prior to the intrusive site investigation a search for utilities was undertaken both via online data providers and physically on site using a Cable Avoidance Tool (CAT). Boreholes were marked out with tape measure from boundary lines as illustrated on plan no. 00254/B outlined in appendix 5.2. As part of the mine entry watching brief, a pre survey was undertaken with no visible evidence of any uncharted mine entries. The process for the intrusive coal seam investigation is outlined via the system chart in appendix 5.4.

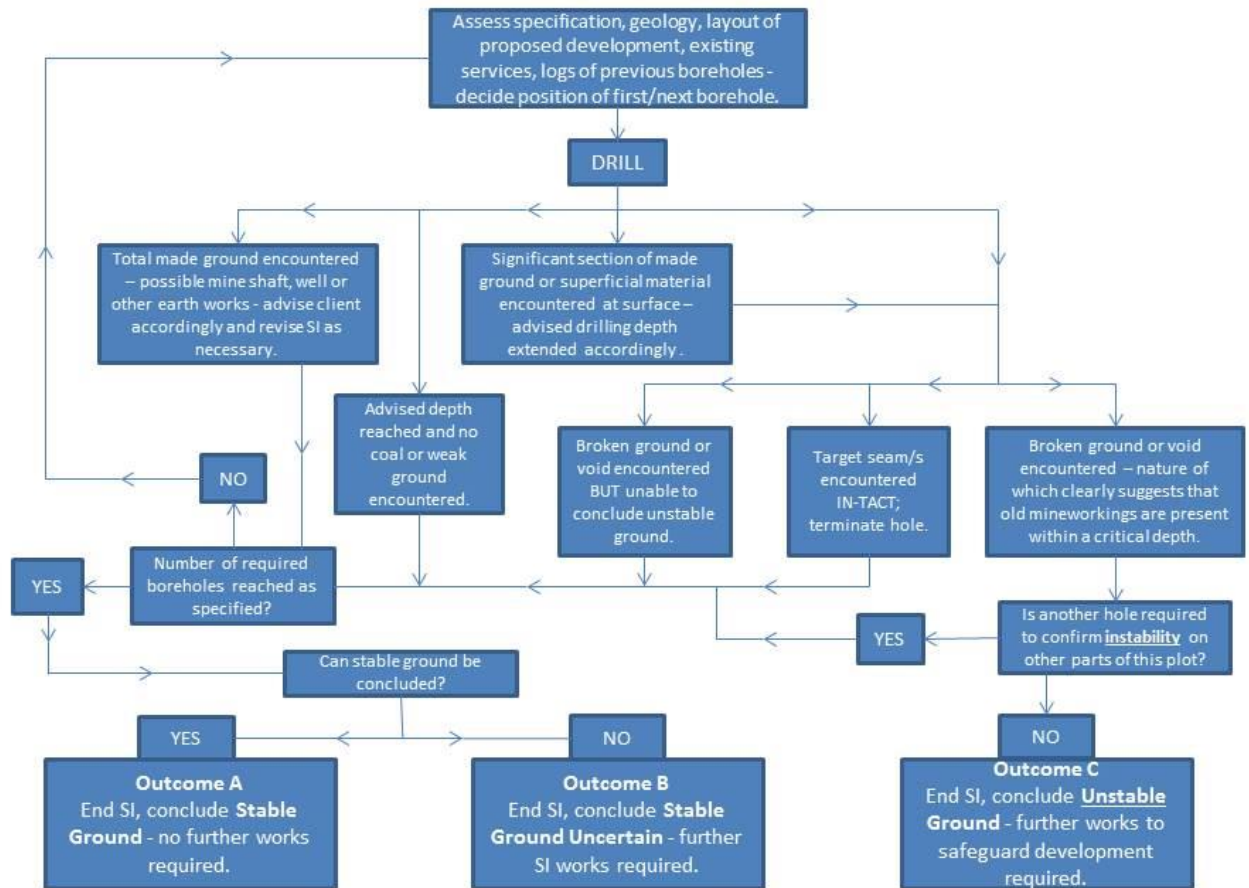
## 5.4 Site Investigation Process

### Borehole Site Investigation (SI) Process Guide (Shallow Underground Coal Workings)
