**THURNSCOE HALL**  
**High Street, Thurnscoe. S63 0ST**  
**Boundary Wall and Fence**

**Design and Access Statement**

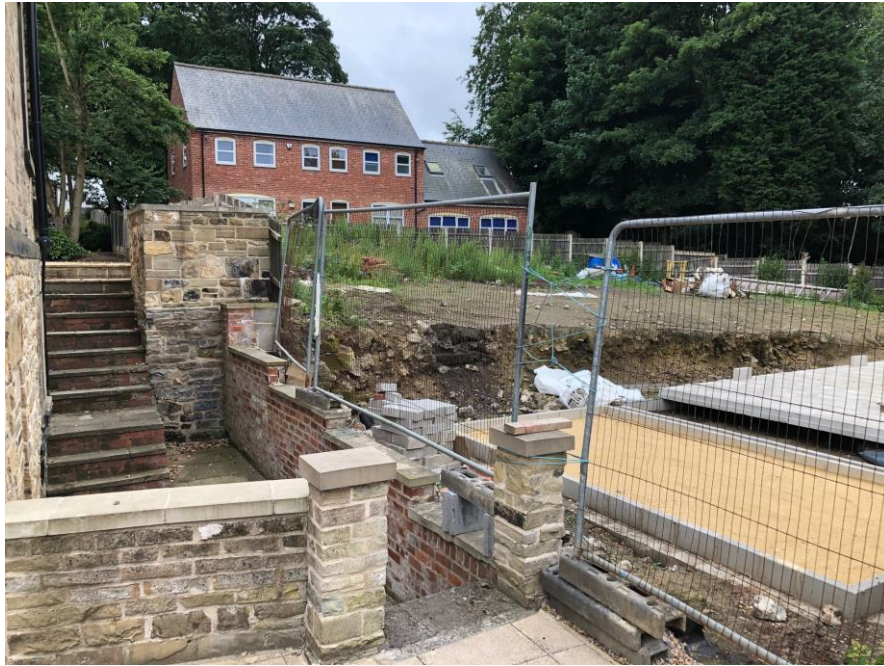
*Fig. 2 – Existing western boundary treatment*

- 5.6 The current lack of boundary treatment to the western boundary immediately adjacent to the Hall detracts from the setting.

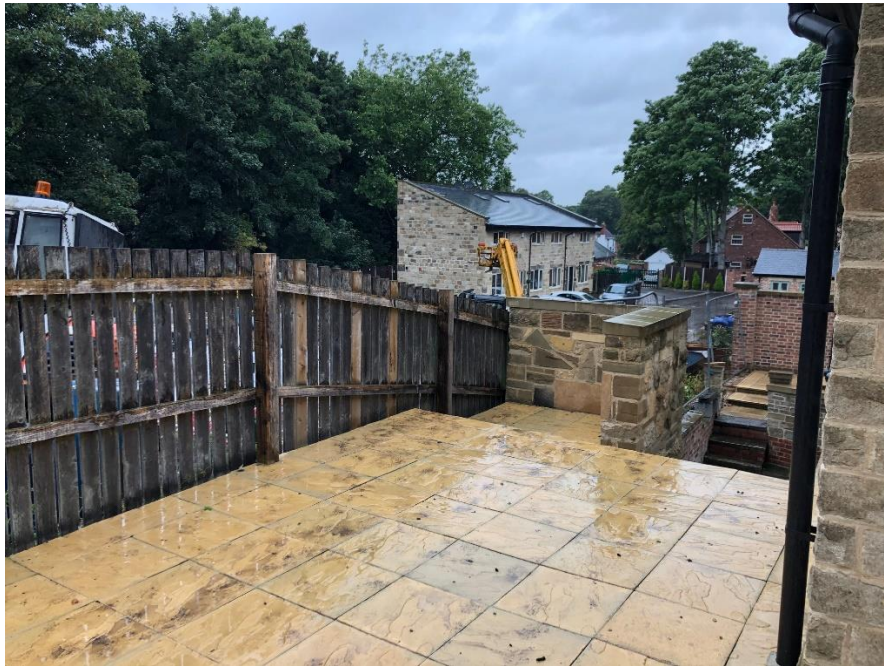
*Fig. 3 – Existing Timber Fence to upper external level – proposed to be replaced*

- 3.2 Further south along this boundary, vertical boarded timber fencing currently runs at the higher level and tapers down to meet the existing stone walling at the upper level. The proposal intends to replace this existing fencing with new panels and posts in the same style, in order to achieve a uniform level of fencing at the upper external floor level, which will co-ordinate with the height of the new brick wall.

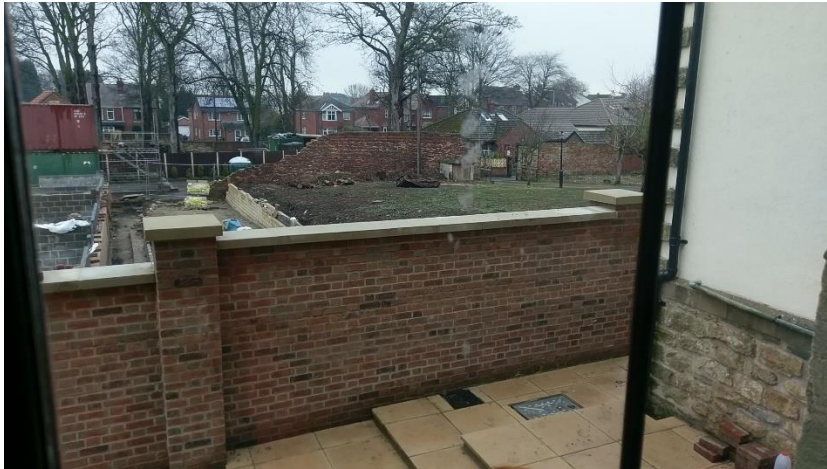
*Fig. 4 - New brick wall with piers and PC copings to north-west boundary.*

- 3.3 The brickwork and copings will match the short section of boundary wall which was erected under the conversion to a dwelling, and which is currently being continued along boundaries further north and to the east.

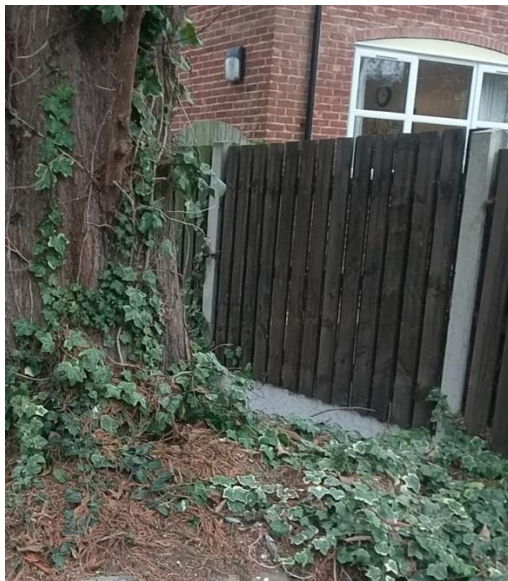
*Fig. 5 – Existing vertical boarded fence with concrete posts and base rail.*

- 3.4 The replacement fencing will be vertical boarded timber fence with concrete posts and concrete base rail. This will match in both appearance and height the retained neighbour's fencing to the west side of the south garden.
