# Listed Building Renovation Statement

The Grange, 36 Huddersfield Road, Ingbirchworth. S36 7GF

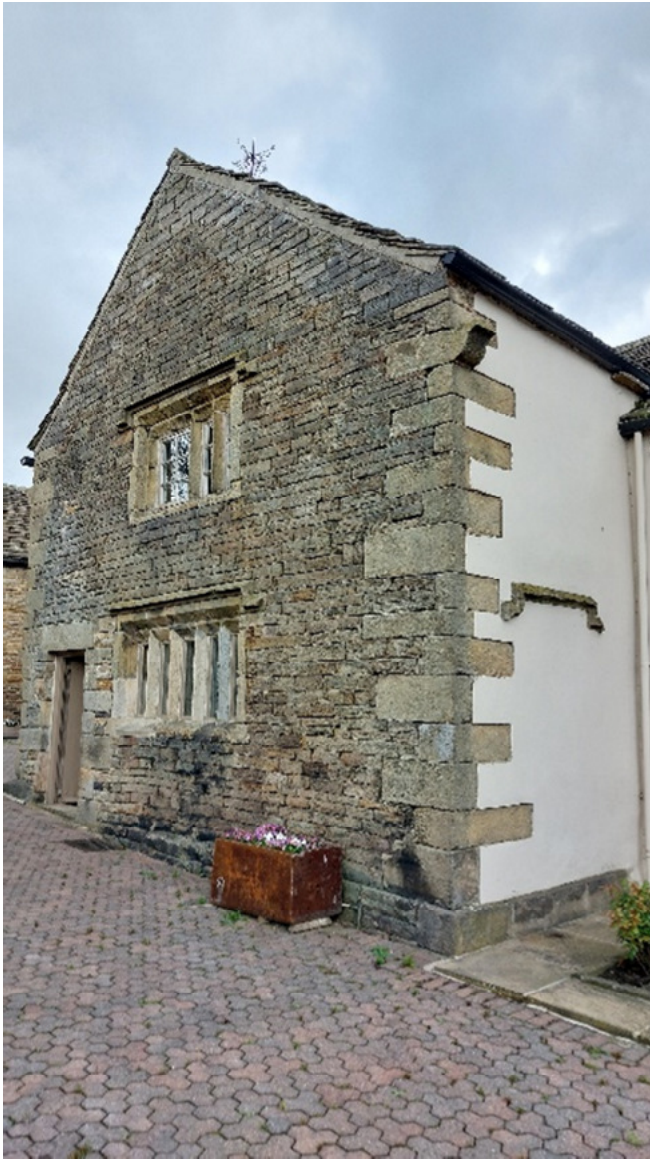
The west wing front (south) elevation, the roof has been raised at some point in its history by approximately 500mm as can be seen from the Kneelers and slight change in stone to the gable

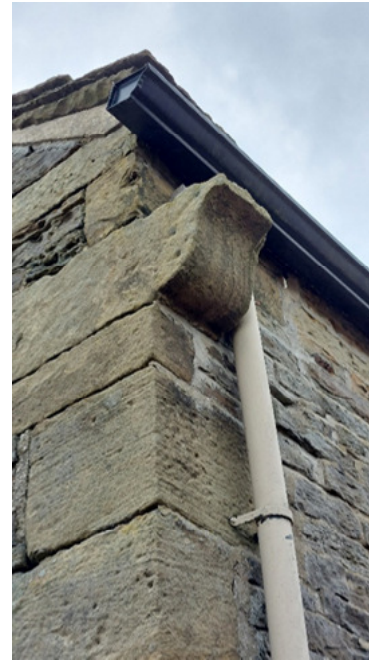
Stone kneeler and raised roof

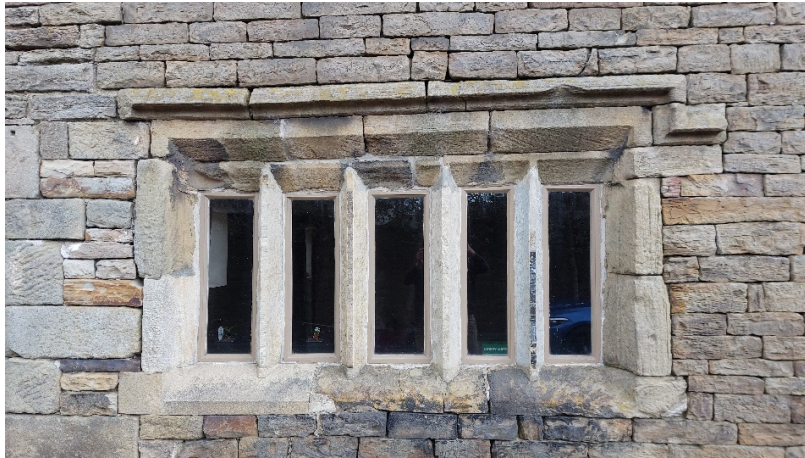
South elevations, ground floor stone mullioned windows with hooded mouldings

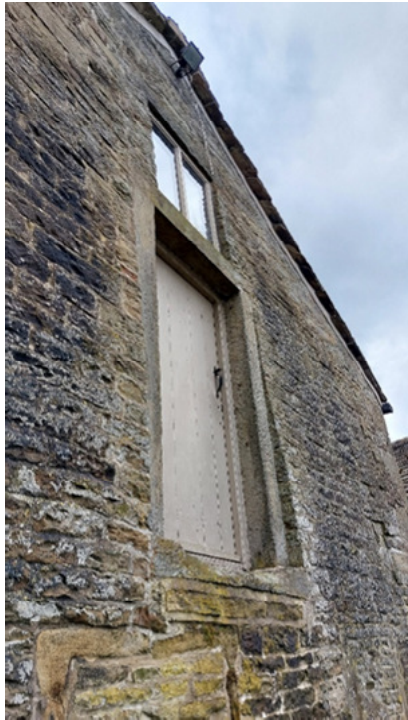
Stone mullioned upper floor door with window above

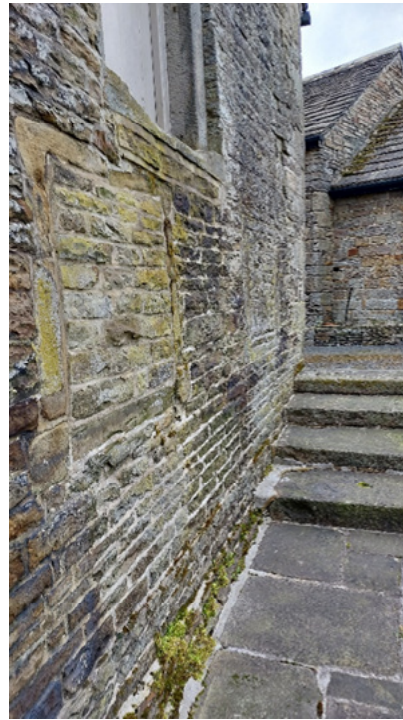
Stone mullions and headers remain of two stoned in windows

Relocation/ Reinstatement of stoned in windows to the rear elevation (including minor relocation of one window) – It is proposed to reinstate the two windows to the rear ground floor of the property to improve natural light, ventilation and views to the rear room, due to the position of one of the former openings being below the door cill above causing potential structural issues it is proposed to relocate this window to the left, this will be done by carefully matching in and reusing only the existing stone. A galvanised steel angle lintel should be installed behind the stone headers to provide support and a series of reinforced concrete lintel to support the inner walls and fill to both windows.

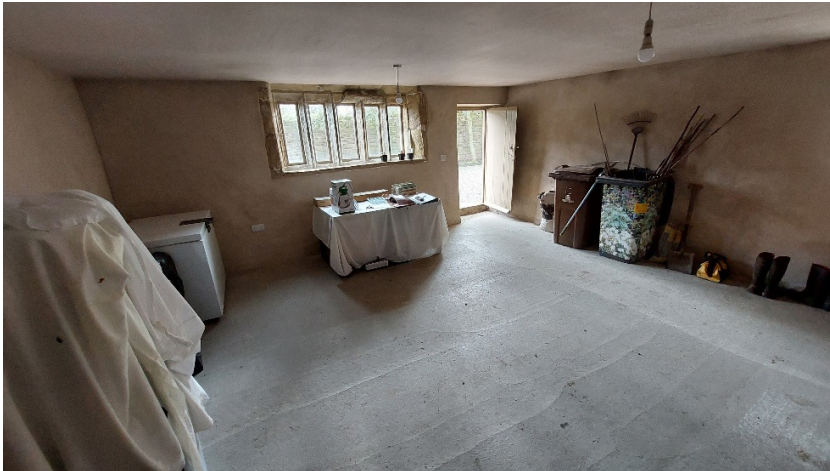
Ground floor room south side, there is a sand cement render to all walls and plasterboard to the ceiling and sand cement screed to the floors

Given the above it is proposed to remove the existing modern sand cement render that is applied to the ground floor walls, to make good the existing walls (lime pointing where required for stability) and then install a Limelite renovating plaster to a height of 1.5m to reduce the passage of moisture and salts through the wall (acting as a DPC). Install using a breathable adhesive such as Wamshell board adhesive (four plastic anchors per board can be used for additional support), STEICO internal (Square edge) woodfibre boards, a natural breathable material onto which can be applied a Lime base render finish such as Limelite Renovating plaster with additional mesh by specialist. The plaster will be stopped at the stone window surrounds so retaining these key details with a raked detail to the edge of the stonework. The existing walls vary in plumbness the boards can be fitted to follow the wall and are not required to be true and plumb. These works should be carried out by a suitably experienced contractor.

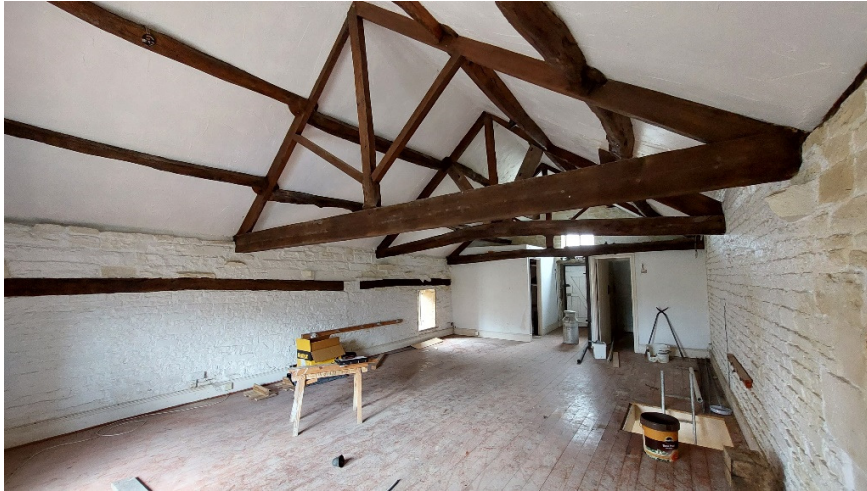
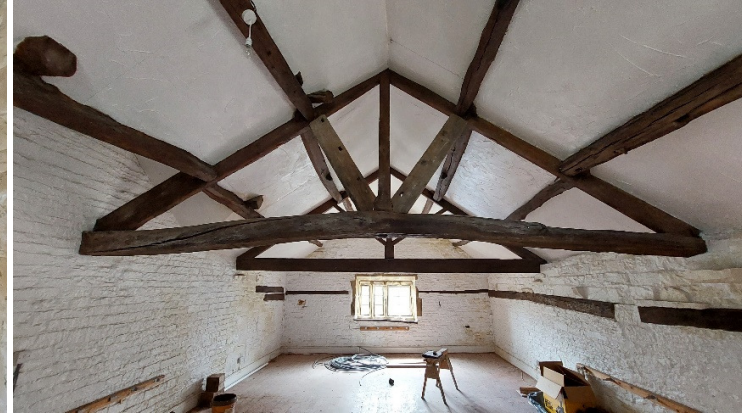
Upper floor king post trusses, this truss to the south has historically been replaced, possibly when the roof was raised, the others it is assumed are original. The walls are whitewashed stone, the floor is a more recent suspended timber with floorboards

Existing first floor stud walls will be removed and floors made good, new stud walls will be introduced as shown, these are positioned to avoid the kingpost trusses allowing a gap between stud wall and truss so the trusses are not damaged and are fully expressed, ensure it is possible to skim the walls. New stud walls should be 75mm studs at 400mm ctrs with 75mm acoustic insulation and 12.5mm plasterboard.

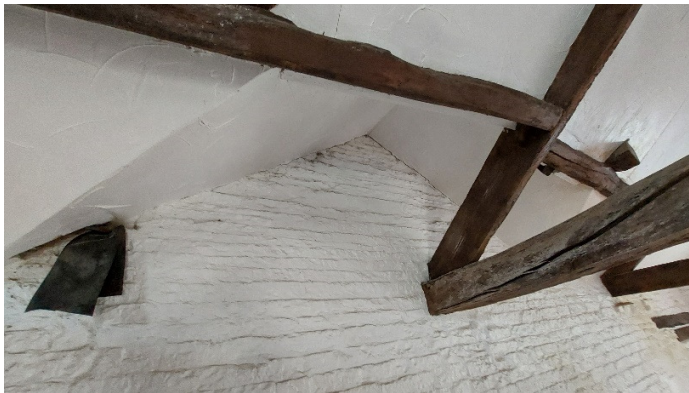
The purlins it is assumed are original to the property

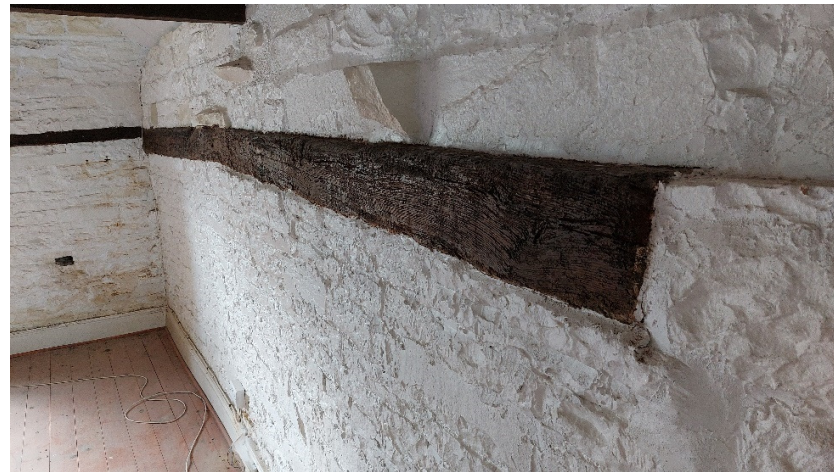
The original stone wall plate is visible in parts where the roof was raised.

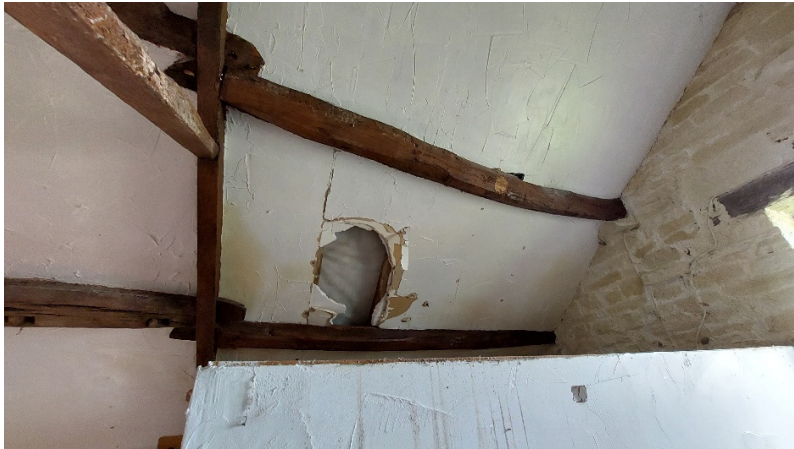
The roof has been renewed at some point with new felt and some insulation and plasterboard finish

The plasterboard ceiling to the vaulted roof will be removed between the purlins, it is understood that the roof was re-roofed a number of years ago with a new roof felt and is in good order so this can remain, remove plasterboard and any between rafter insulation and install 50mm STEICOflex 036 between rafters, Allows for 50mm ventilation zone within the rafter depth.  
50mm STEICOflex 036 below rafters screwed to the rafters.  
Limelite Renovating plaster with mesh by specialist

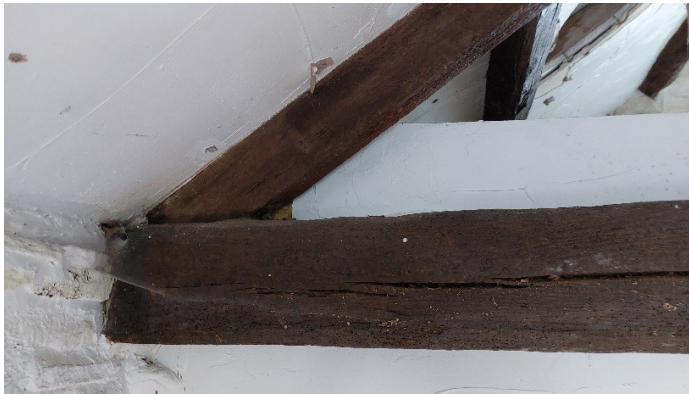
Truss to wall connection

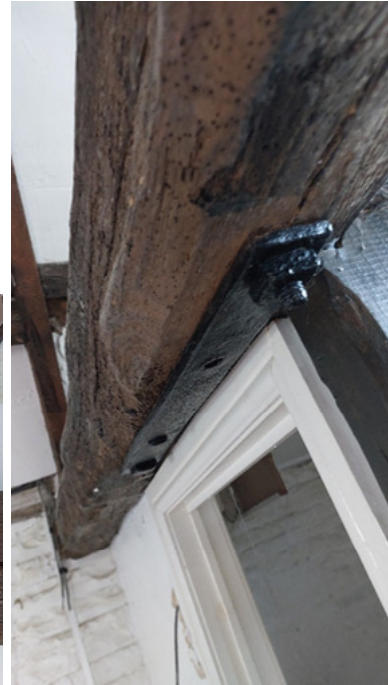
Steel plate to truss

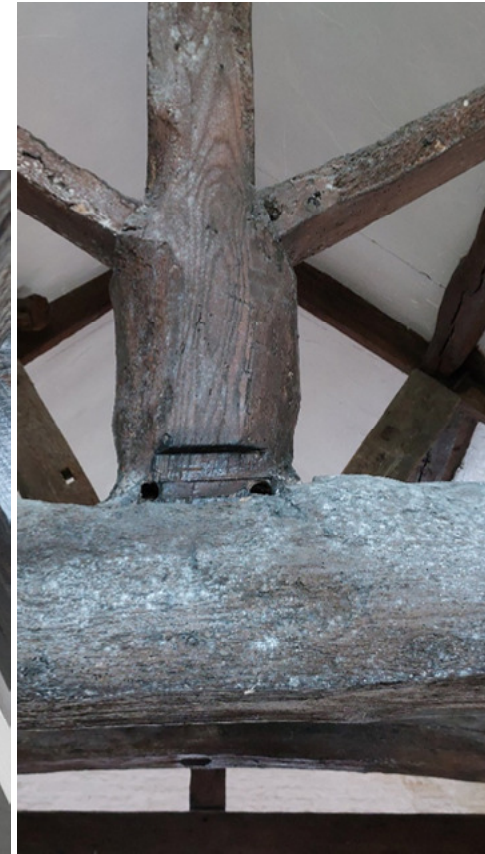
Original king post detail

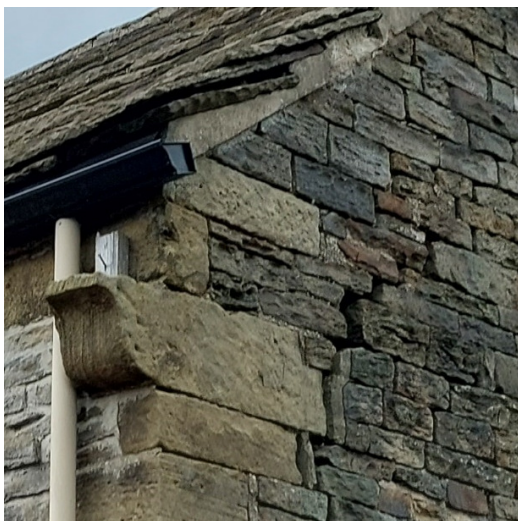
Front elevation cracks to be closed

The front elevation has a number of cracks due to historical movement, some of these cracks offer an easy passage for moisture and so local repair including removing of stones and replacement with reclaimed and carefully matched stone or rebedding of stones to equalise gaps will be required to reduce the width of perpends, some deeply recessed pointing using lime mortar may be acceptable to reduce the passage of moisture through the wall.

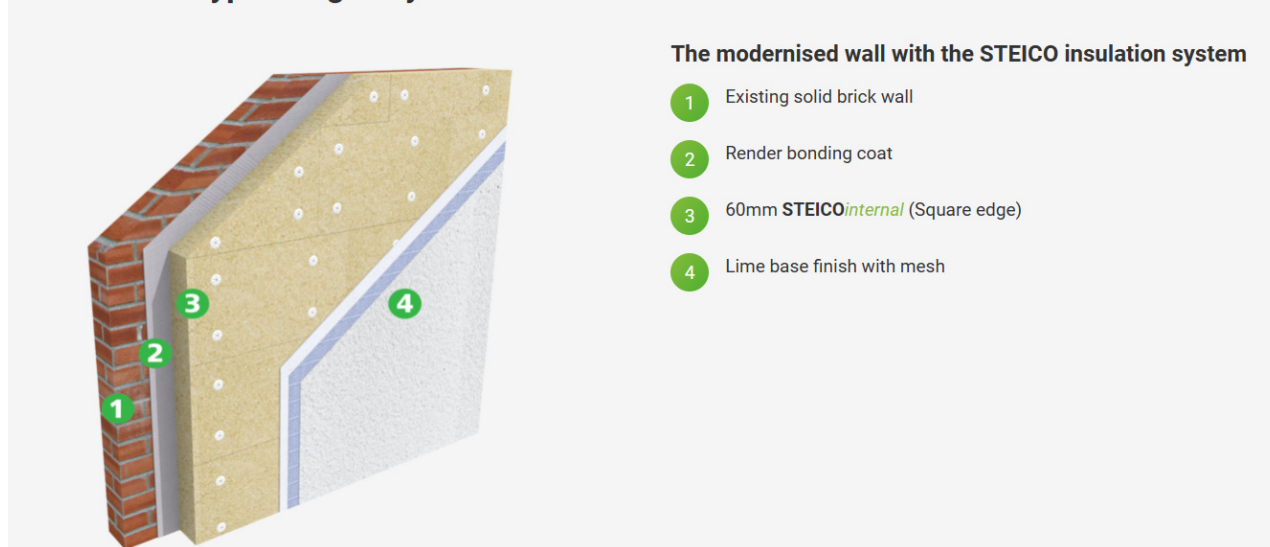
### Renovation type: Single layer internal insulation

The same solution will be provided to the first floor external walls, sand cement render not present but the white paint to the walls will need carefully removing (as this acts as a barrier to water vapour, unless details can be found for the type of paint used then removal can be assessed) and

projecting stones to be cut flush and the insulation boards bonded directly to the stone (4 plastic anchors per board). The render should be stopped at the stone window surrounds with a raked detail, the wall insulation should be carefully joined with the roof insulation.

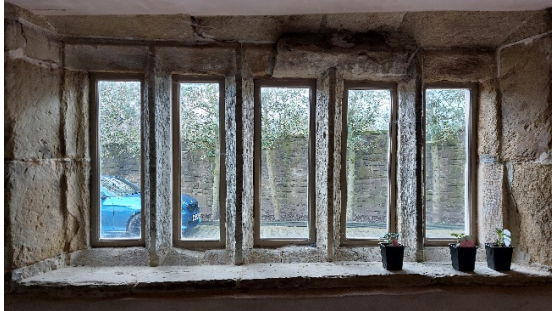
Kitchen window, render to be finished with a raked detail to the edge of the stone surround.

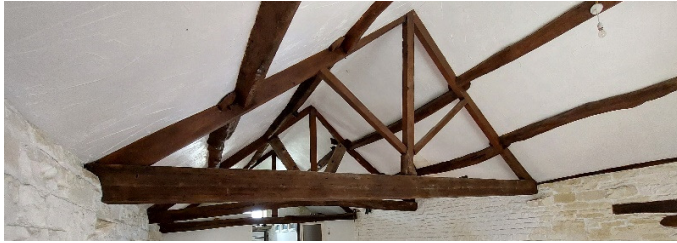
Oak trusses and purlins will lose approx 50mm of their depth with the thicker insulation

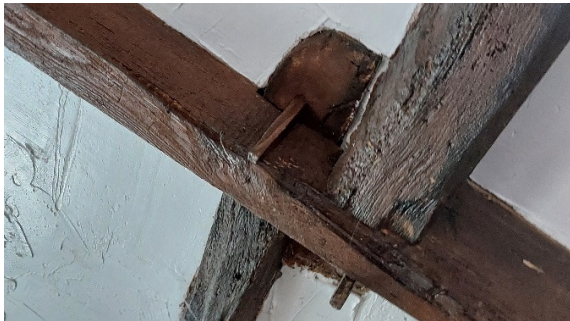
Timber to timber details will lose some depth
