Replacement of gutters and rainwater pipes

Darton Church Hall, Church Street, Darton, Barnsley S75 5HF

### **Design and Heritage Statement**

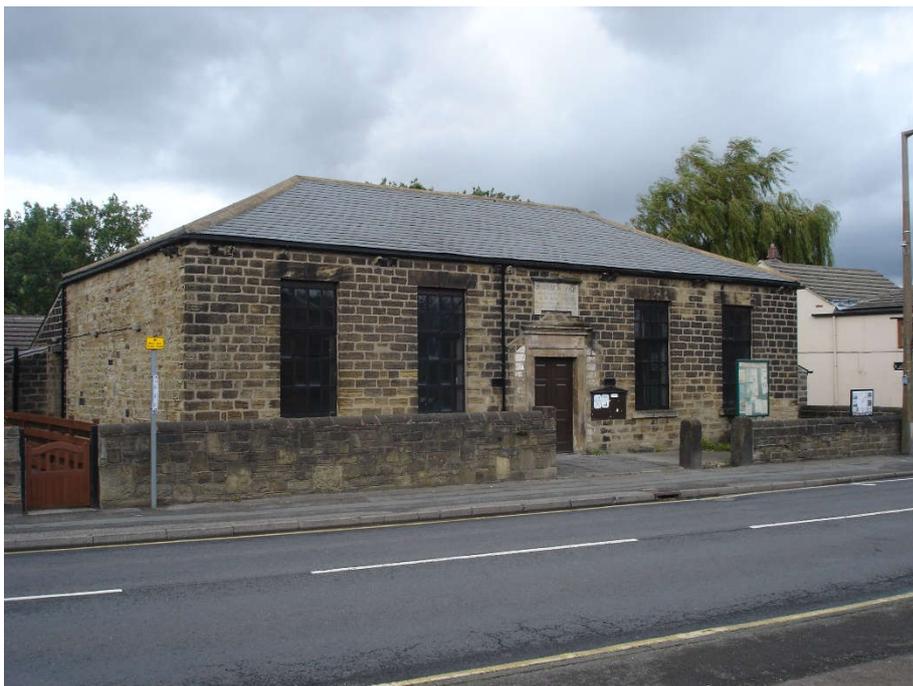
Fig 01. Front, south east elevation.

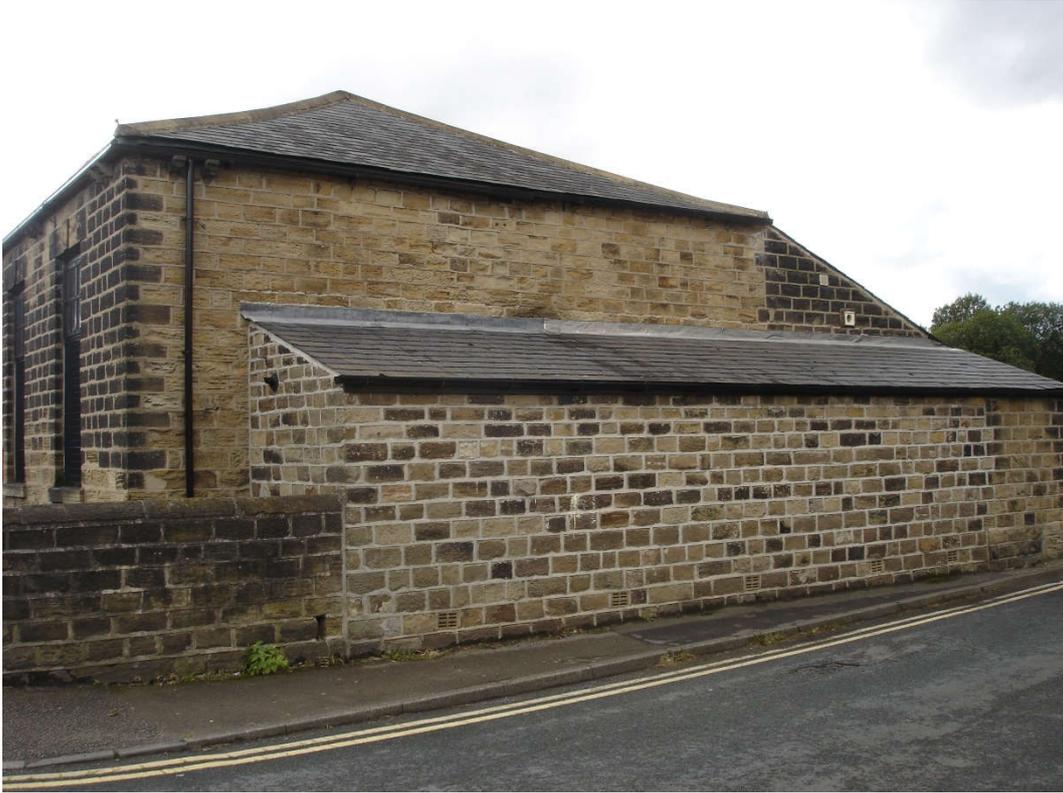
Fig 02. Side, north east elevation showing lean to.

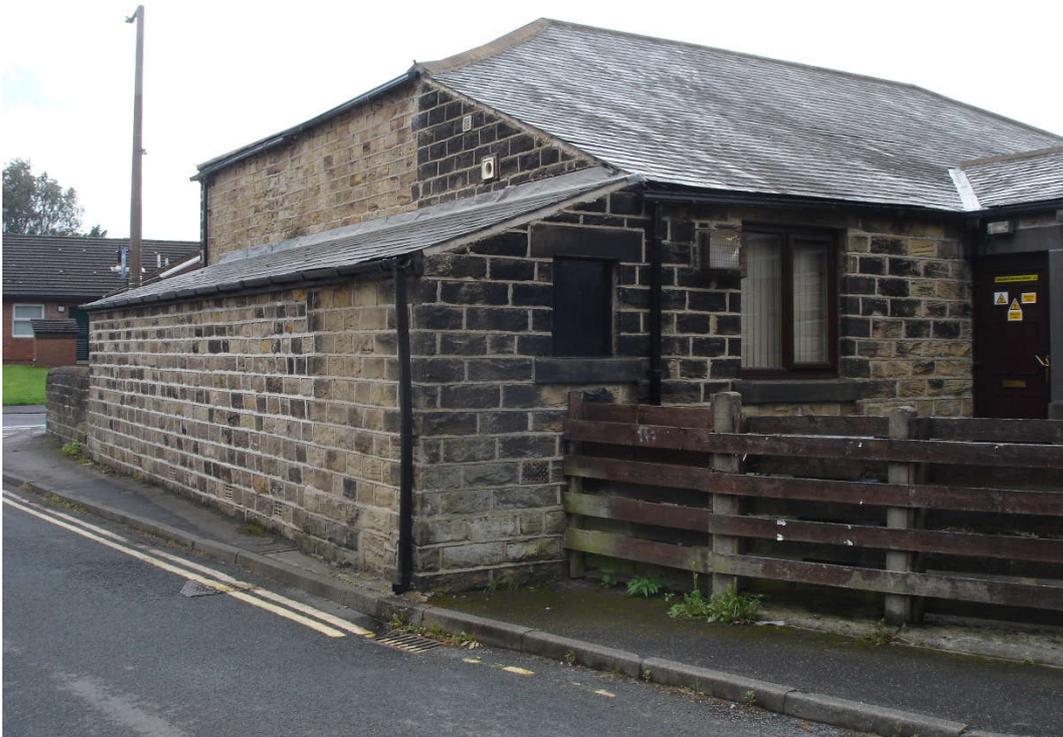
Fig 03. Side and part rear north west elevation.

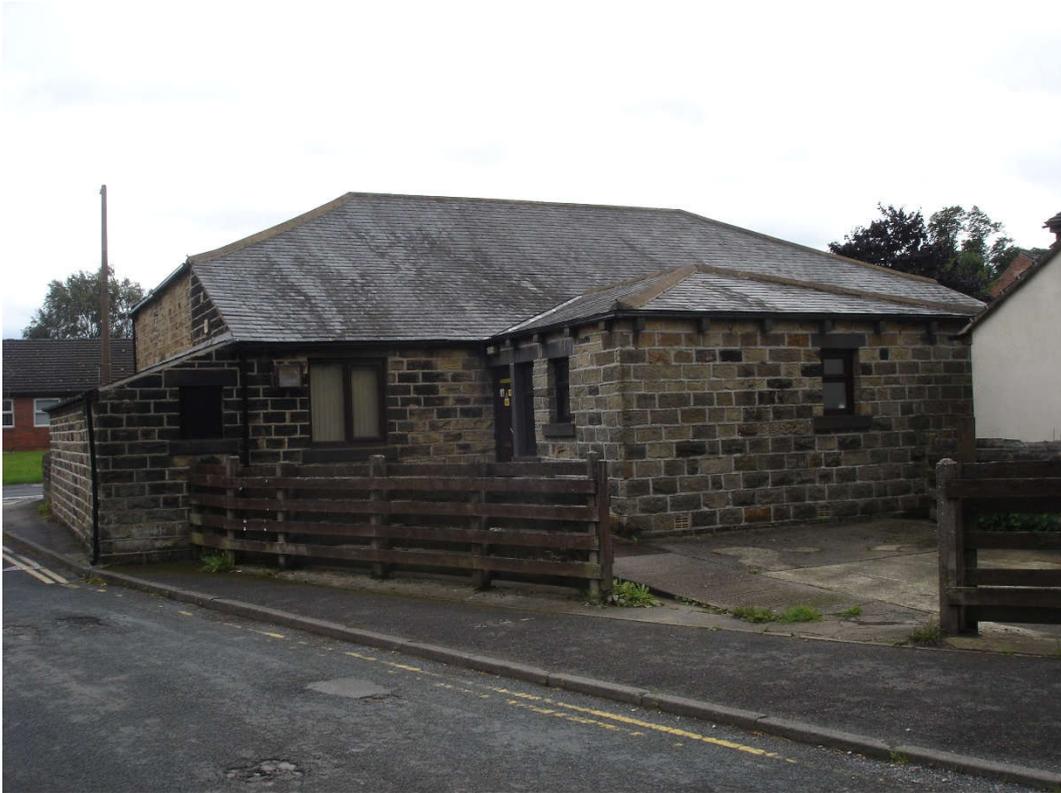
Fig 04. Rear, north west elevation showing single storey pitched roof extension.

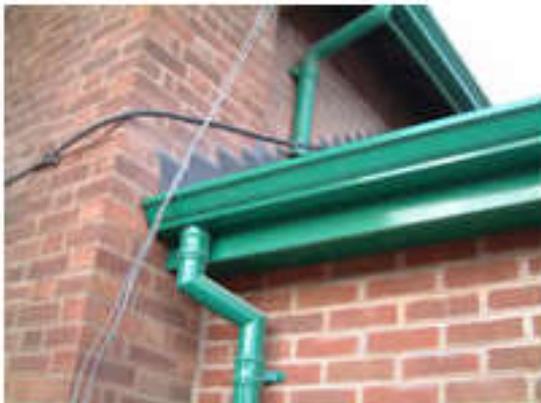
Fig 05. Image showing typical gutter section and rainwater pipe with cast-look collars used at a church hall in Balby Doncaster. Proposals for this project wil have a black finish.

They propose to use 125mm Ogee Section Aluminium gutters and 76mm dia rainwater pipes with cast-look collars all with a black ppc finish by Amazon Rainwater Systems. The ogee section gutters provide a similar profile to the to the timber ogee but provide better capacity and the rainwater pipes include collars that provide a similar appearance to original cast iron rainwater pipes. Where there are stone corbels these will be retained and used to support the replacement gutters and elsewhere the gutter will be supported on simple rise and fall brackets fixed directly to the stone without timber fascias.

The impact of the replacement gutters and rainwater pipes on the external appearance of the building is considered to be very low. The ogee section of the proposed gutters and the rainwater pipes with cast-look collars will be almost indistinguishable from traditional timber ogee gutters and cast-iron rainwater pipes.
