Client  
**Paul Thackray**  
**Shotties Island**  
**Shaw Lane**  
**Carlton**  
**Barnsley**

Job Title <b>Former Carlton Colliery</b>			
Project Title <b>Restoration Strategy</b>			
Scale 1:1250	Date Aug 06	Drawn by SW	Checked JC
Dwg. title <b>Restoration Scheme</b>			
DWG No. DTS/CC/2006/REST	Job. no. 03	Rev. 00

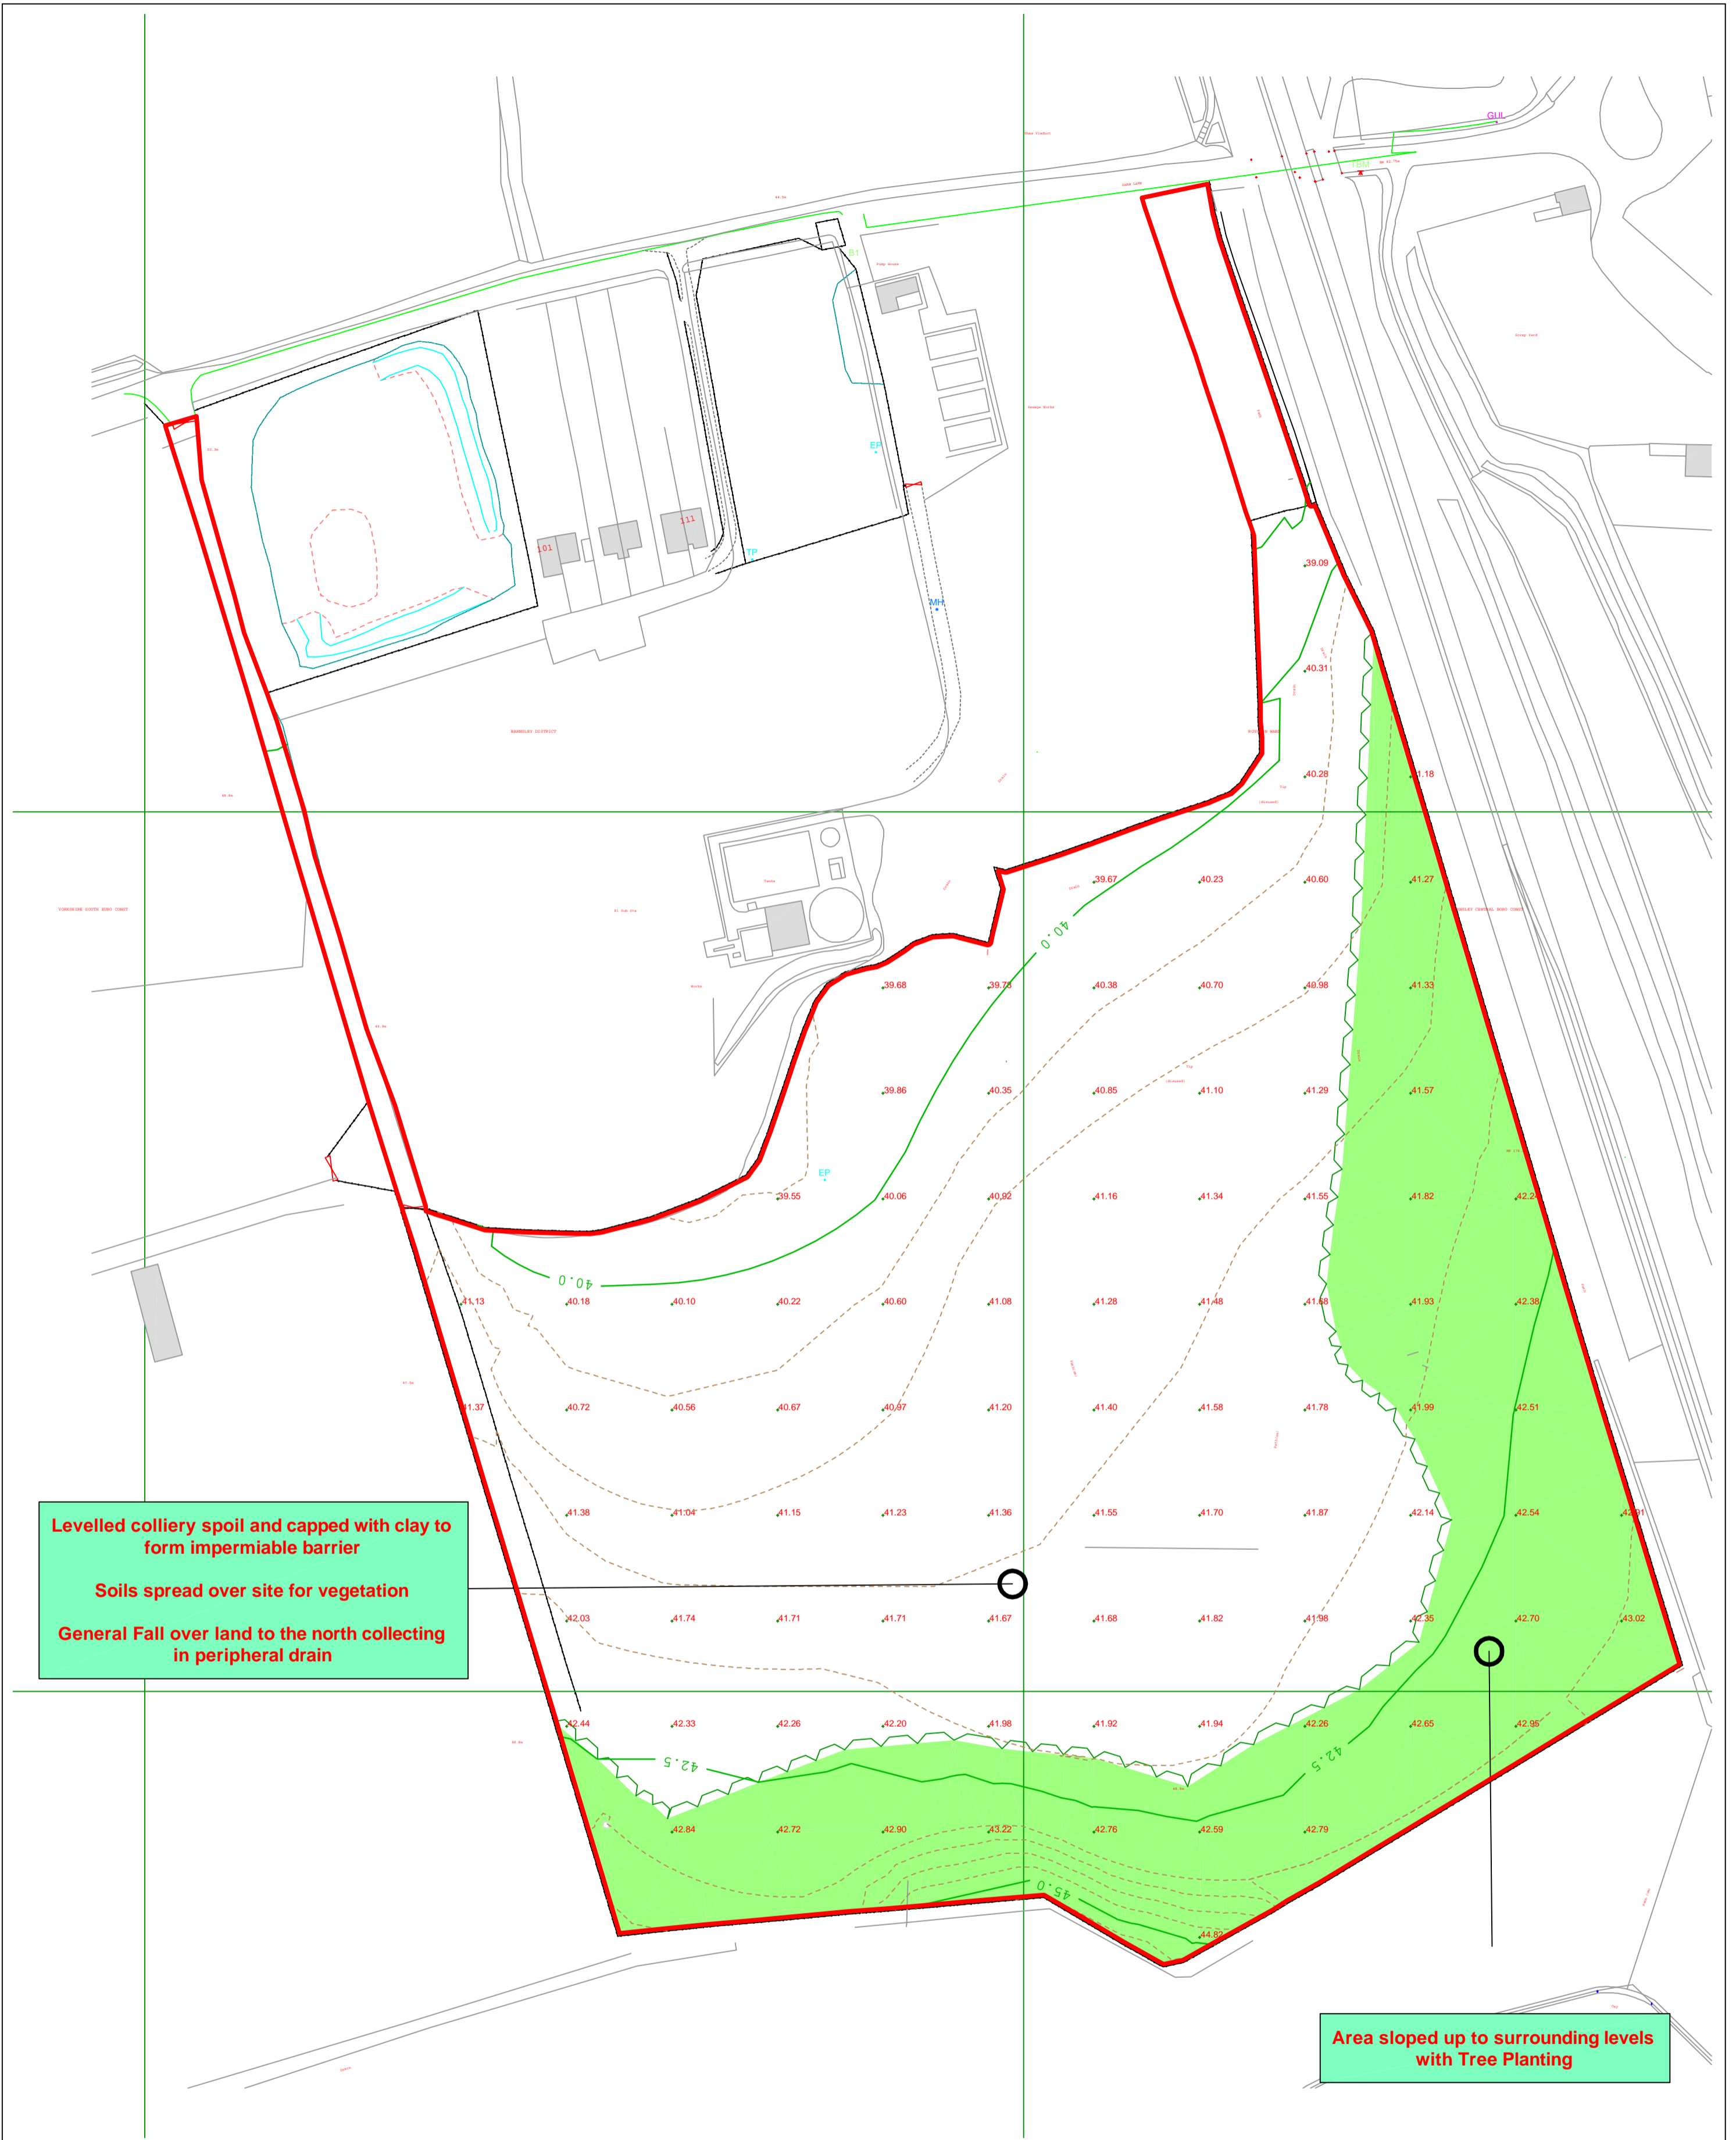
**Levelled colliery spoil and capped with clay to form impermeable barrier**

**Soils spread over site for vegetation**

**General Fall over land to the north collecting in peripheral drain**

**Area sloped up to surrounding levels with Tree Planting**
