Sevenairs Consulting Ltd

Thurnscoe Bridge Lane, Thurnscoe, Barnsley

Road Safety Audit Stage 1

July 2025

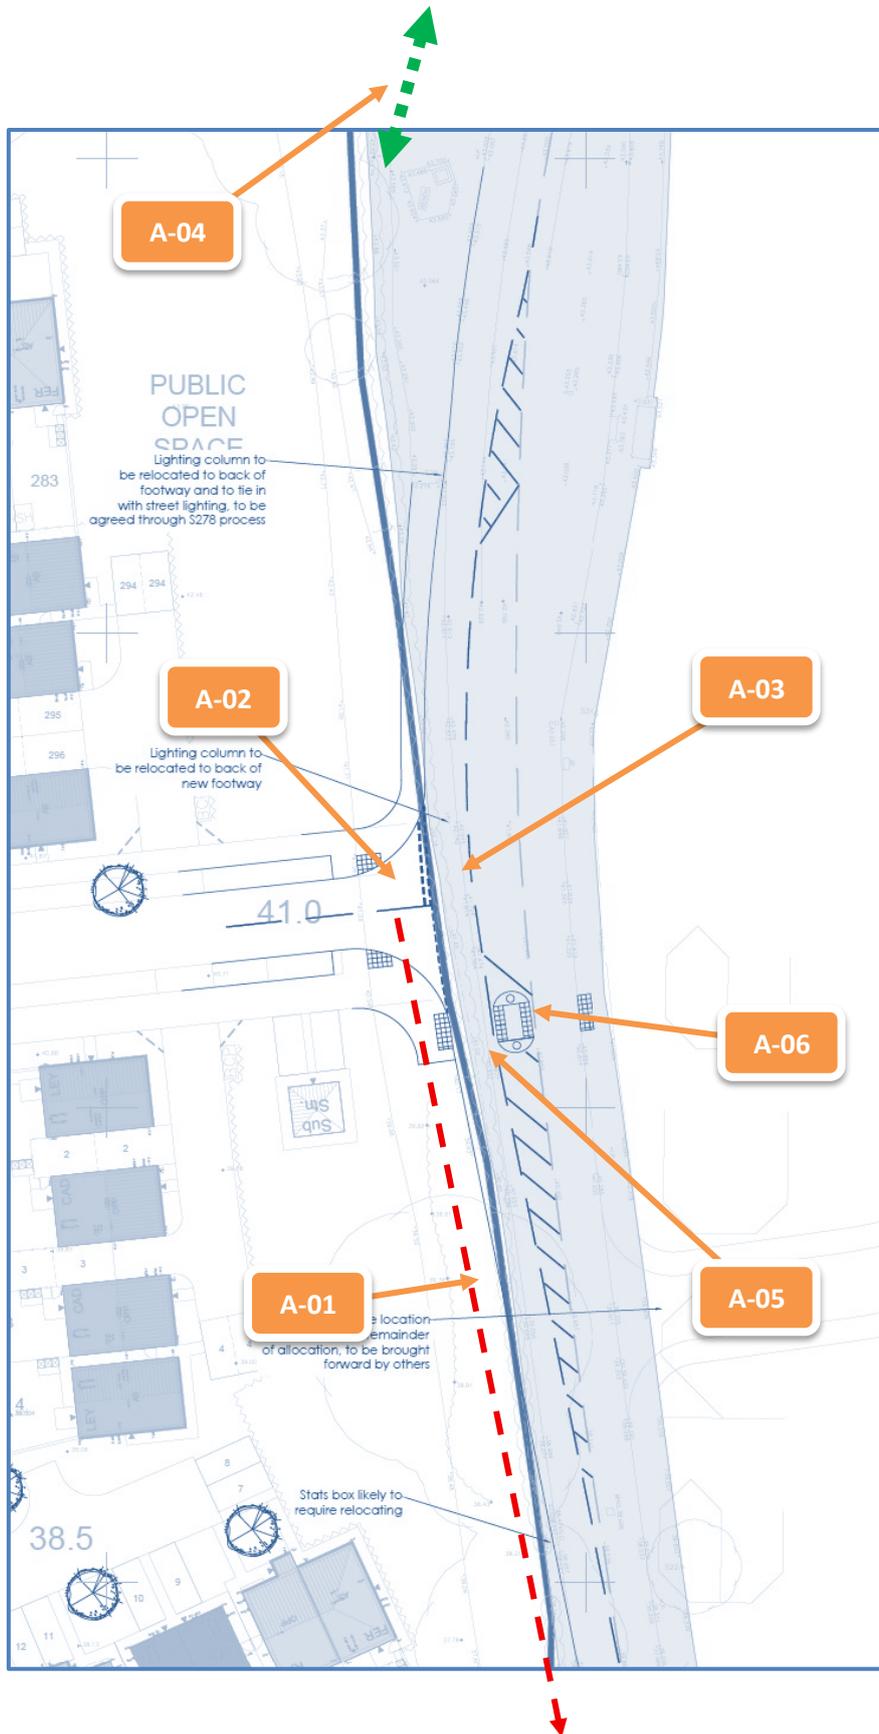
Problem Location Plan

PROBLEM – A-01

Location: Thurnscoe Bridge Lane – South of the development access.

Summary: Landscaping – Future growth from trees and bushes may obstruct visibility consequentially increasing the risk of junction related collisions.

No junction visibility has been indicated on the development access. Whilst this will be sufficient to the north, provision to the south when considering the likely speed of vehicles transitioning from the semi-rural section is likely to require some removal of landscaping. The audit team consider that speeds may be greater than a typical 30mph road on this approach. Future growth from remaining trees and bushes to the southern side of the development access may obstruct visibility consequentially increasing the risk of junction related collisions.

PROBLEM – A-02

Location: Thurnscoe Bridge Lane – Development access and main carriageway

Summary: Drainage – Insufficient surface water drainage may increase the risk of skidding type collisions at the junction as well as slips and falls by pedestrians.

At this early stage, no details have been provided on the proposed drainage arrangements. The site appears to raise up to a higher level than the main carriageway. As such, this may require measures to manage surface water around the junction to reduce the risk of surface water from the development entering Thurnscoe Bridge Lane or standing water and detritus in the junction area that may consequently cause skidding type collisions near the junction or slips and falls by pedestrians crossing in this area.

PROBLEM – A-03

Location: Thurnscoe Bridge Lane – Main carriageway.

Summary: Skidding Resistance – Carriageway surfacing across part lane widths may increase the risk of loss of control type collisions.

The drawings indicate that carriageway widening is to be provided with no indication of resurfacing of the existing carriageway nor what skidding resistance is to be provided. There is a risk here that, if widening is provided by means of haunching the carriageway width into the verge, a differential skidding resistance is introduced between the new and old carriageway surfacing. This difference in skidding resistance may increase the risk of loss of control type collisions, especially when the carriageway surface is wet.

PROBLEM – A-04

Location: Derry Grove – Near junction with Thurnscoe Bridge Lane.

Summary: Specific Road Users – Lack of crossing facility may increase the risk of collisions involving users who rely on mobility aids.

There is a desire line for pedestrians between the development and facilities to the north. However, there is no provision for pedestrians with mobility issues, specifically those users with prams, wheelchairs or mobility scooters. The alternatives for these users may require them to use drop kerbs provided for driveways or to cross at locations where visibility to approaching vehicles may be otherwise compromised. This lack of dropped crossings on desire lines may increase the risk of collisions involving users with mobility issues.

PROBLEM – A-05

Location: Thurnscoe Bridge Lane – At the pedestrian refuge.

Summary: Cycles – Width provision for cycles may increase the risk of shunt or side swipe type collisions involving this user group.

Details of kerb-to-kerb widths have not been provided at the proposed refuge. At this location, cyclists may be at risk from motor vehicles passing too close due to a potential ambiguity of width as they overtake the slower moving cycle. This would be especially a problem for northbound cyclists who are traveling uphill at this point. Incompatible width provision for cycles may increase the risk of shunt or side swipe type collisions involving this user group.

PROBLEM – A-06

Summary: Lighting – Insufficient carriageway surface illumination may increase the risk of collisions involving pedestrians during the hours of darkness.

There is currently street lighting provision in the vicinity of the proposed pedestrian refuge. This is likely to provide a standard level of carriageway illumination for a semi-rural/residential frontage. The introduction of a refuge will focus pedestrians to cross at this location where pedestrians may not have enough contrast against background light from the adjacent development and vehicle headlights. Insufficient carriageway surface illumination at the crossing point may increase the risk of collisions involving pedestrians during the hours of darkness.

RECOMMENDATION

It is recommended that the extents of junction visibility at the development access is established and kept clear of any obstruction that may grow or mature in future years and that the extents of the visibility is clearly marked to aid future maintenance.

It is recommended that drainage details are provided at the next stage of road safety audit including gully locations, levels and contours.

It is recommended that the widening provided is done so in full lane widths and the revised crown of the road is located such to avoid the application of any adverse camber.

It is recommended that a dropped pedestrian crossing with (ideally) tactile paving is provided across Derry Grove. This is likely to require the dropped vehicle crossing off Derry Grove for the field access to be removed also.

It is recommended that, as per advice in LTN 1/20 Chapter 7, that widths between 3.1m and 3.9m may encourage close overtaking by motor vehicles at pinch points and should be avoided. It is also recommended that wider provision is made for the northbound, uphill direction.

It is recommended that carriageway surface illumination is provided to higher class/level in the vicinity of the proposed crossing point. This may be as simple as increasing the output from the existing LED luminaries.
