# Arboricultural Method Statement

## Capitol Park, Barnsley

| <b>Project Description</b> | Hybrid planning application for an extension to Capitol Park comprising a) development of 2no warehouses (floorspace of 9,755m <sup>2</sup> and 7,804m <sup>2</sup> ) for general industrial and storage and distribution purposes (use classes B2 and B8) with provision of ancillary office accommodation - Outline with all matters reserved apart from means of access; and b) full application for provision of associated earthworks, demolition of existing bungalow and formation of access (Amended Plans) |
| <b>Document Reference</b> | 220825-1.0-CPB-AMS-T21 |

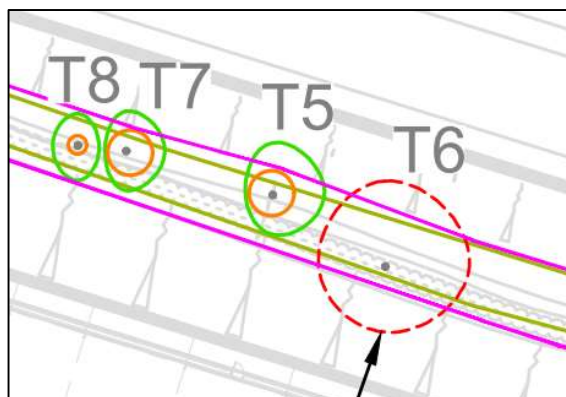
- 8) Areas of groups, woodland, or hedges to be removed will be minimised to enable the works and installation of tree protection barriers only.
- 9) An example of trees/groups/hedges and part groups/hedges to be removed in the Tree Protection Plan with red dashed outline and retained trees/groups/hedges with green solid outline (crown spread) and orange outline (Root Protection Area) is provided below.

**Example of red dashed outline (to be removed) and solid green and orange outline (to be retained)**

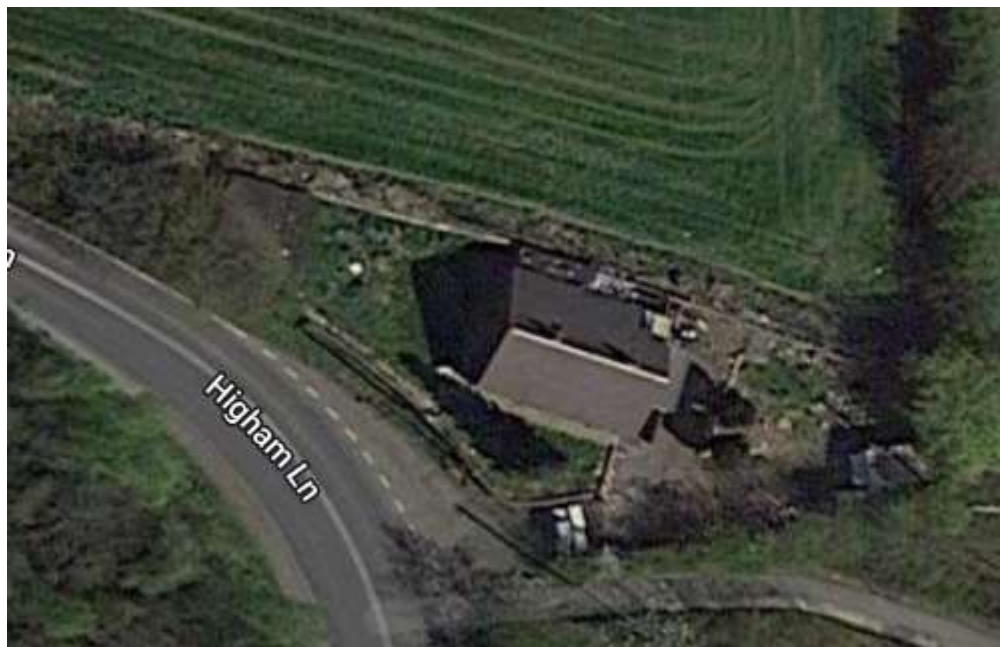
- 1) Before access can be gained an existing bungalow and associated landscaping will need to be demolished and cleared.
- 2) Tree removal and protection measures associated with this task will depend on the final layout (roundabout or no roundabout).
- 3) The same applies to this work, as the wider site and trees to be removed should be removed first, followed by the installation of the tree protection barrier, as shown on the relevant Tree Protection Plan, following the principles in Tasks 1 and 2 above before the bungalow is demolished and the site is cleared, or any plant machinery is brought onto the site.
- 4) Once the tree work is complete and the tree protection barriers are installed, the works can progress as planned, once all operatives have been briefed on the relevance of the tree protection barrier.
- 5) Location of Bungalow to be removed is shown below.

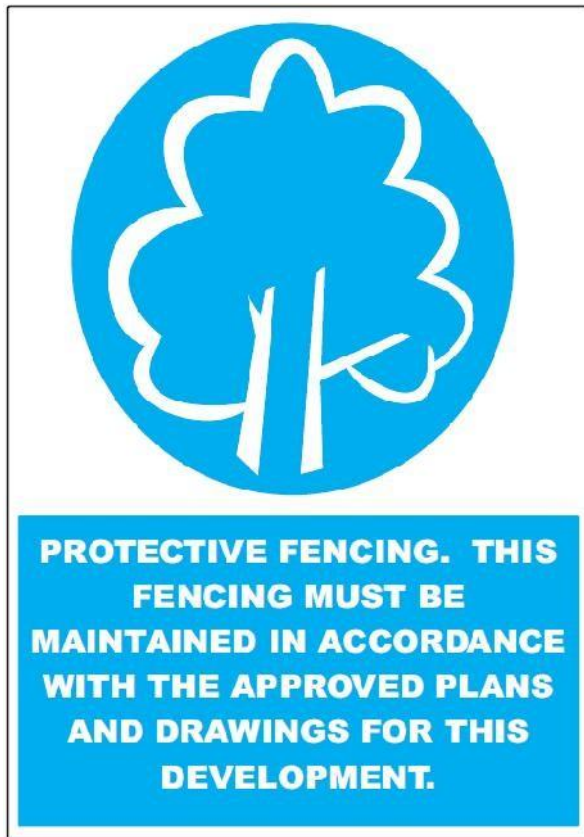
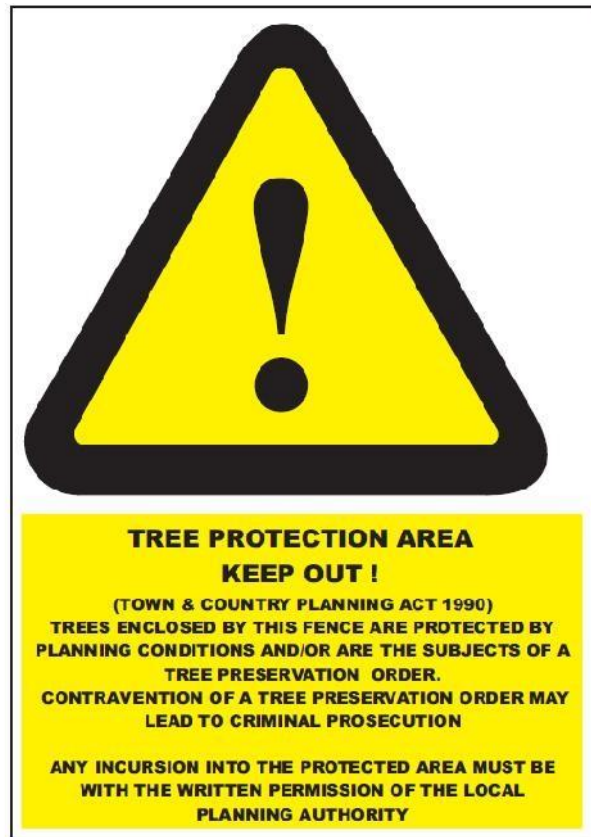
**Example Tree Protection Fencing Sign**

- 4) A tree protection information sign (example shown at Appendix E) will be secured to every third fencing panel at eye level, facing into the site. This will aid identification of the CEZ and inform site operatives of its importance.
