## **ACCESS AND DESIGN STATEMENT**

| <b>Project Ref:</b> | <b>Derbyshire barn</b> |
| <b>Proposal:</b> | <b>The site currently has planning permission to convert an attached barn into a residential dwelling – App. No. 2006/1128. &amp; App 2008/0422 [both granted]</b> |

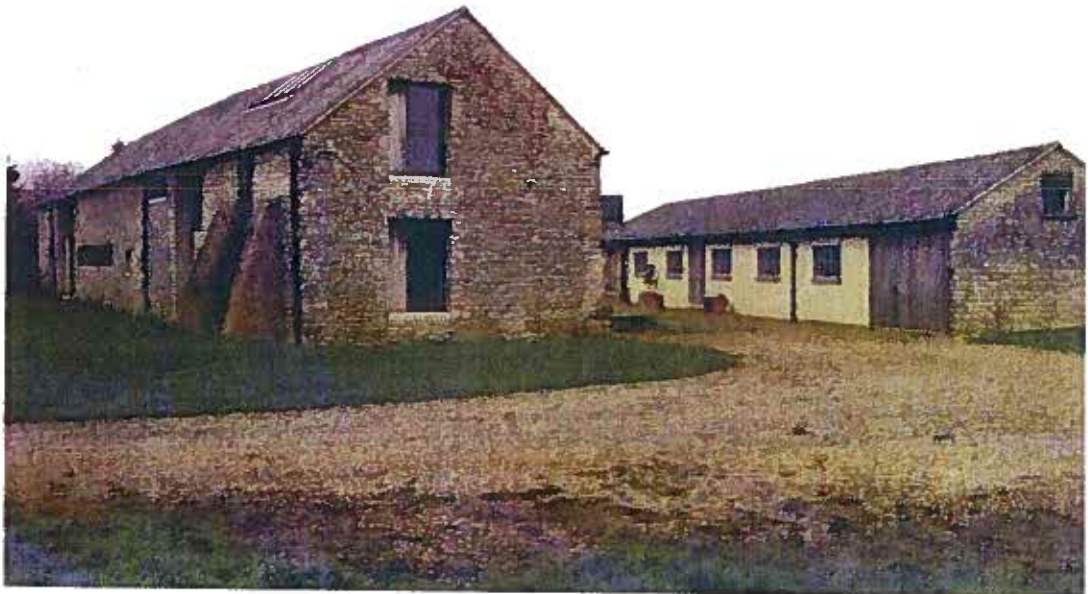
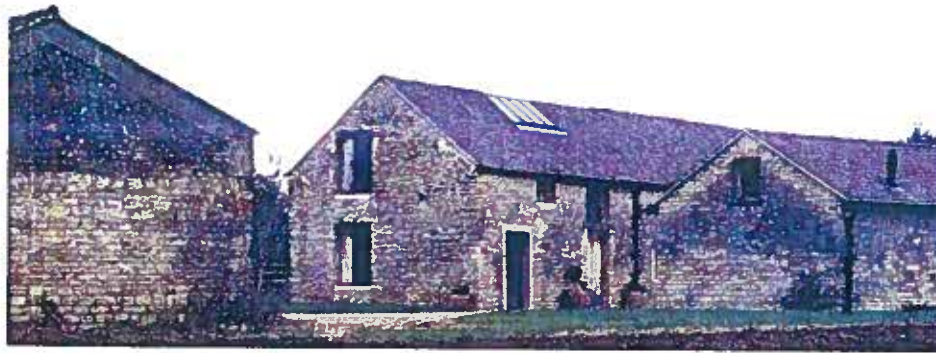
The proposed windows seek to in both material and form to be sympathetic to the context of a farmland barn. Below are images of a similar successful conversion utilising a similar fenestration strategy.
