Barugh Green Road, Barugh Green, Barnsley

Road Safety Audit Stage 1

July 2025

Barugh Green Road, Barugh Green, Barnsley – Road Safety Audit Stage 1

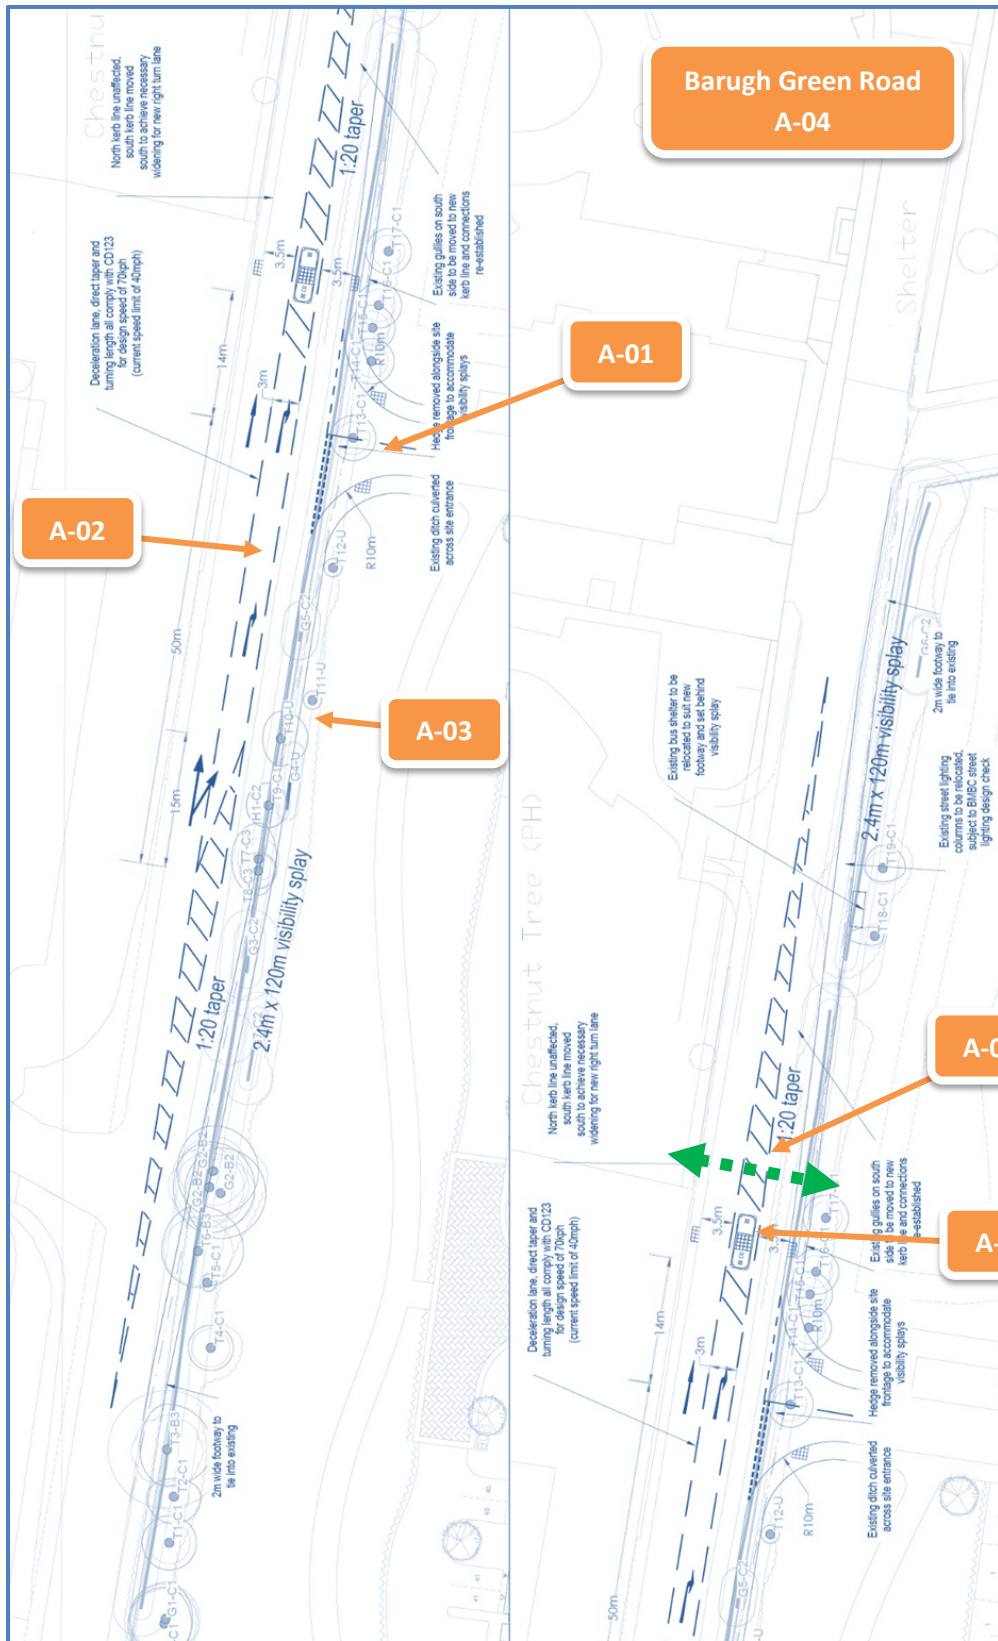
Problem Location Plan

Summary: Drainage – Insufficient surface water drainage may increase the risk of skidding type collisions at the junction as well as slips and falls by pedestrians.

Summary: Skidding Resistance – Carriageway surfacing across part lane widths may increase the risk of loss of control type collisions.

Summary: Fences and Road Restraint Systems – Lack of barrier protection to the drainage ditch may increase the risk that pedestrians or other road users enter the ditch and sustain injuries or drown.

Summary: Speed Management – Speed limit may increase the injury severity in the event of a collision involving a pedestrian or other active mode.

Summary: Pedestrians – Lack of footway space at the dropped crossing may increase the risk of pedestrians and other active modes being involved in a collision on the main carriageway.

Summary: Lighting – Insufficient carriageway surface illumination may increase the risk of collisions involving pedestrians during the hours of darkness.

It is recommended that drainage details are provided at the next stage of road safety audit including gully locations, levels and contours.

It is recommended that the widening provided is done so in full lane widths and the revised crown of the road is located such to avoid the application of any adverse camber.

It is recommended that a barrier treatment proportionate to the level of risk is provided between the drainage ditch and areas where pedestrians and other road users may be. This could be as simple as a fence or hedgerow or, if established as appropriate, a road restraint system.

It is recommended that the existing 40mph speed limit along Barugh Green Road is reduced to 30mph.

It is recommended that the proposed pedestrian refuge is relocated marginally east to the supermarket pedestrian access where there is additional space at the back of the footway. It is also recommended that negotiations are entered into to establish if widening of the footway behind the highway boundary can be provided.

It is recommended that carriageway surface illumination is provided to a higher class/level in the vicinity of the proposed crossing point. This may be as simple as increasing the output from the existing LED luminaries.
