**ARBORICULTURAL IMPACT ASSESSMENT
to BS 5837:2012
at
Clough Fields Road
Hoyland
Barnsley
South Yorkshire
S74 0DB**

JCA Ref:
22701-A/AJB

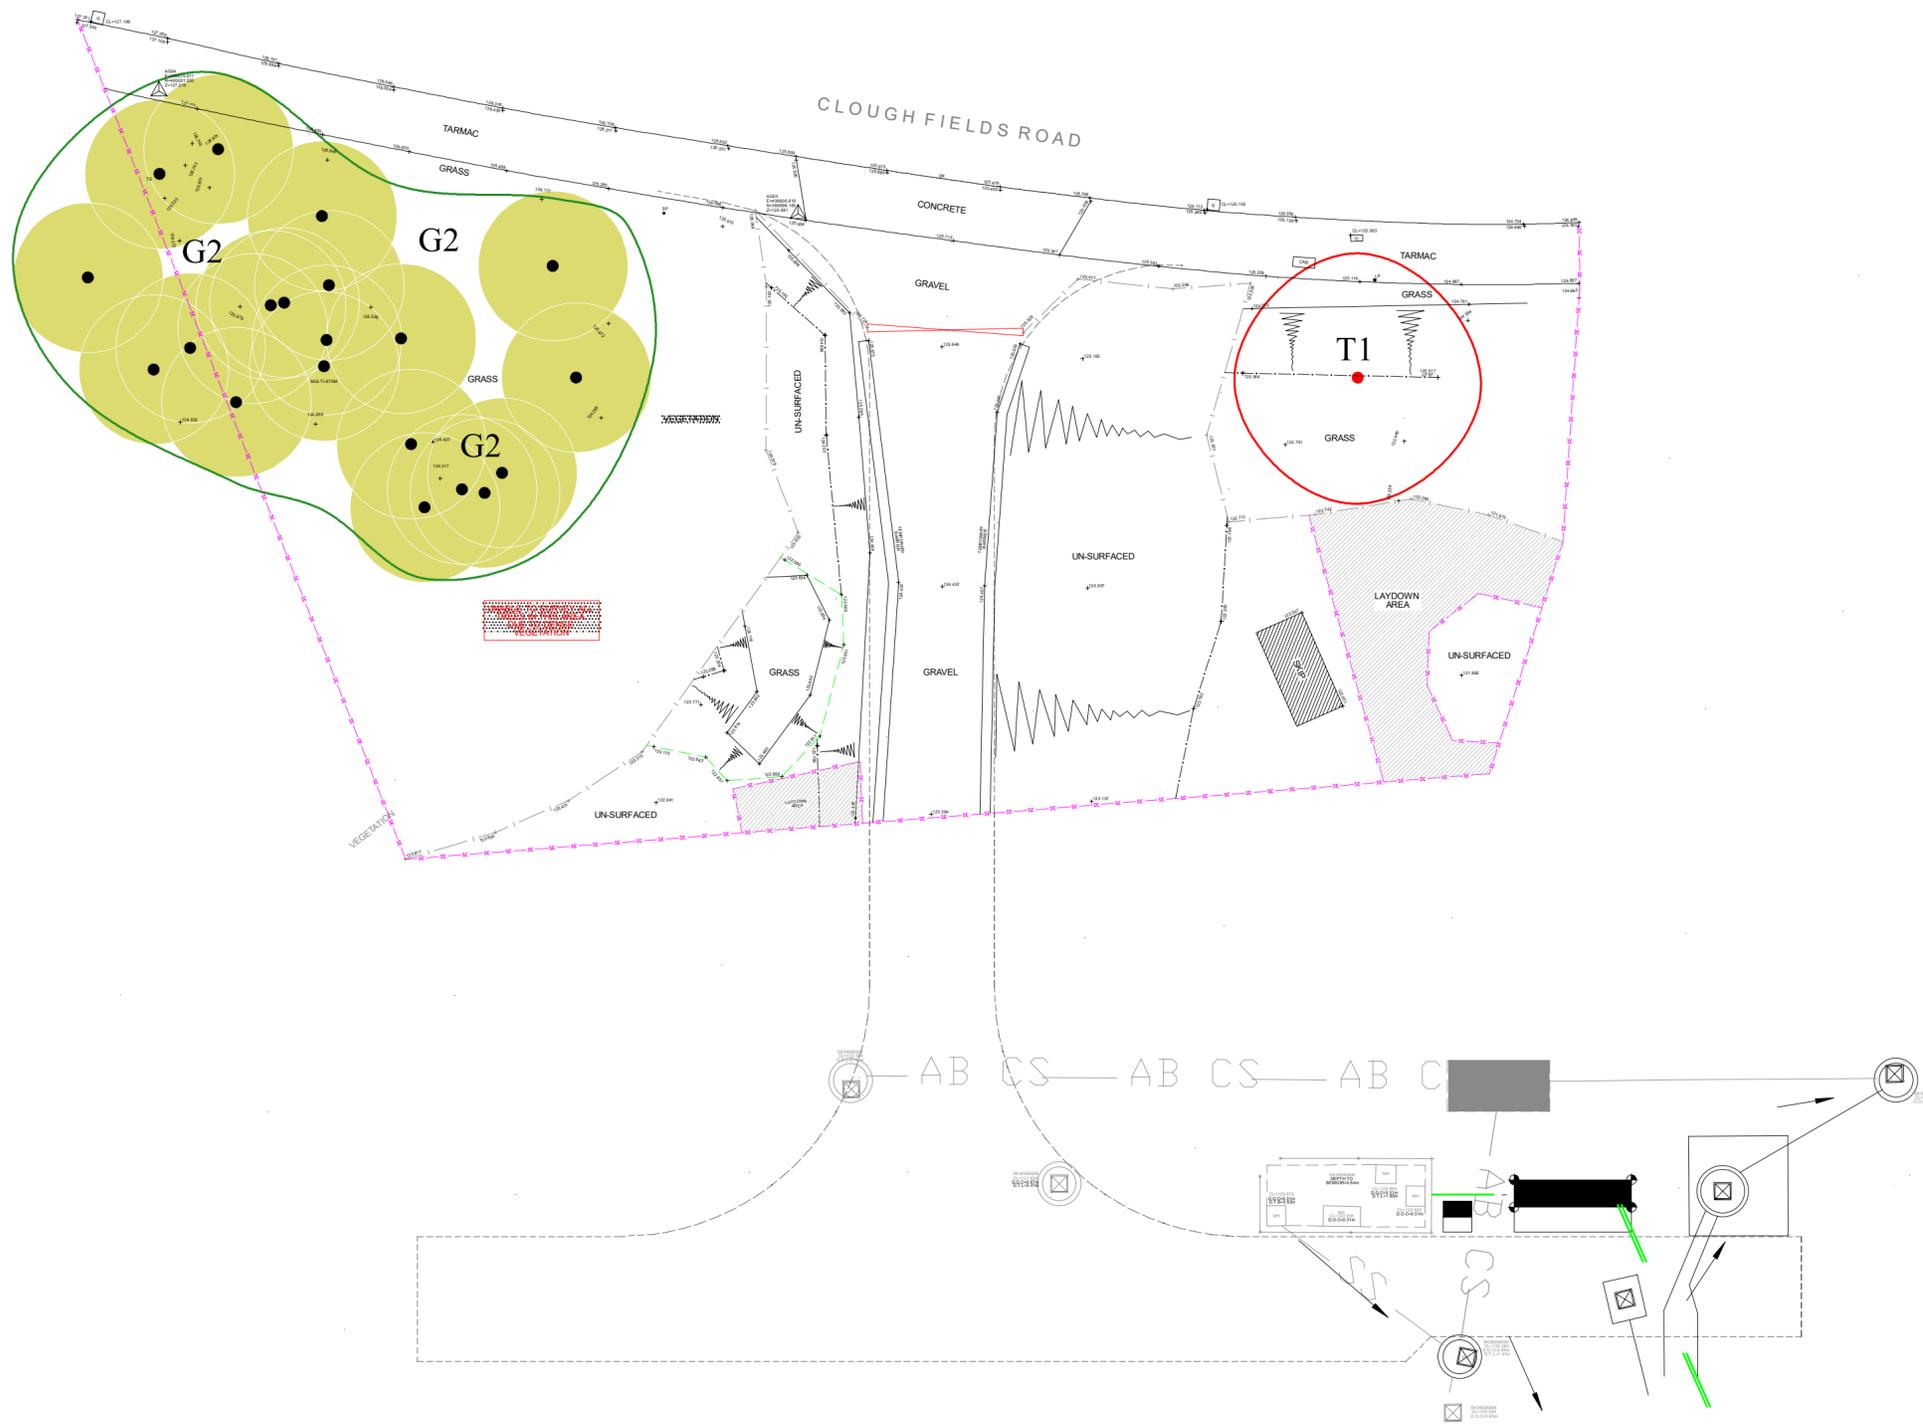
Appendix 6: Arboricultural Implications Plan

TREE/GROUP TO BE RETAINED
	TREE TO BE REMOVED FOR ARBORICULTURAL REASONS
	STEM OF TREE TO BE RETAINED
	STEM OF TREE TO BE REMOVED FOR ARBORICULTURAL REASONS
	ROOT PROTECTION AREA

- 3.3.1 As the development has already taken place and as **G2** is afforded adequate protection by a site perimeter fence, there are no implications for retained trees and additional tree protection measures are not deemed to be necessary.
