# ARBORICULTURAL REPORT

to BS 5837:2012 at:

***Thurnscoe Road,  
Bolton Upon Dearne,  
Rotherham  
S63 8JW***

Reference: *AWA6250*

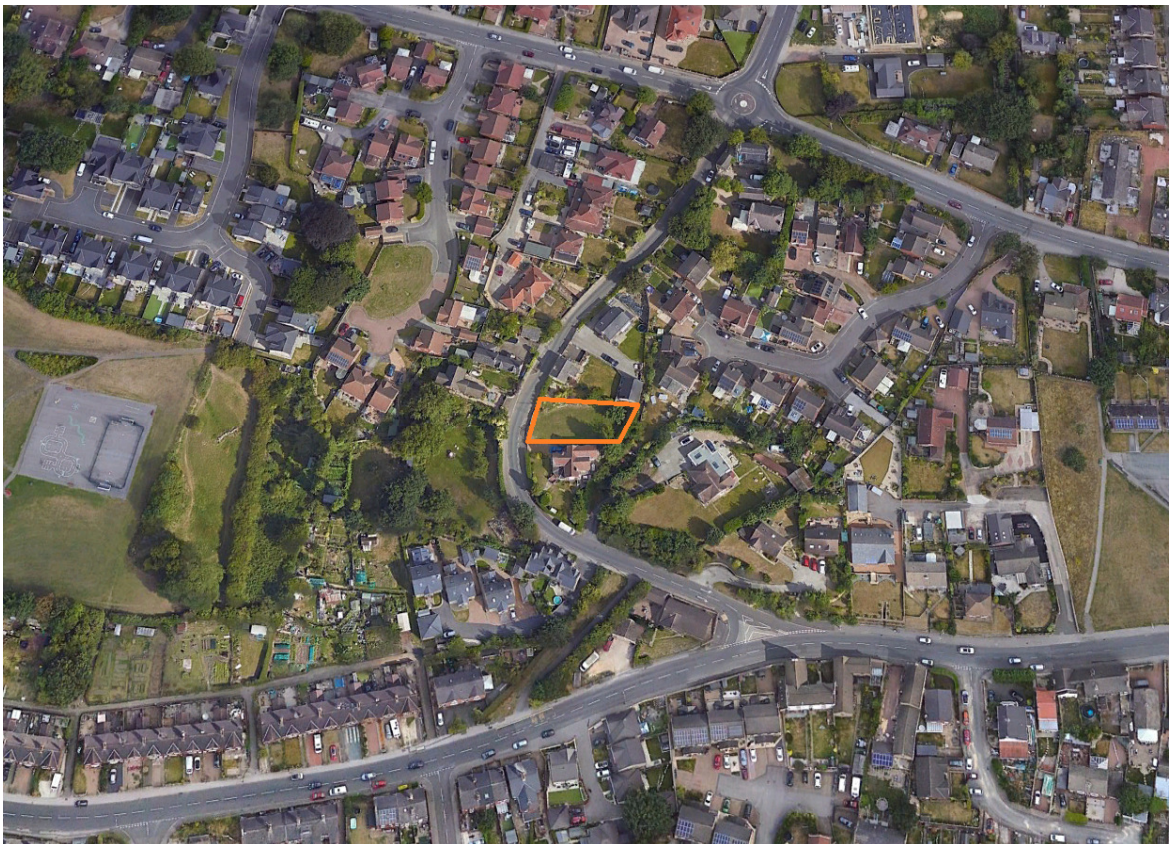
2.1.1 The site comprises a vacant plot of land located on Thurnscoe Road in Bolton Upon Dearne, Rotherham, South Yorkshire. Thurnscoe Road borders the site's western boundary and residential properties are situated to the north, east and south of the site.

2.1.2 The approximate area of the survey is highlighted in the (2022 Google Earth) image below:

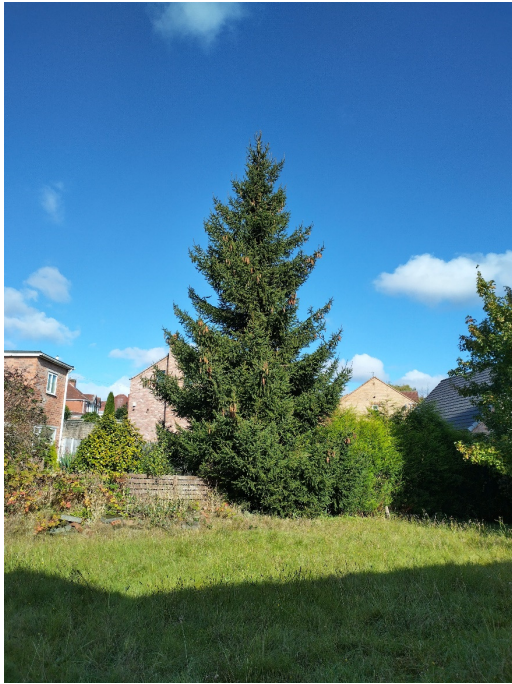
Photo 1: T1 from south west

- 3.2.5 Spruce T1 and Cypress T2 are situated in neighbouring gardens and were inaccessible so were only given cursory inspections with measurements estimated and condition values indicative only.

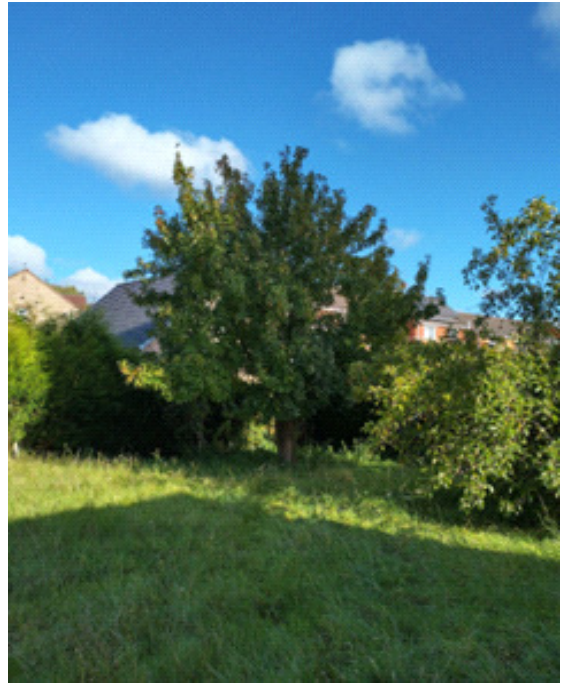
Photo 2: T2 from south west

- 3.2.3 Full details of the surveyed trees are provided in the attached tree data schedule at Appendix 4. General comments are provided below:
- 3.2.4 The only significant tree within site boundaries is T2, a semi mature Apple of low value which should not pose a constraint on development at the site.
