# REPORT

| job number | J3943/17/E | site address | Land off Bismark Street |

## Report on a Coal Mining Risk Assessment

Location: Land off Bismark Street  
Worsbrough Common, Barnsley, S70 4NA

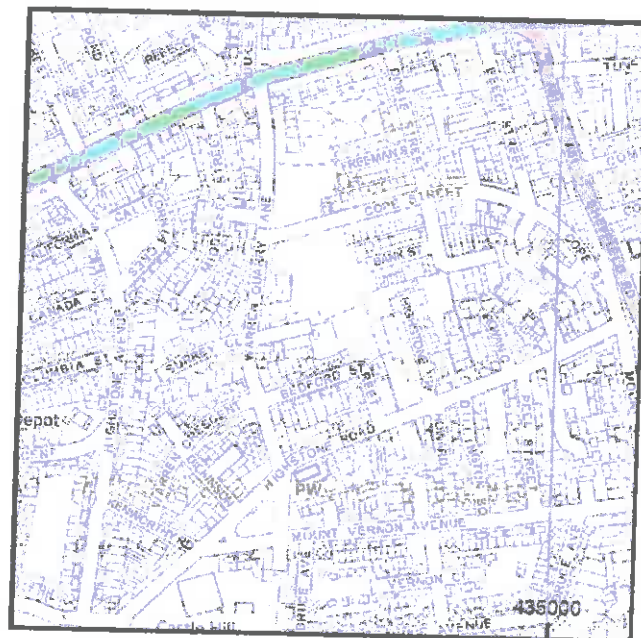
Approximate position of property
