Site:
**Barnburgh Lane,
 Goldthorpe Phase 2.**

Title:
**Road Layout :
 Centreline Levels.**

Date: Apr 2016 Scales: 1/500 Drawing No.: 16/660/7737C

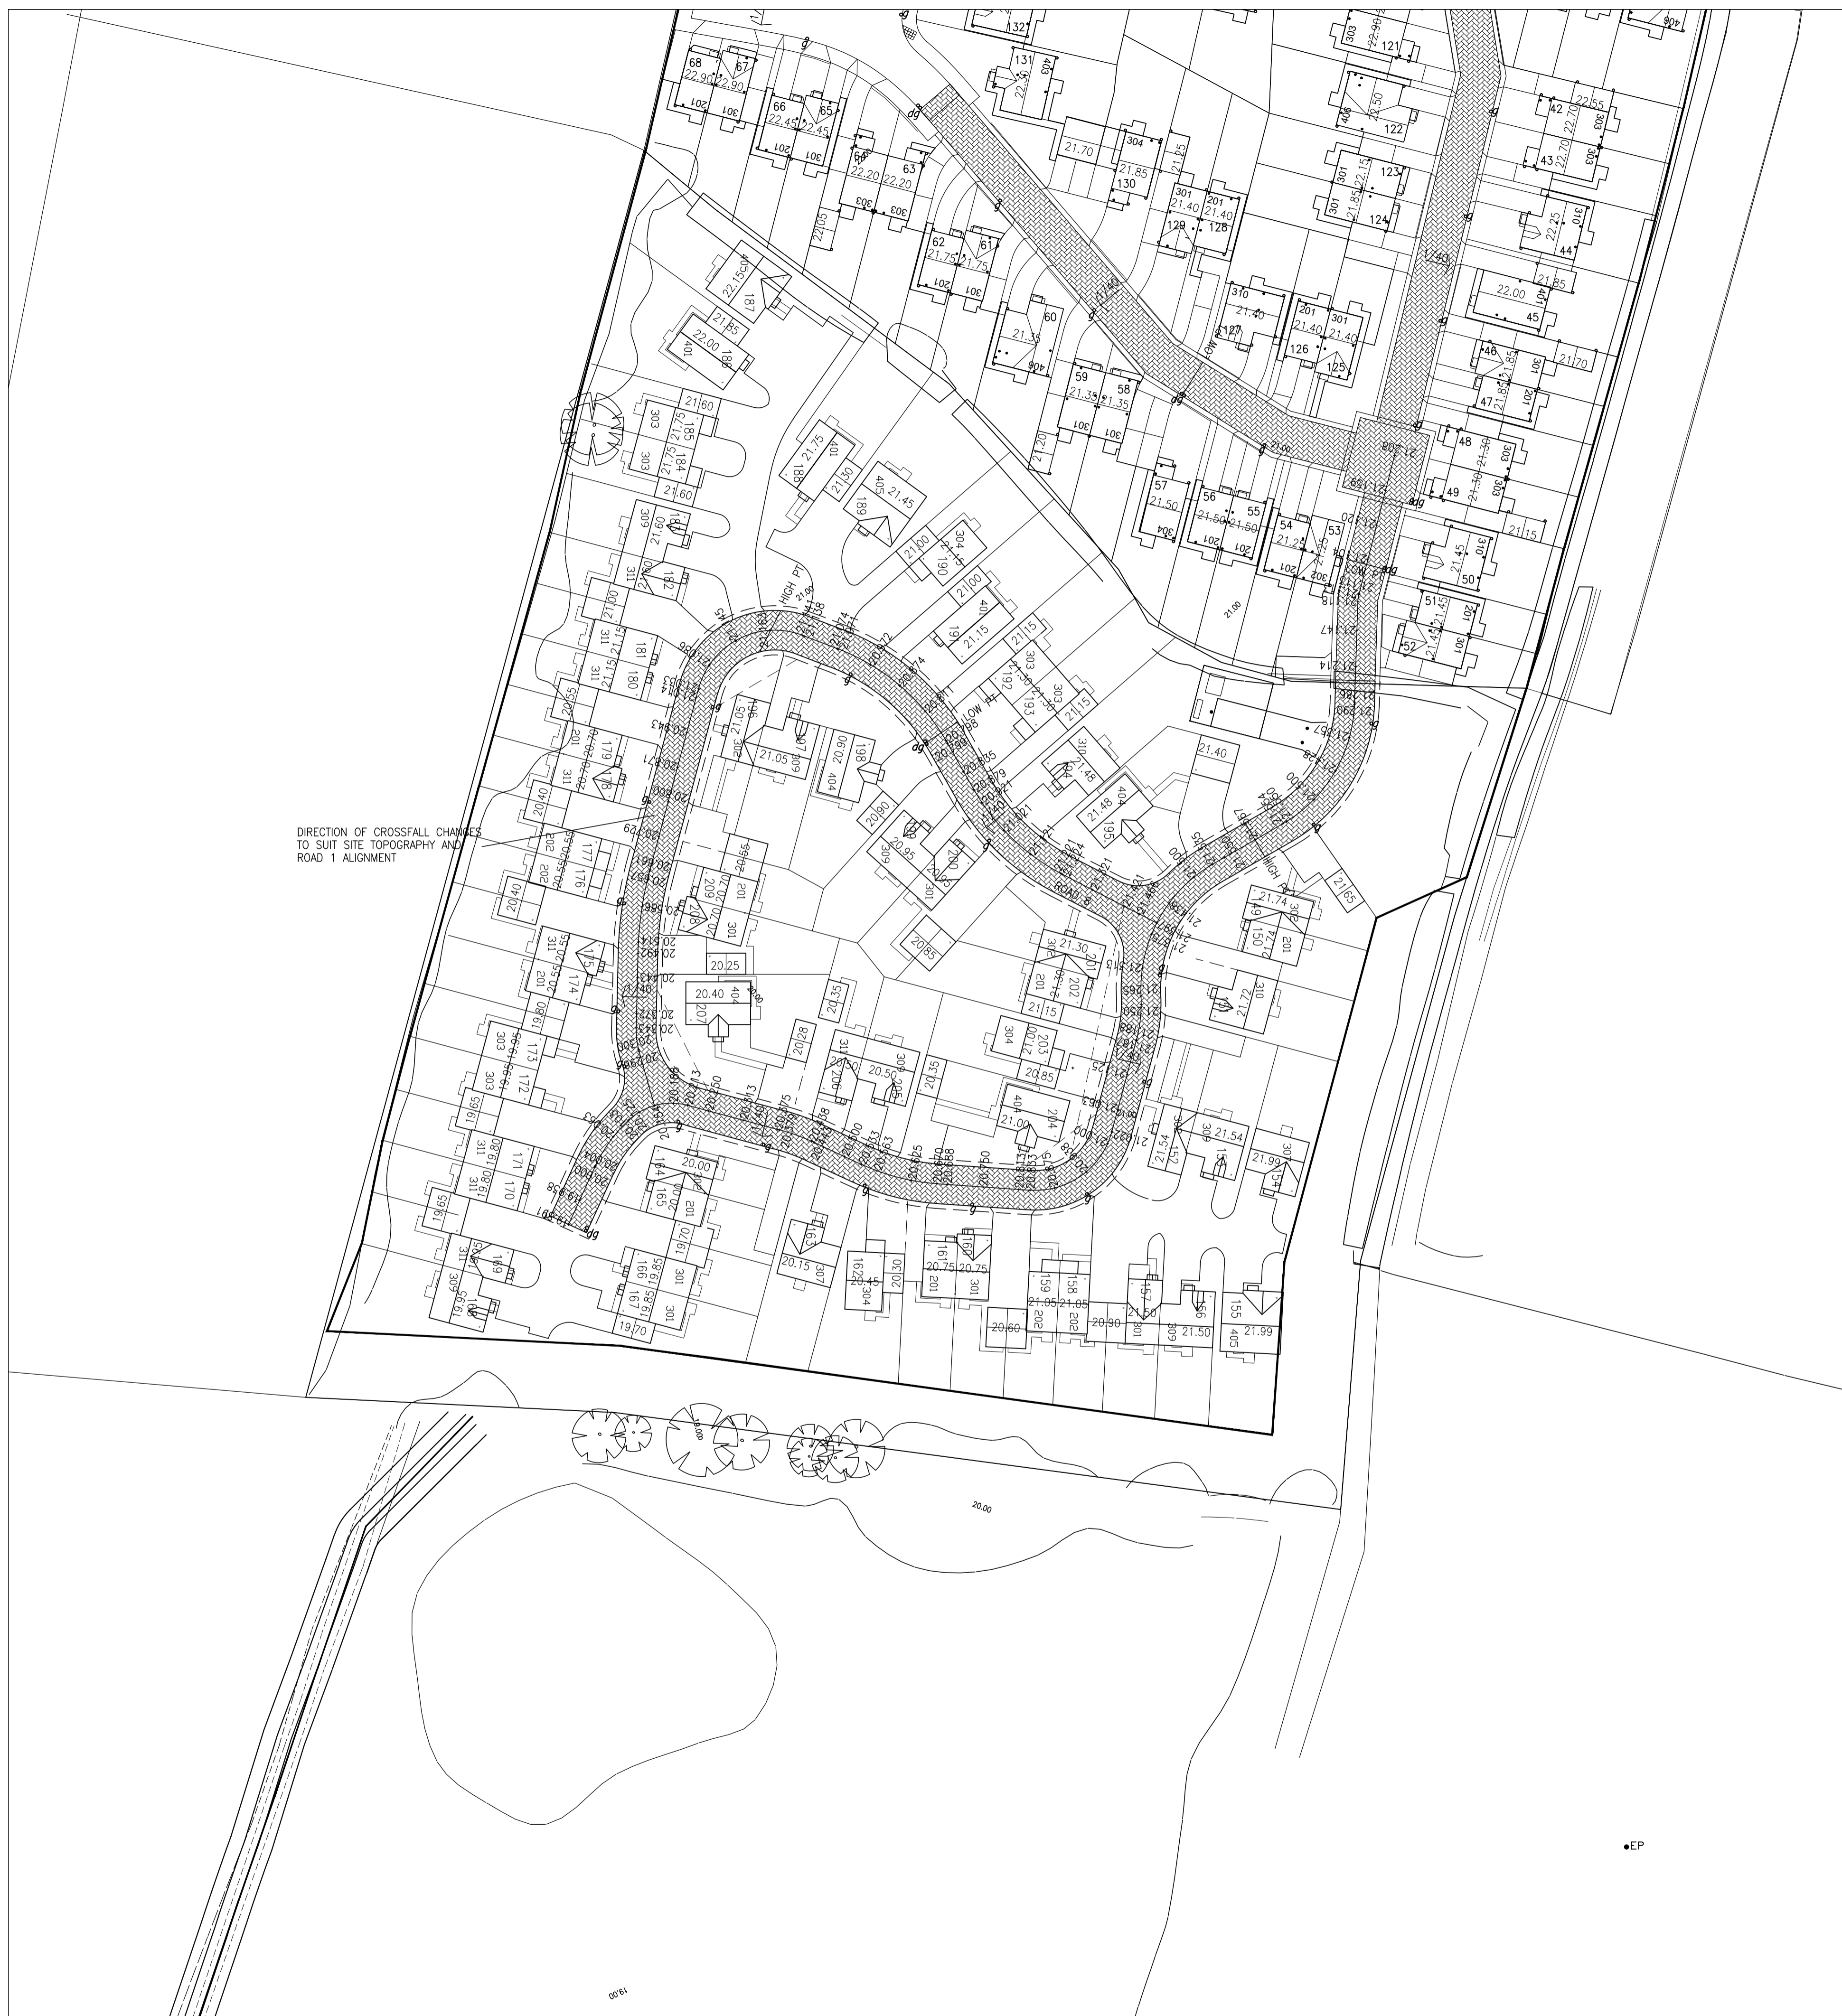
DIRECTION OF CROSSFALL CHANGES
TO SUIT SITE TOPOGRAPHY AND
ROAD 1 ALIGNMENT
