**Former Wombwell High  
Barnsley**

## **Ground Investigation Report**

On behalf of Barnsley Metropolitan Borough  
Council

Report 23-24-18-1-6003/GIR1  
May 2018

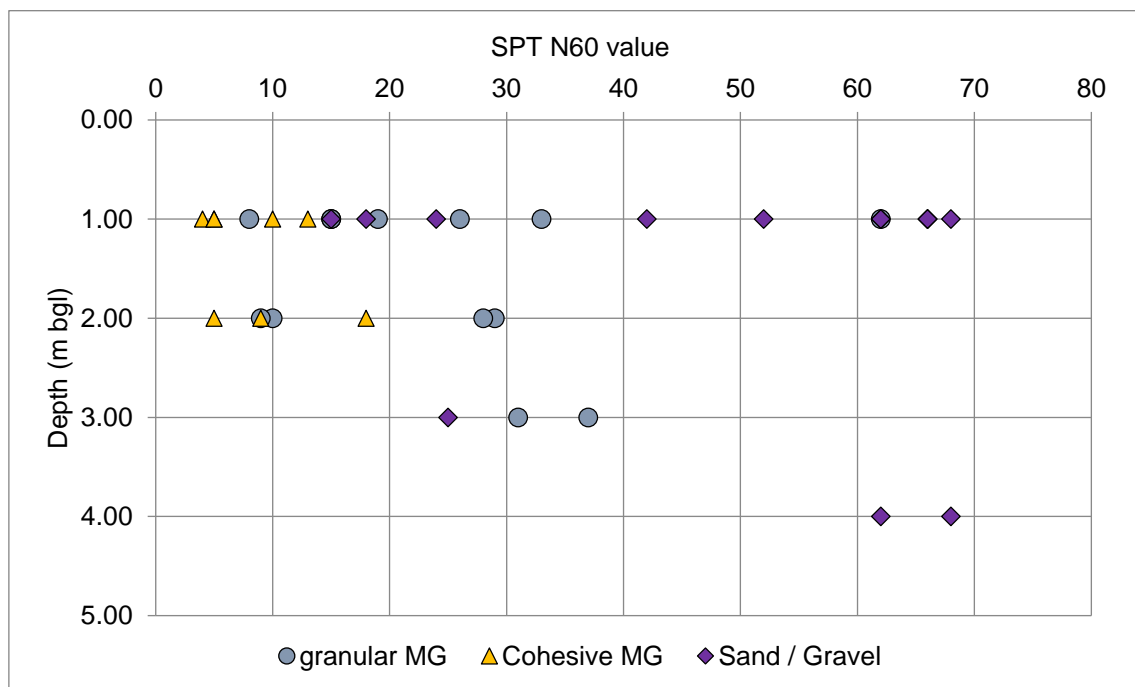
Figure 4 Corrected SPT N values

The SPT hammer energy ratio for the drilling rig is 74%. Based on a plasticity index of 30%, the correlation proposed by Stroud 1975 gives a factor  $f_1$  of 5 between the SPT N values and undrained shear strength. This equates to values of 20kPa to 90kPa. The shear strength values are shown on Figure 5. Based on the correlation of Peck, Hansen and Thornburn (1974), the corrected N values equate to soil friction values of 29 to 38 degrees, increasing with depth. The friction angle values are shown on Figure 6.

Assessment of the SPTs carried out within the boreholes indicates a conservative N value of 12 to 19 (see Figure 4) for the granular soils of the weathered bedrock. Based on the correlation of Peck, Hansen and Thornburn (1974), this equates to a soil friction of 31 to 34 degrees. At a founding depth of 0.6m bgl this provides a safe bearing capacity of 140kPa for strip footings.

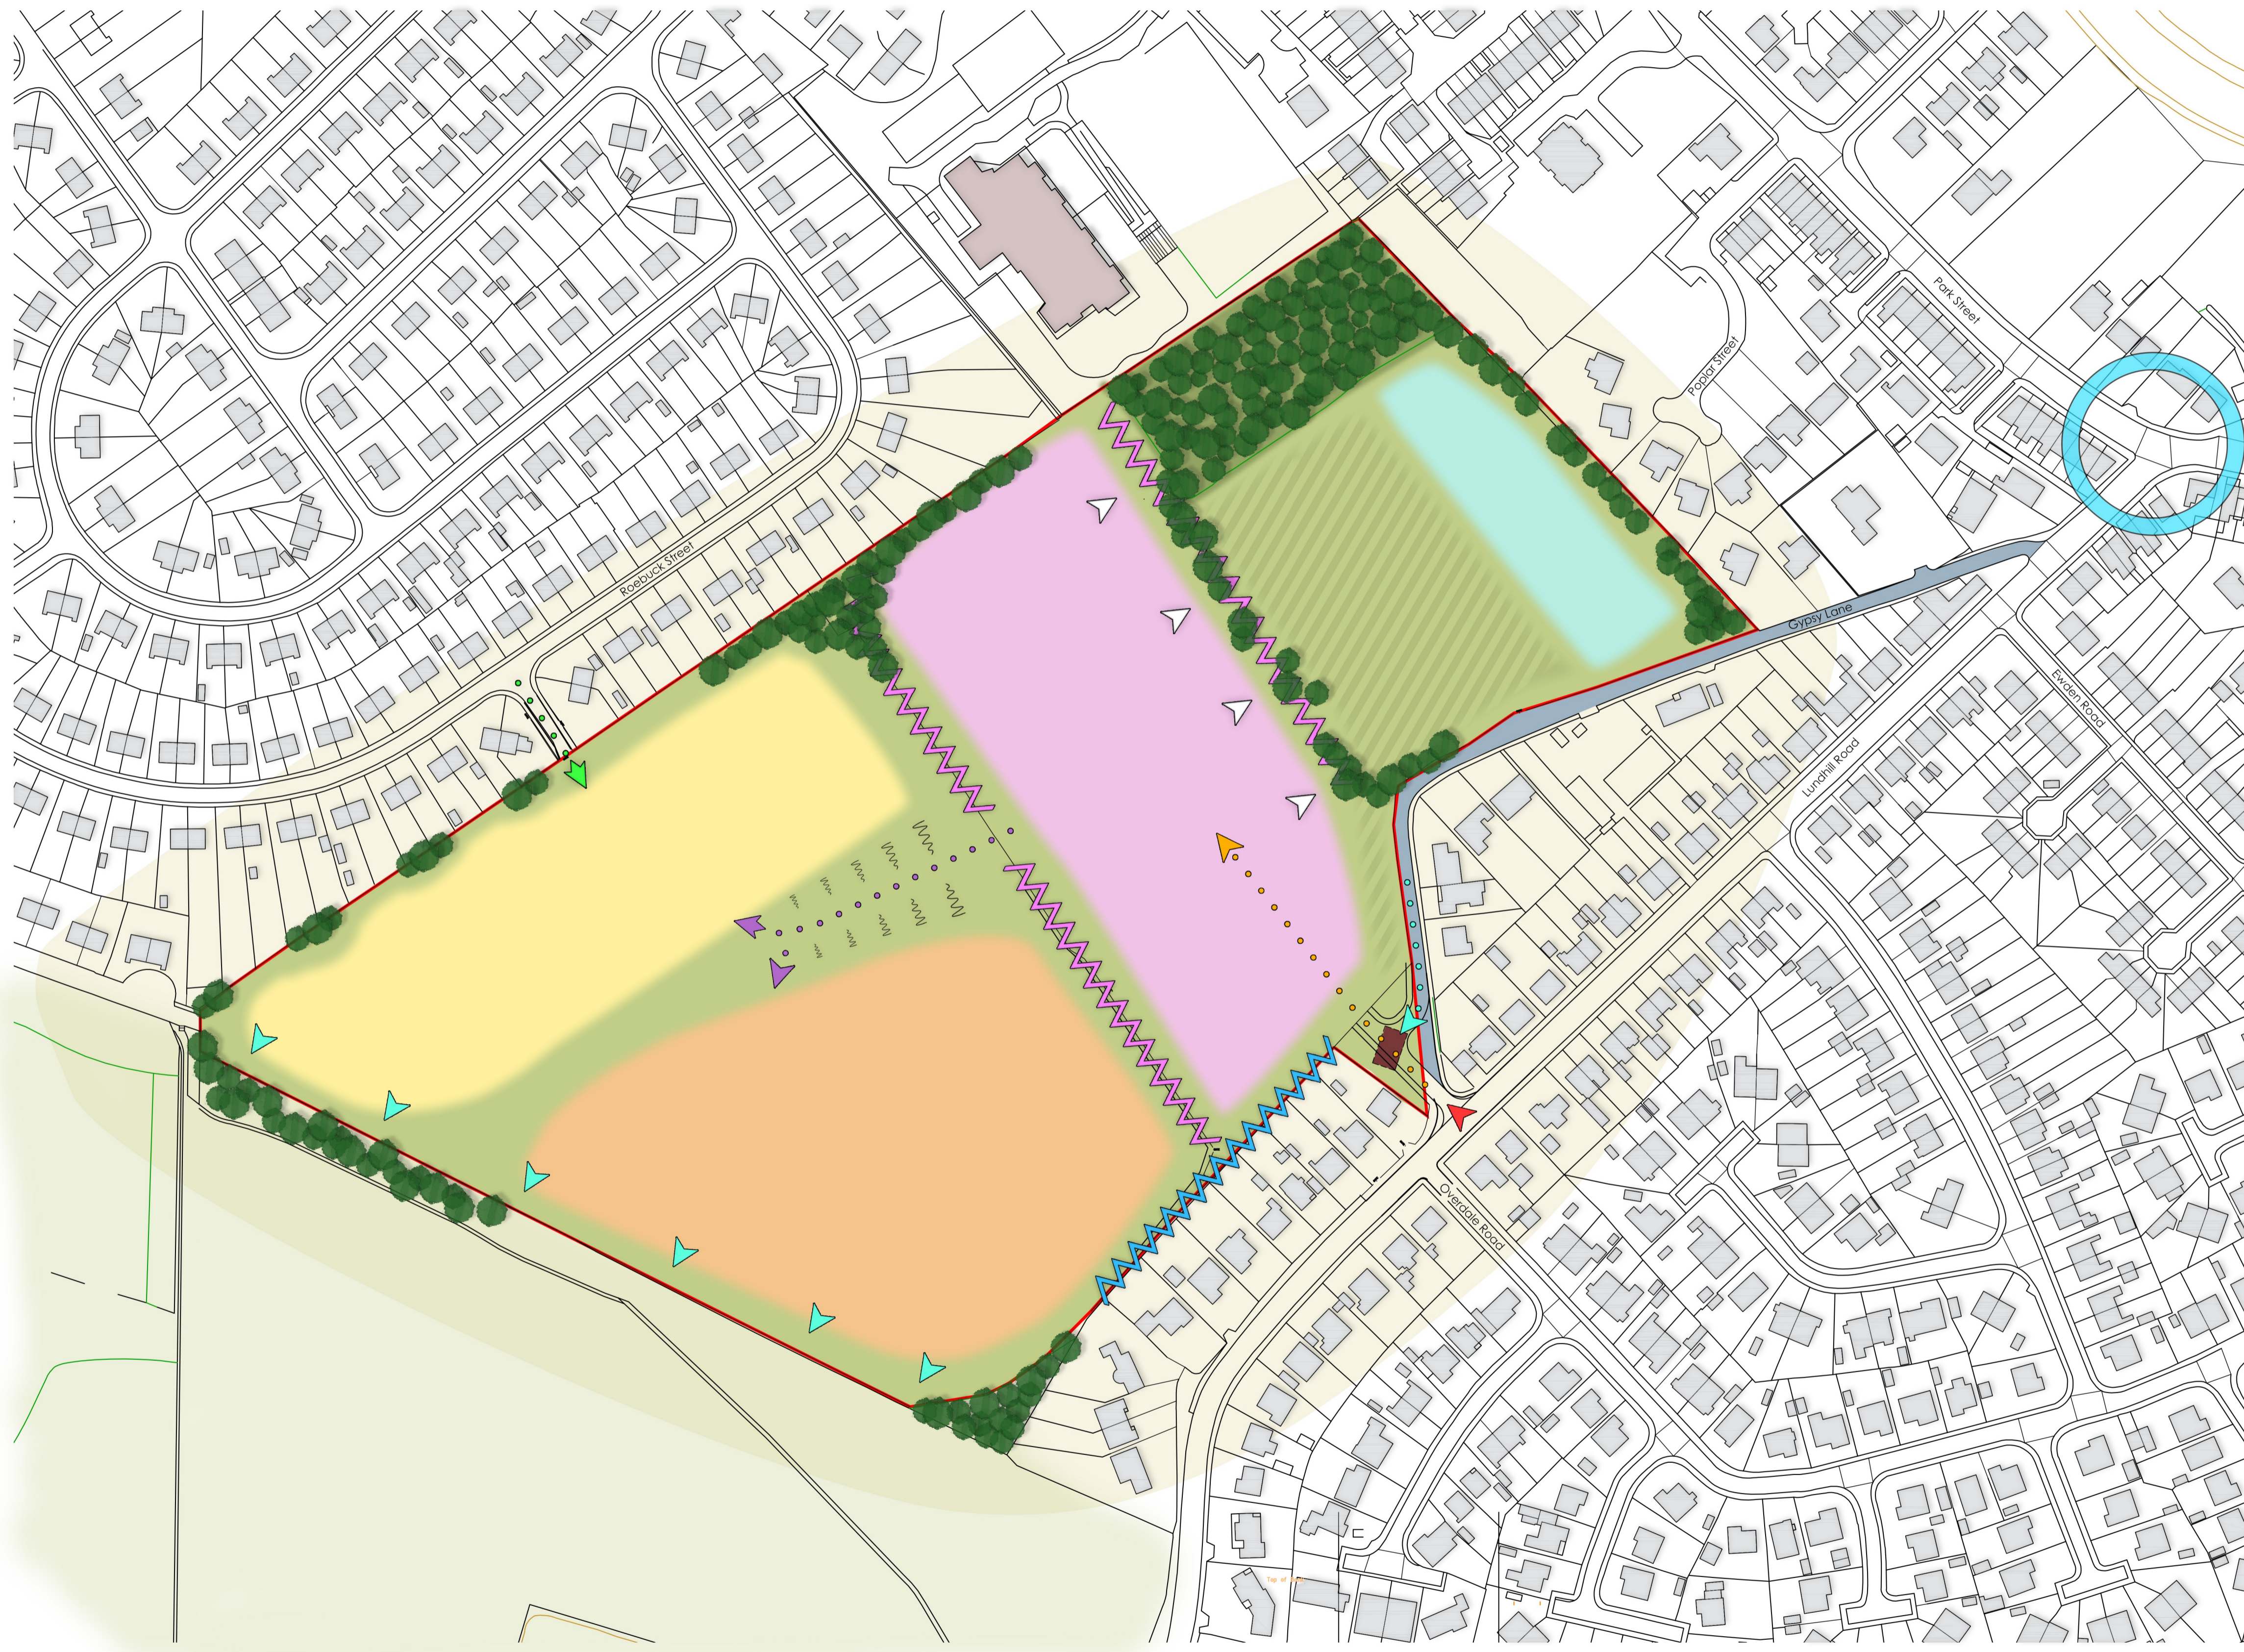
## Proposed Master Plan

- Gross site area 24.05 acres approx
- Proposed site access from Lundhill Road
- Main access street into development site
- Possible re-alignment of Gypsy Lane to link with new access street into site

- Potential footpath link into new school site from Robuck Street
- Main access into new school site and phase 2 residential. Approx 80m road @ 1:20 to accommodate level change with 1:3 embankments adjacent
