Whitcher Wildlife Ltd. Ecological Consultants.

1.1. Planning Consent 2021/1107 has been granted for the replacement of the existing dwelling at Banks View, Greenmoor. Condition 4 of the planning consent states.

2. Bat Method Statement.

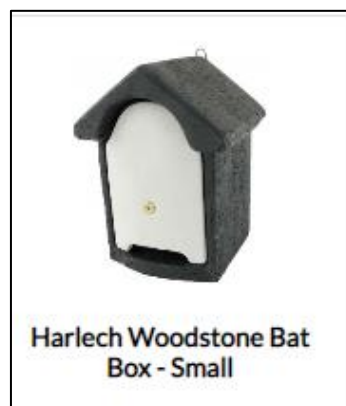
2.4. Prior to that happening, a bat box will be erected on a tree around the site perimeter. A Harlech Woodstone bat box as shown below or equivalent will be erected at least 3m up a suitable tree. In the unlikely event of a bat being found, if the bat cannot be safely left in situ, it can then be moved and placed into the bat box and it will provide the bats with an alternative roost during the development.

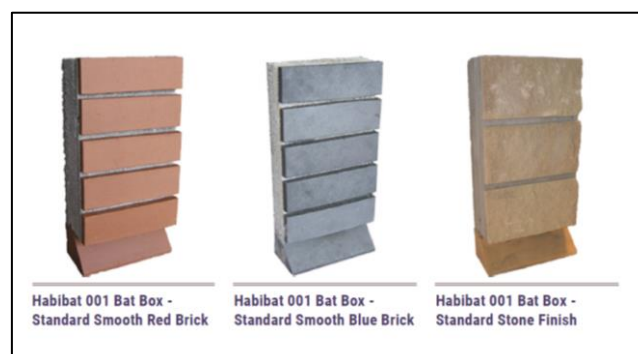
2.5. In addition, bat roosting opportunities will be built into the new dwelling. One integrated bat brick with a finish to match the new dwelling will be placed high in a gable end wall. The design will be as shown below or equivalent.

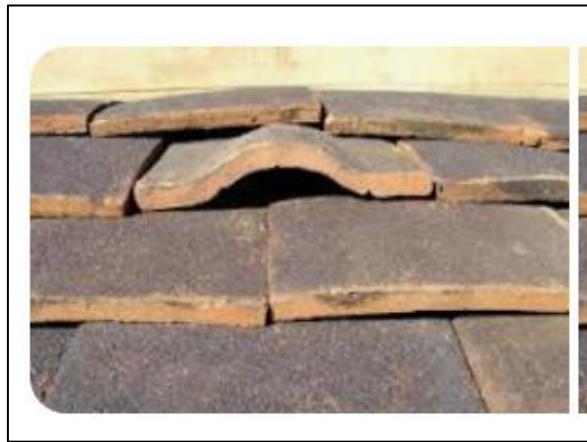
2.6. In addition, four bat access slates will be incorporated into the roof of the building to provide access for crevice dwelling bats to access the gap between the tiles and the roof lining. These will be as shown below or equivalent.

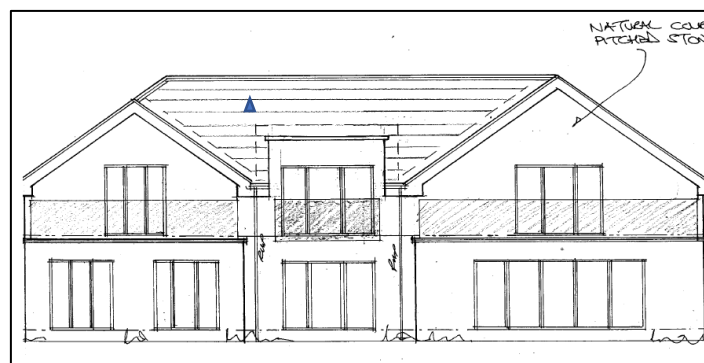
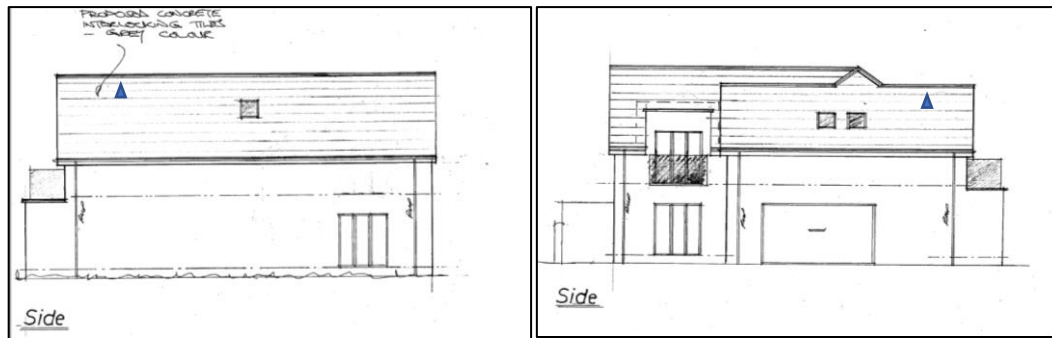
2.7. The locations of the integrated bat brick and the bat access slates are shown on the following plans. The bat brick is shown as a blue square and a bat tile as a blue triangle.

2.10. The lighting strategy will avoid light interference of the roosting opportunities shown above. A detailed scheme is being prepared by others.
