**BAT MITIGATION STRATEGY**

| | | <div><div>Current08-10-19EHSS</div></div> | <div><div>PROJECT</div><div>Wentworth Castle and Stainborough Park 2019</div></div> | <div><div>SIZE &amp; SCALE</div><div>A1L 1:50 @ A1</div></div> | <div><div>DRAWING NO.</div><div>2000</div></div> | |

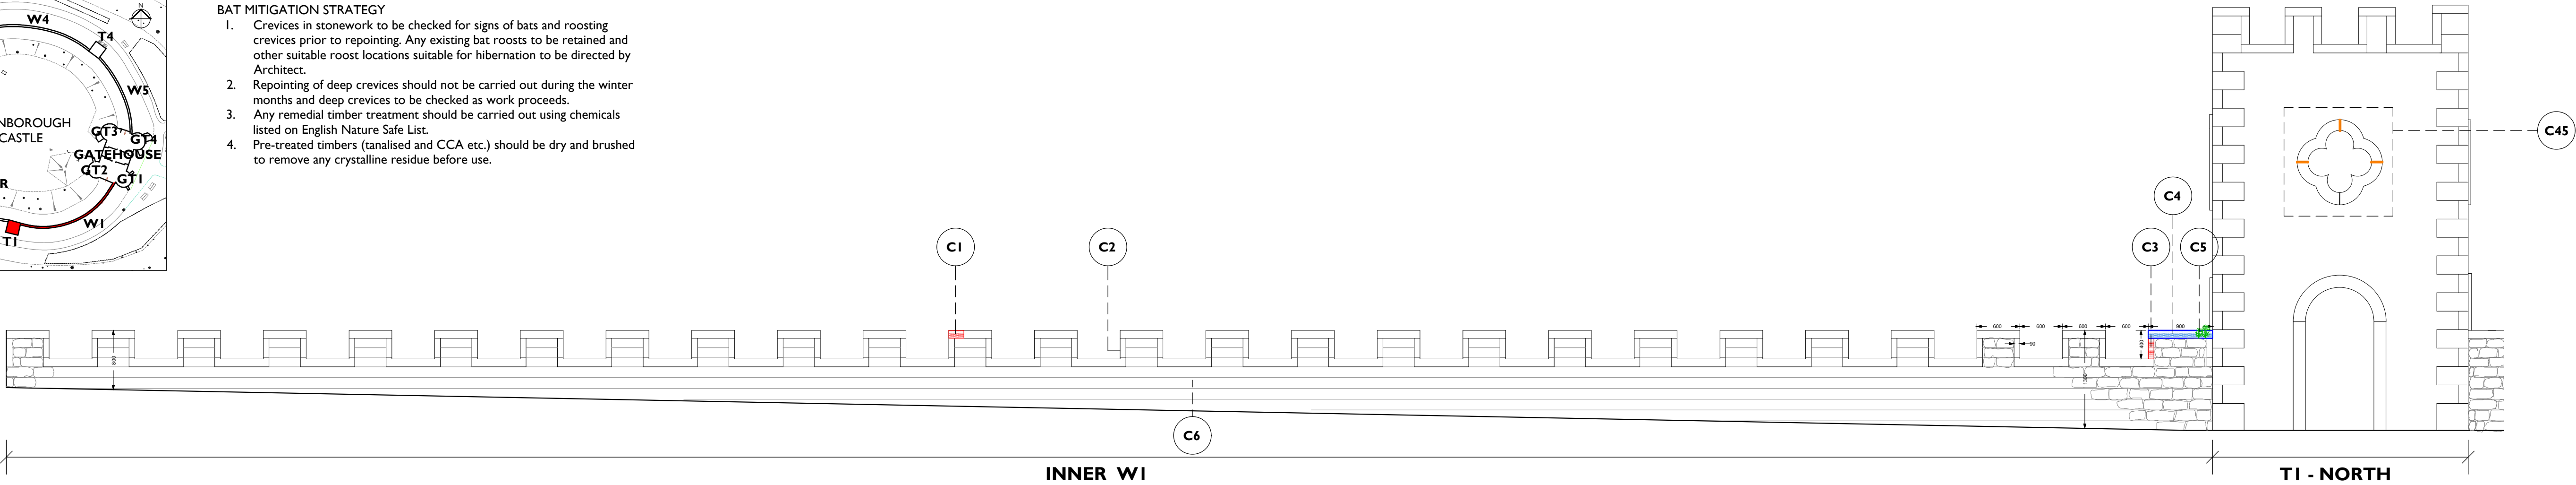
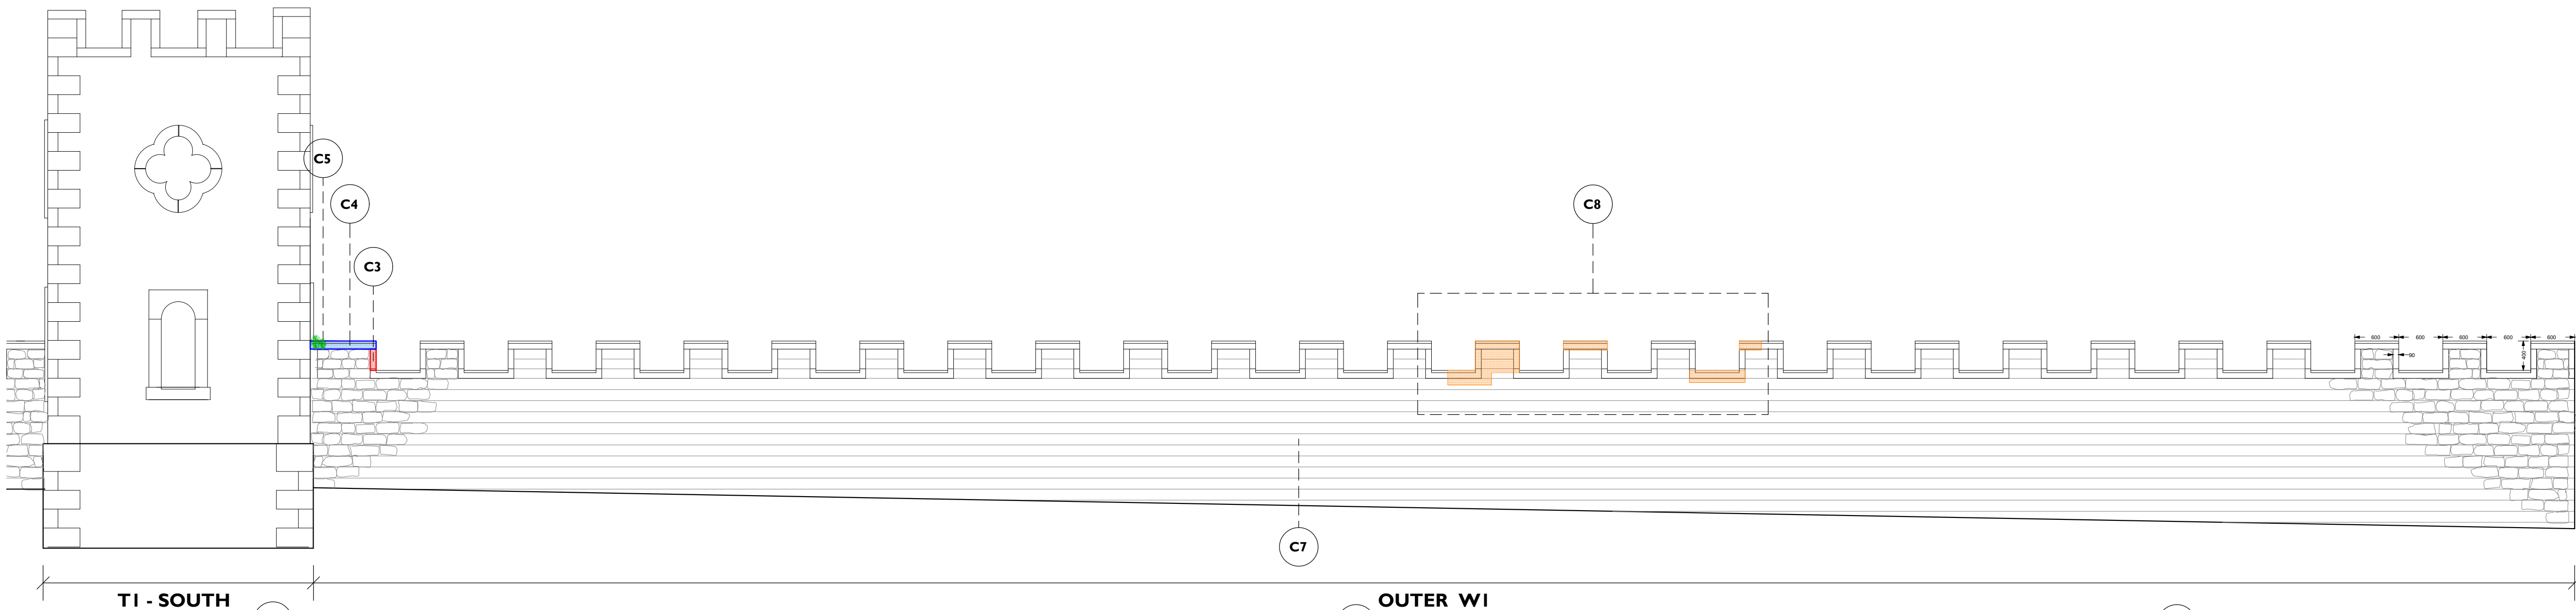
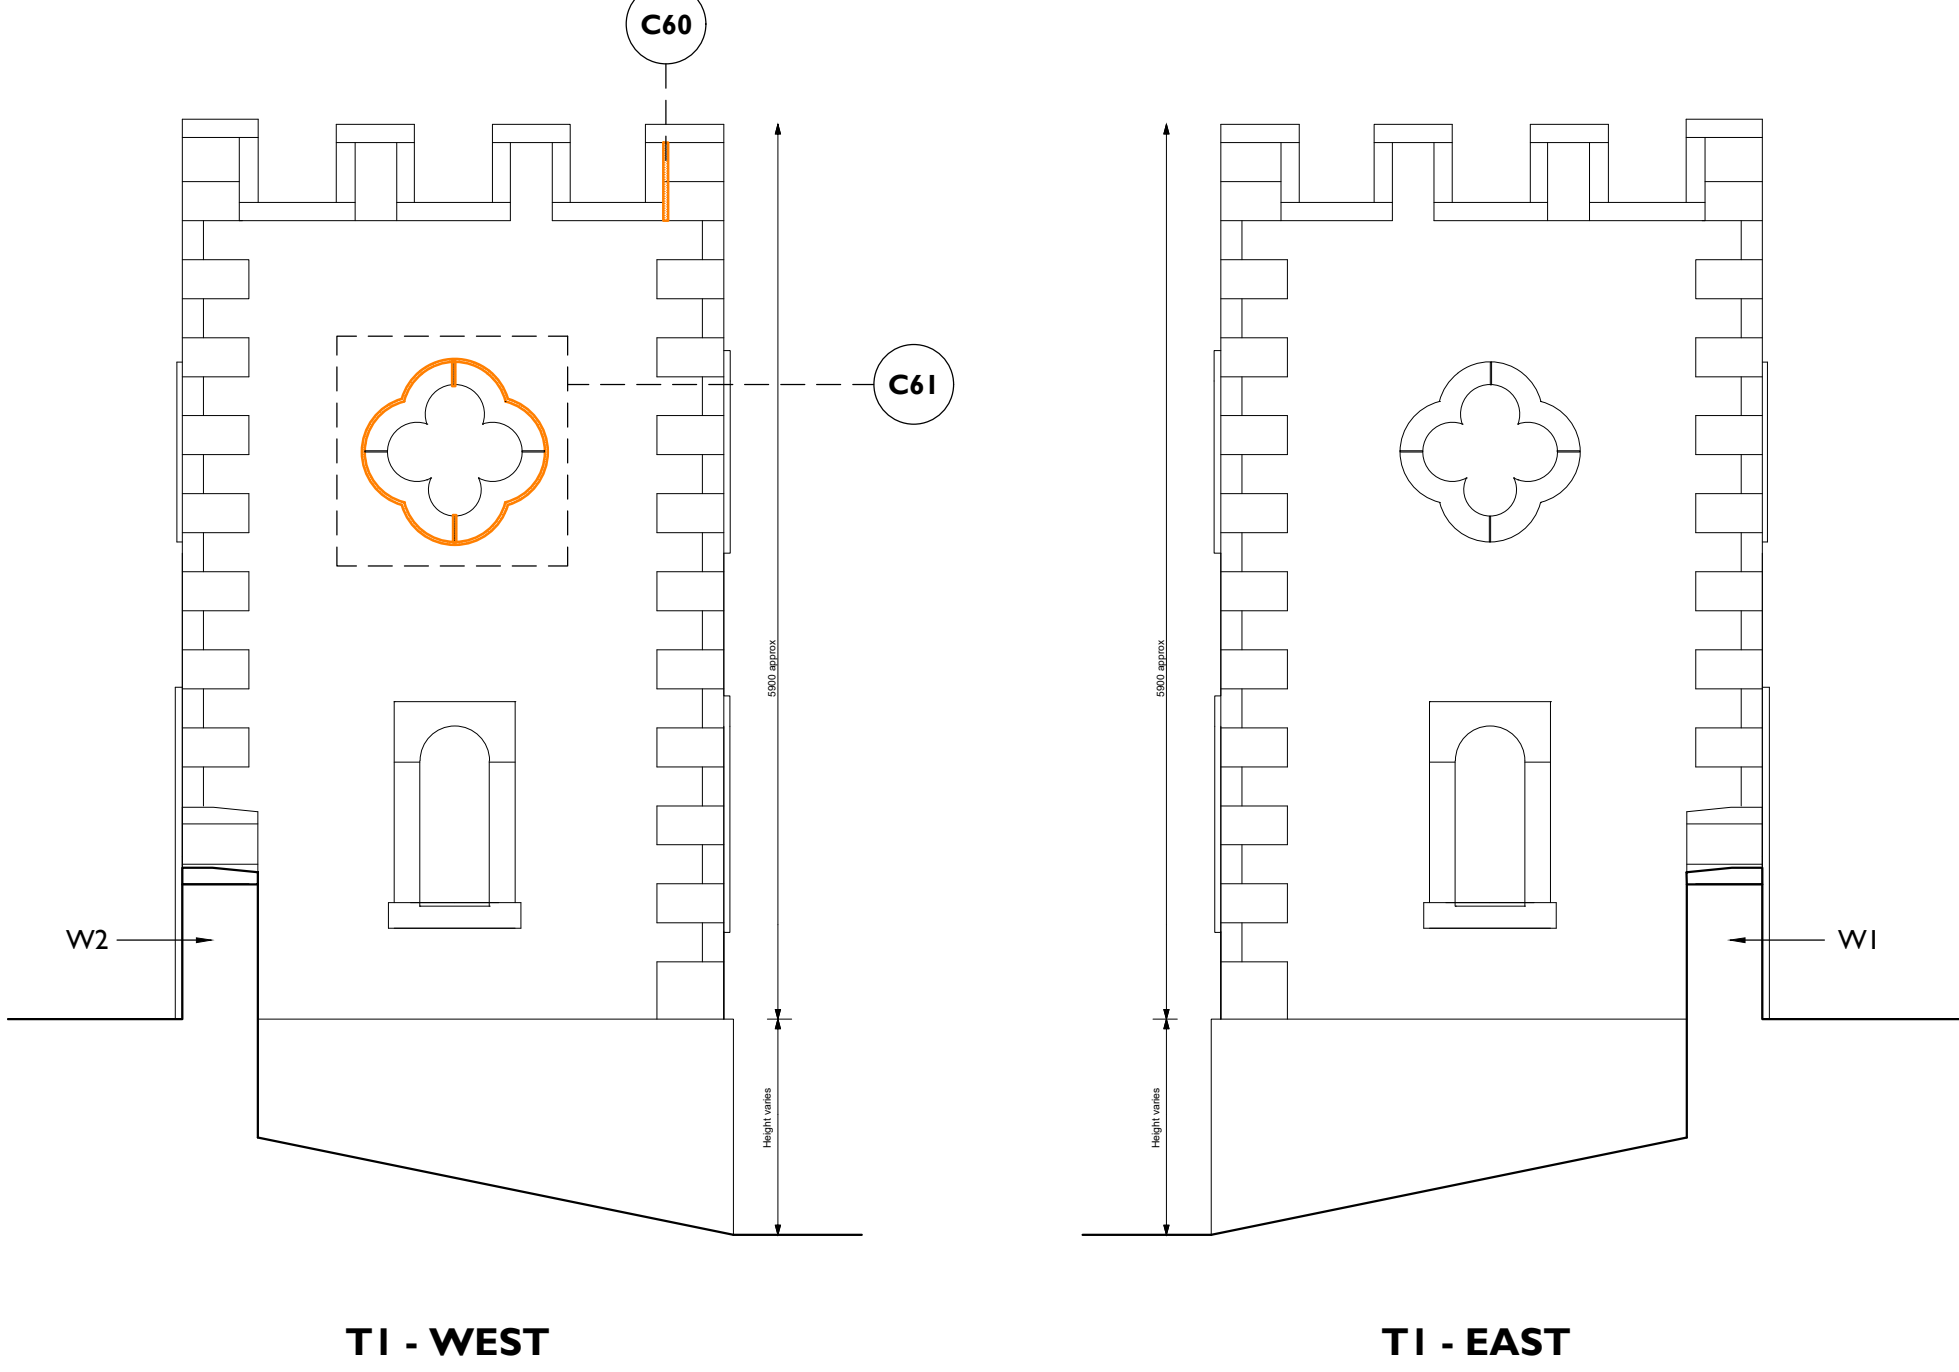
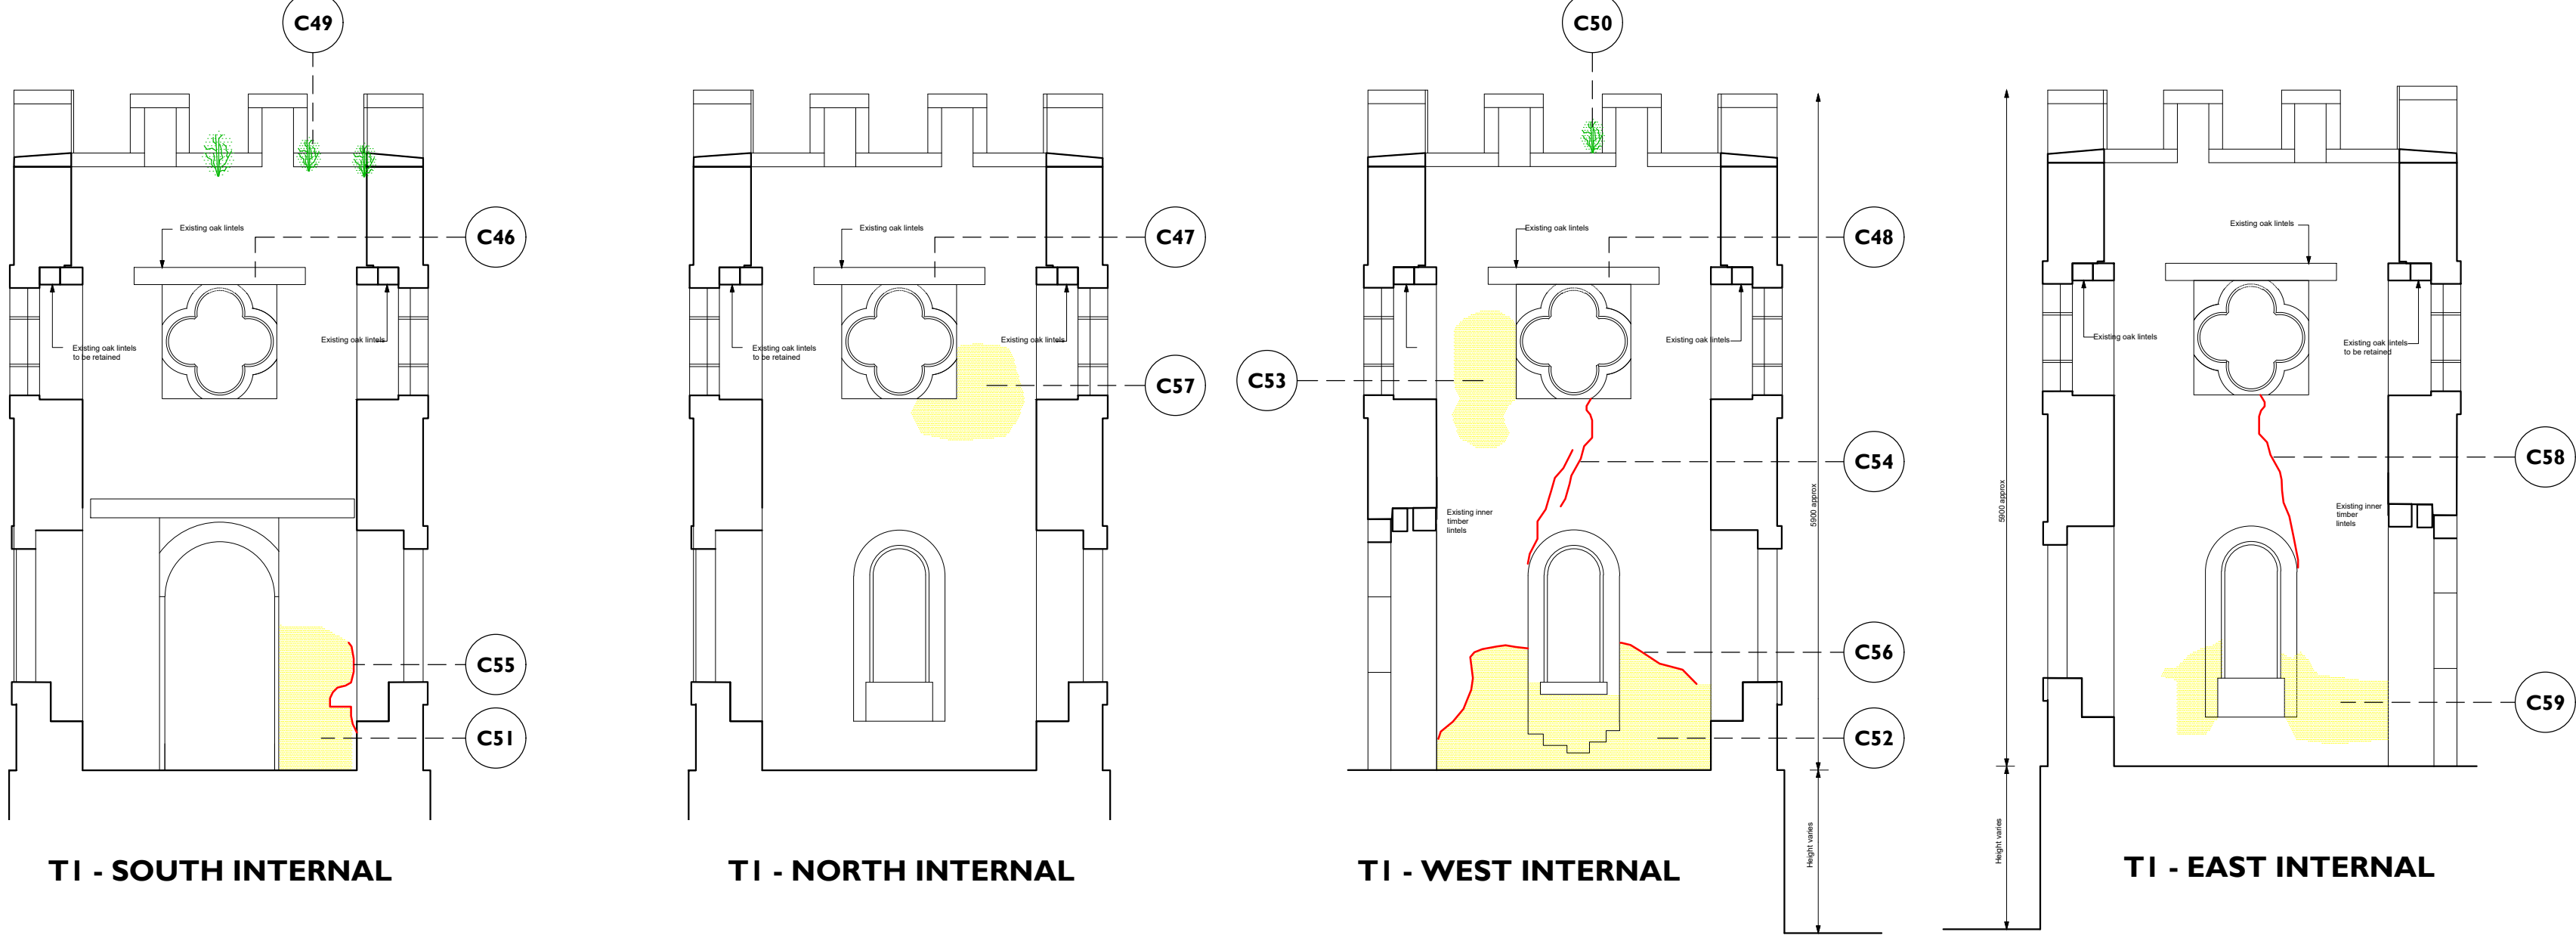
1. Crevices in stonework to be checked for signs of bats and roosting crevices prior to repointing. Any existing bat roosts to be retained and other suitable roost locations suitable for hibernation to be directed by Architect.
2. Repointing of deep crevices should not be carried out during the winter months and deep crevices to be checked as work proceeds.
3. Any remedial timber treatment should be carried out using chemicals listed on English Nature Safe List.
4. Pre-treated timbers (tanalised and CCA etc.) should be dry and brushed to remove any crystalline residue before use.
