Cannon Hall Contractors Document - Cawthorn Road Network

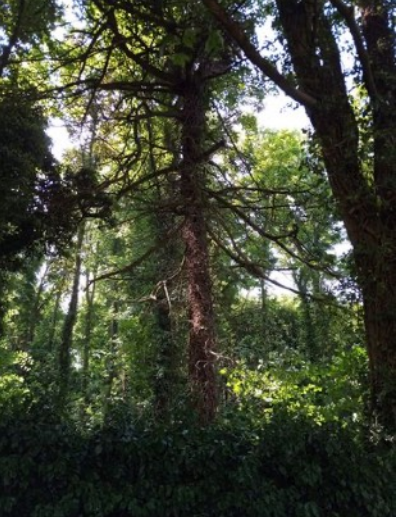
| Ref. | Species | Description | What 3 Words | Measurements | Survey Notes | Recommendation | Work Timescale |
|--|---|---|---|--|---|---|---|
| T018 | Larch (Larix sp.) | Next to road behind wall | /// supporter.cookie.enj oy | Height (m): 10 Crown Radius (m): 3 DBH (cm): 40 Life Stage: Dead | Standing dead tree. Previously ivy clad. Tangled in canopy of neighbouring sycamores. | Fell tree. | 26-Jun-2024 (Urgent) |

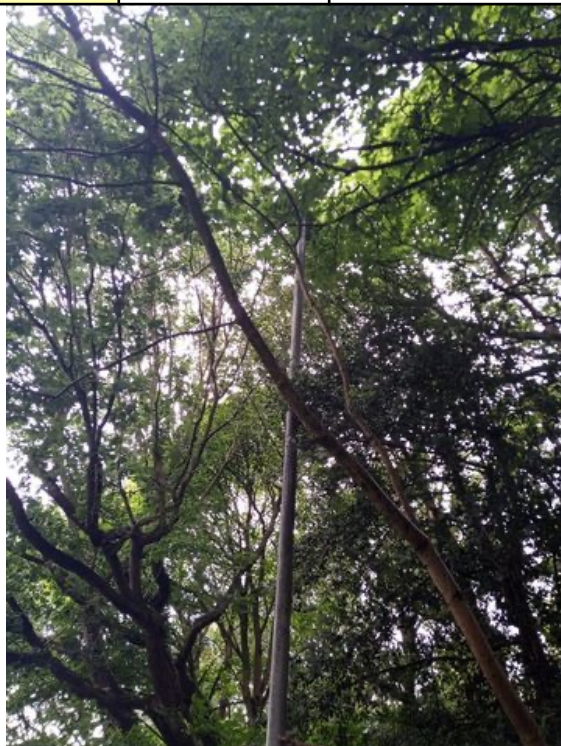
| T056 | Sycamore (Acer pseudoplatanus) | Roadside tree, set back from road. Next to street lighting | /// retraced.s plice.putte r | Height (m): 18 Crown Radius (m): 9 DBH (cm): 80 Stems: 2 Life Stage: Mature Life Exp.: 50+ Years | Tight union at main stem, slight bulge as reactionary growth. Broad form. Canopy obscuring street lighting severely. | Ensure 1m clearance around Street lighting. | 01-Oct-2024 (3 Months) |

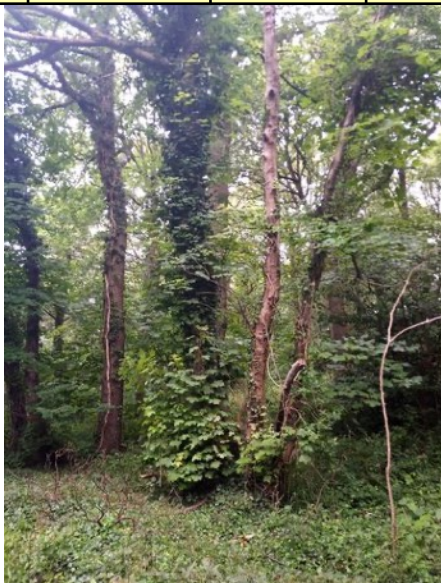
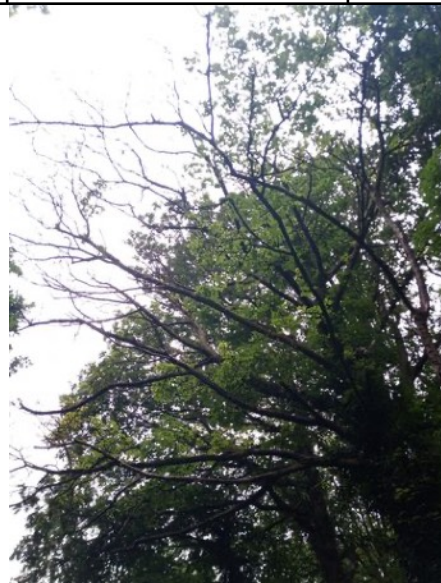
| T058 | Sycamore (Acer pseudoplatanus) | Roadside tree, slightly set back on woodland edge | /// rely.enhan ces.impeached | Height (m): 18 Crown Radius (m): 5 DBH (cm): 40 Life Stage: Mature Life Exp.: <10 years | In decline, has smaller stems at base, one dead. Large area of bark missing on main stem, around 30 percent circumference loss. Upper canopy dead, with large dead limbs throughout canopy. Main foliage is epicormic on main stem | Fell tree. | 01-Oct-2024 (3 Months) |

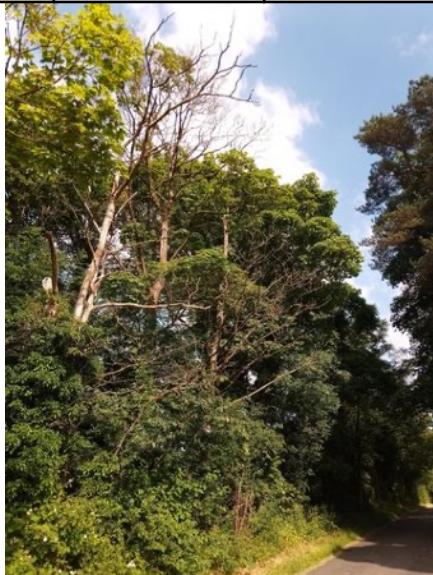
| G006 | Sycamore x3 (Acer pseudoplatanus) | Roadside trees in front of wall | /// vanilla.inc uring.reti na | Height (m): 11 Crown Radius (m): 2.5 Trees: 3 Life Stage: Mature Life Exp.: <10 years | Four trees in decline. Two standing dead, either side of one tree in severe decline with little canopy remaining, and one small tree in similar poor condition, with foliage all on lower branches. Two trees severely ivy clad. | Fell trees | 26-Dec-2024 (6 Months) |

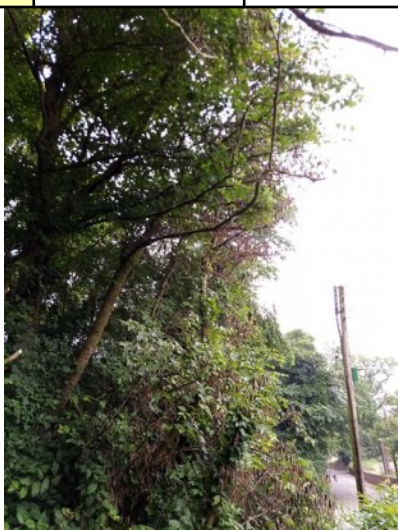
| T001 | Wych elm (Ulmus glabra) | Slightly set back from road after caravan park entrance. Proximity to power lines. | /// reserving. pegged.sa ge | Height (m): 8 Crown Radius (m): 1.5 DBH (cm): 20 Stems: 5 Life Stage: Semi Mature Life Exp.: <10 years | Dead leaves throughout canopy, stems with slight lean towards road and power lines. Little potential to recover. Pests and Diseases: Dutch Elm Disease (Ophiostoma novo-ulmi) | Fell tree. | 26-Dec-2024 (6 Months) |

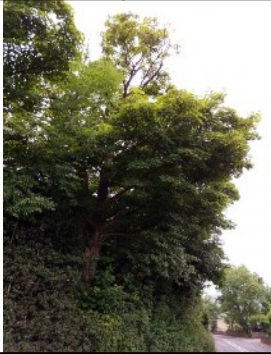
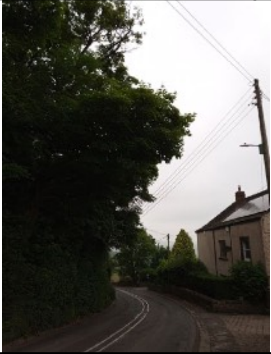
| T003 | Sycamore (Acer pseudoplatanus) | On inside bend next to road. Potential to impact power cables and phone cables. | /// windmill.s ong.safety | Height (m): 15 Crown Radius (m): 4 DBH (cm): 60 Life Stage: Mature Life Exp.: 20+ Years | Thick undergrowth around base. double stemmed at 3m. To dying back leaving some dead branches, some over roadside. Potentially in decline. | Remove deadwood - greater than 25 mm. | 26-Dec-2024 (6 Months) |

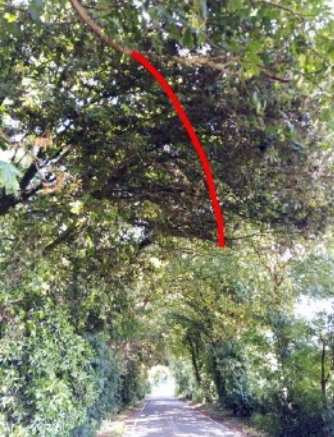
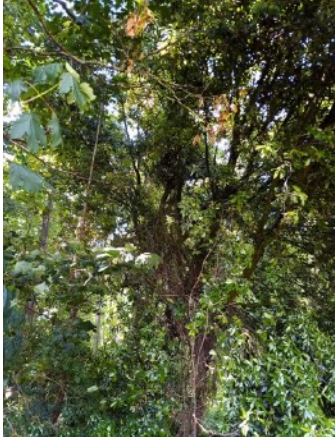
| T016 | Holm oak (Quercus ilex) | Roadside tree over wall on woodland edge. | /// failed.dart. cowboys | Height (m): 11 Crown Radius (m): 6 DBH (cm): 35 Life Stage: Early Mature Life Exp.: 30+ Years | Dual stemmed at 2m. Roadside limb with moderate lean, heavy foliage, becoming dominant. Snapped out top from main upright limb hung up, smaller snapped branch over road. | Remove snapped out limbs. Reduce roadside canopy by 2m in line with midway point on road, to attempt to correct form. | 26-Dec-2024 (6 Months) |

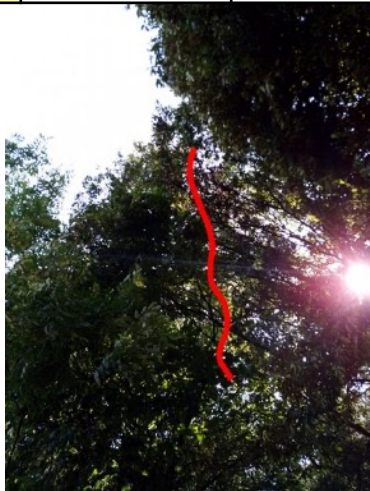
| T017 | Holm oak (Quercus ilex) | | /// drifting.jo usting.thin k | Height (m): 15 Crown Radius (m): 6 DBH (cm): 45 Life Stage: Mature Life Exp.: 30+ Years | Ivy clad. Moderate lean N. Become multi-stemmed at 3m. Gas several smaller branches over road. Growing into tree canopy opposite | Remove snapped branches from canopy. Reduce NE canopy by 3m to wound midway point on road to correct form. | 26-Dec-2024 (6 Months) |

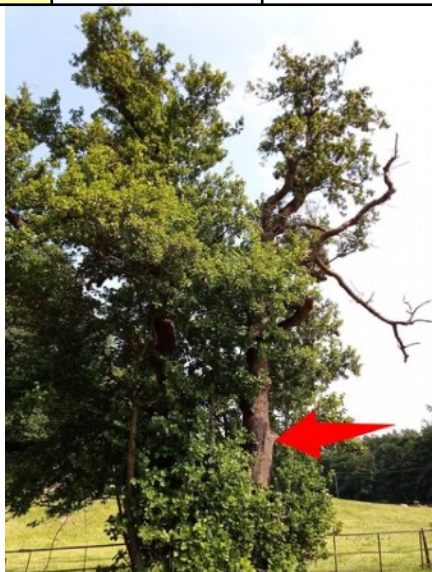
| T021 | Common alder (Alnus glutinosa) | Roadside tree, in front of stock fencing. | /// knowledge .mops.rob ot | Height (m): 10 Crown Radius (m): 3 DBH (cm): 50 Stems: 6 Life Stage: Mature Life Exp.: 20+ Years | Two major stems with 4 smaller stems amongst lower growth. S main stem appears weak with multiple large dead branches and sparse foliage. Several cavities noted up main stem and insect and bird holes higher on stem. Other main appears healthier with occasional dead tips and a few larger dead branches. | Remove S stem to ground level. Remove substantial deadwood. | 26-Dec-2024 (6 Months) |

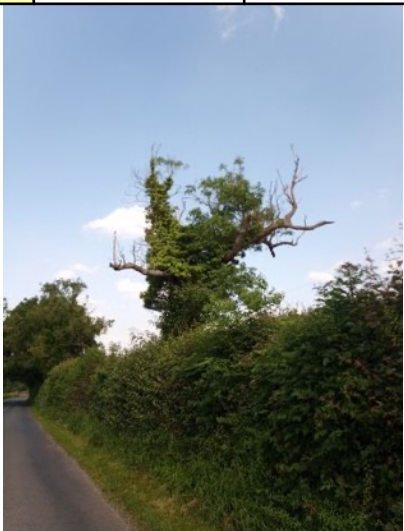
| T023 | Common ash (Fraxinus excelsior) | Roadside tree in hedgerow. | /// lasts.bean s.fulfilled | Height (m): 6 Crown Radius (m): 2.5 Life Stage: Over Mature Life Exp.: <10 years | Nearly completely dead. Ivy clad. Only remaining foliage is small amount of epicormic growth in centre. Several large dead branches, two with potential to fail roadside. | Remove dead roadside limbs | 26-Dec-2024 (6 Months) |

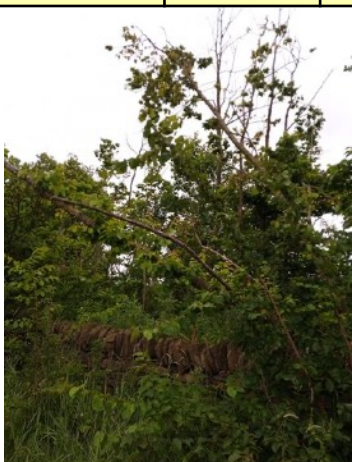
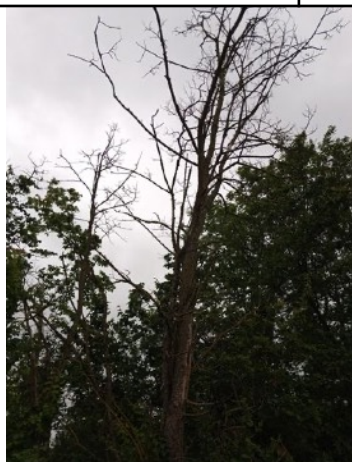
| G011 | Wych elm (Ulmus glabra) | Small group of roadside trees. Not including larger healthy elms near field entrance. | /// wiggling.re lax.painted | Height (m): 8 Crown Radius (m): 2 Life Stage: Semi Mature Life Exp.: <10 years | Small trees weakening and dying, withering foliage. Some stems completely dead. Pests and Diseases: Dutch Elm Disease (Ophiostoma novo-ulmi) | Fell trees | 01-Jan-2025 (6 Months) |

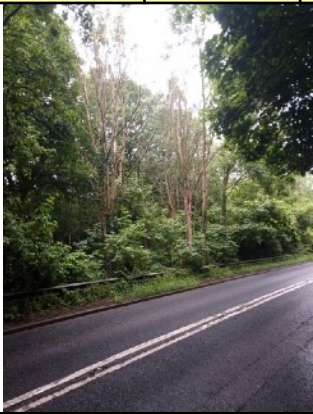
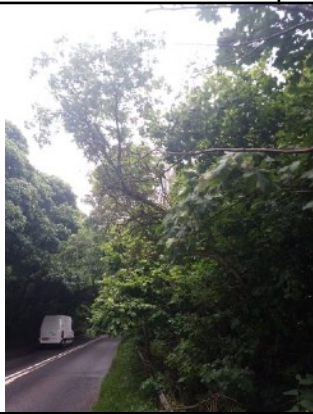
| G013 | Elder (Sambucus nigra) Common ash x3 (Fraxinus excelsior) Wych elm x4 (Ulmus glabra) | Small group of trees next to road behind barrier. | /// unwraps.b umping.ca re | Height (m): 10 Crown Radius (m): 2 DBH (cm): 40 Trees: 8 Life Stage: Semi Mature Life Exp.: <10 years | 4 of the elm are standing dead, with larger elm weak with little foliage remaining. Many stems ivy clad. Some elder. Ash are tall form with little lower foliage. Exposed, especially with removal of elm. Hazel undergrowth. Elder with moderate lean growing into road. | Fell trees | 01-Jan-2025 (6 Months) |

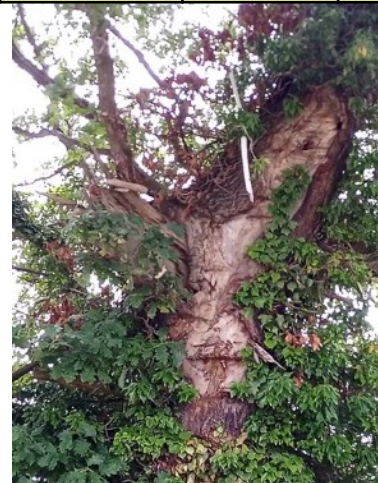
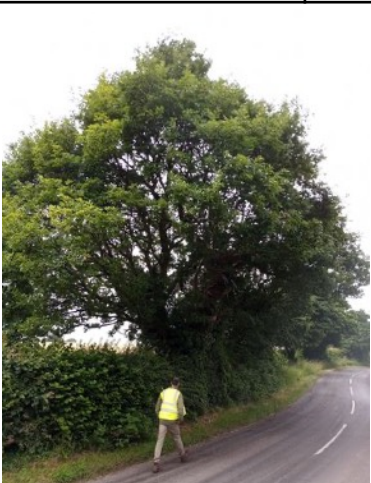
| T036 | Pedunculate oak (Quercus robur) | Roadside tree on bend | /// awkward. tiny.triathlon | Height (m): 12 Crown Radius (m): 5 DBH (cm): 100 Life Stage: Mature Life Exp.: 30+ Years | Growing in hedge row. Severe vehicle damage to main stem at around 3.5m. Multiple wound, some sealing. Some debris from danger vehicle still present and scattered around road. Leaning form. Stem grows slightly into road, mitigation of damage not possible without impact to traffic safety. | Fell tree | 01-Jan-2025 (6 Months) |

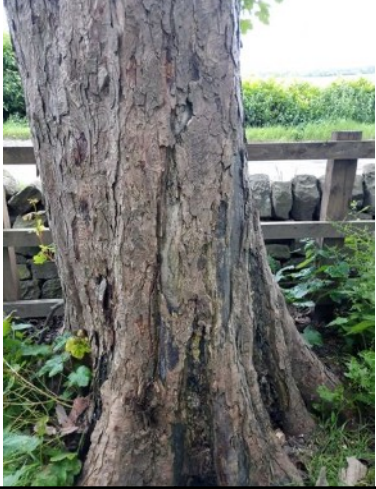
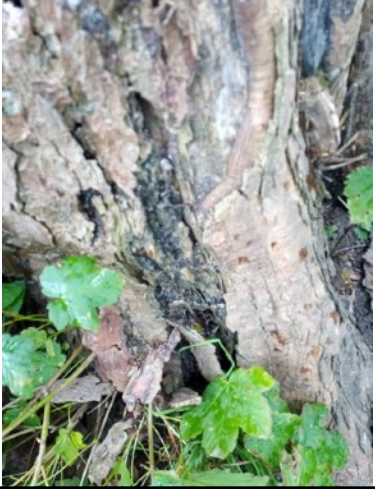
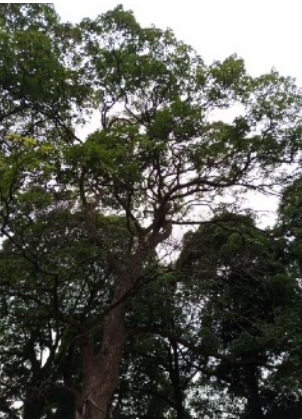
| T037 | Sycamore (Acer pseudoplatanus) | Roadside tree, in lower norcroft farm garden. | /// steadier.unheated.s nores | Height (m): 17 Crown Radius (m): 5 DBH (cm): 85 Life Stage: Mature Life Exp.: <10 years | Growing in copse of established nature trees. Butteress roots, one damaged in fence installation, some decay in butteresses w side of tree with soft root. Leading to area of necrotic bark with exposed heartwood, large area leaving around 60 percent circumference of live tissue. Multiple dead branches in lower canopy, and heavily crown lifted, some major limbs removed leaving wound areas, good habitat. Sparse open upper canopy some deadwood. Slight lean NW away from road. | Remove all substantial dead. | 01-Jan-2025 (6 Months) |

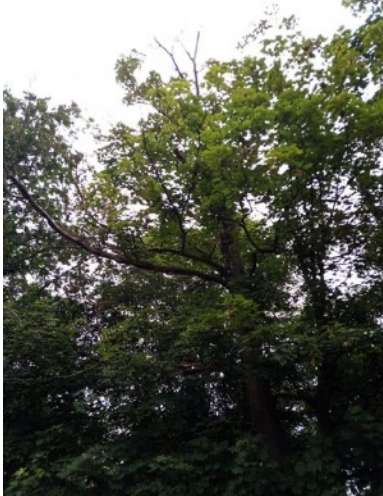
| T039 | Sycamore (Acer pseudoplatanus) | Roadside tree behind stock fence. | /// sprinting.fr uity.detect | Height (m): 13 Crown Radius (m): 4 DBH (cm): 45 Life Stage: Mature Life Exp.: 30+ Years | Large dead branches. Healthy stem low down. Lightening damage: dead to with multiple dead branches in a line, lenticular splits from to to midway point | Remove major deadwood and dead branches | 01-Jan-2025 (6 Months) |

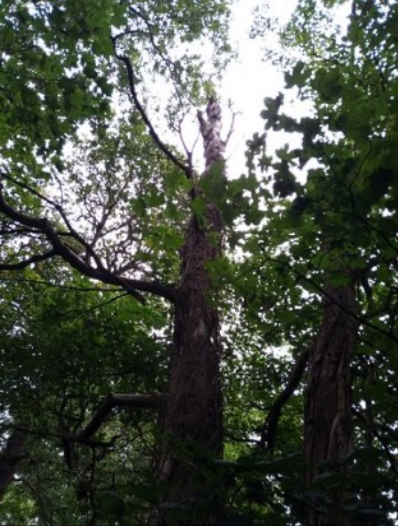
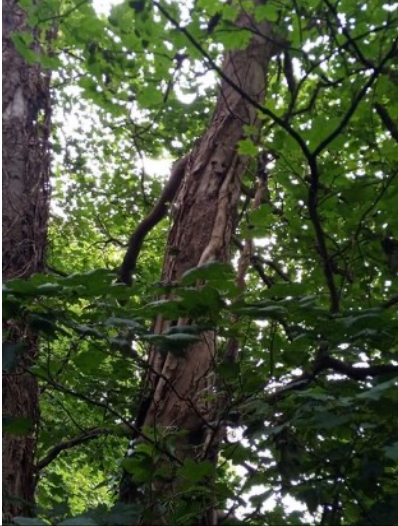
| T040 | Sycamore (Acer pseudoplatanus) | Road side tree, slightly set back from the road. | /// grab.custodial.towels | Height (m): 15 Crown Radius (m): 5 DBH (cm): 65 Stems: 2 Life Stage: Mature Life Exp.: <10 years | Dual stemmed. Western stem nearly completely dead. Severe decay at base including main union. Roadside stem with split up back and exposed heartwood with rot. Dead top with dieback further down. | Fell tree. | 01-Jan-2025 (6 Months) |

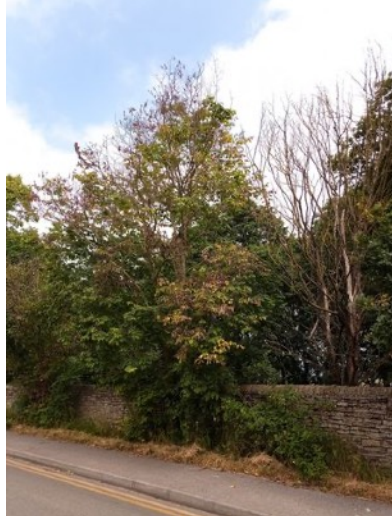
| G002 | Wych elm x3 (Ulmus glabra) | Strip of 3 trees next to road, one other side of boundary wall | /// rifled.benc hed.extre mely | Height (m): 5 Crown Radius (m): 2 DBH (cm): 25 Trees: 3 Life Stage: Semi Mature Life Exp.: <10 years | 3 trees with clear Dutch elm symptoms, all in poor condition with the one over the wall nearly completely dead. One has Oak sapling growing at base. Pests and Diseases: Dutch Elm Disease (Ophiostoma novo-ulmi) | Fell trees | 26-Jun-2025 (1 Year) |

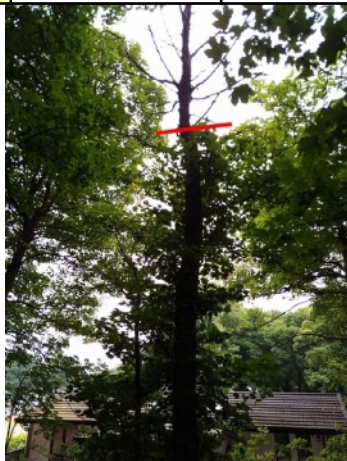
| T002 | Sycamore (Acer pseudoplatanus) | Next to caravan park and outbuildings. | /// able.likewi se.remakin g | Height (m): 16 Crown Radius (m): 2 DBH (cm): 40 Life Stage: Mature Life Exp.: <10 years | Completely dead top. Lower 50% canopy made up o epicormic and one live branch. | Remove dead top leaving totem with new growth. | 26-Jun-2025 (1 Year) |

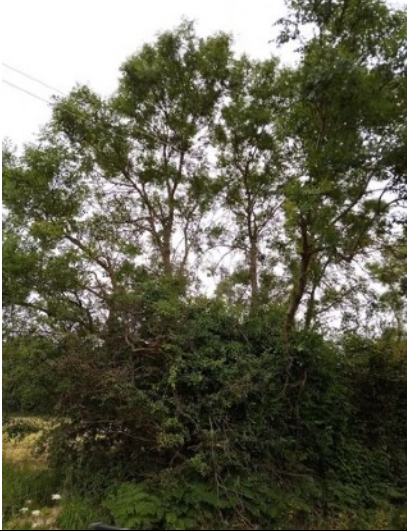
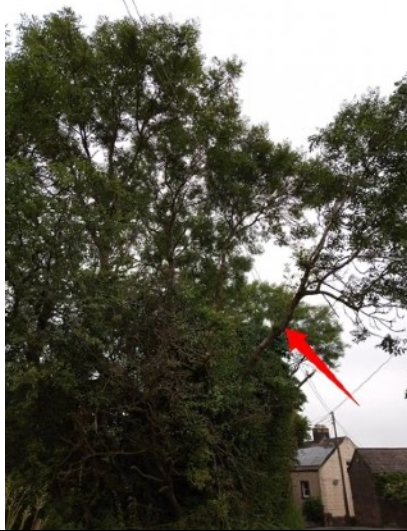
| T004 | Common ash (Fraxinus excelsior) | Next to road, power cables through canopy | /// overdrive. drag.attention | Height (m): 9 Crown Radius (m): 3.5 DBH (cm): 30 Stems: 2 Life Stage: Early Mature Life Exp.: 20+ Years | Hedgerow tree growing with hawthorn and hazel. Single stems growing out over road with severe lean, epicormic growth on stem. | Remove stem back to hedge | 26-Jun-2025 (1 Year) |

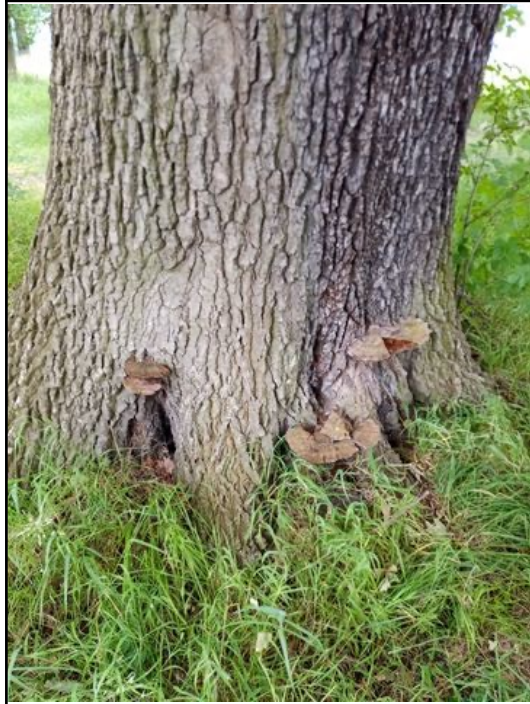
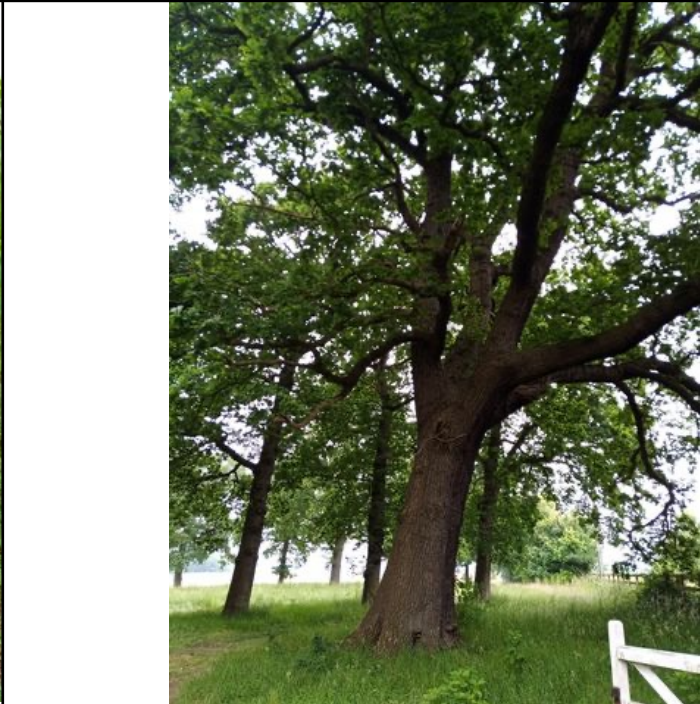
| T012 | Pedunculate oak (Quercus robur) | Set back from road, within parkland to S of track. | /// hook.wear y. fulfilled | Height (m): 21 Crown Radius (m): 9 DBH (cm): 140 Life Stage: Over Mature Life Exp.: 20+ Years | Large specimen, broad form, multi stemmed from 3.5m. Butteress roots with some cavities beginning to form. Fungal brackets around base in several butteresses, senescent so exact ID unclear. Canopy appears healthy and full with minimal dead branches. Tree has clear lean S. 4 or so tear stubs from previous snap outs, historic | Further inspection using tomography to assess structural integrity of main stem and butt. | FOR SURVEYOR NOT CONTRACTOR 26-Jun-2025 (1 Year) |

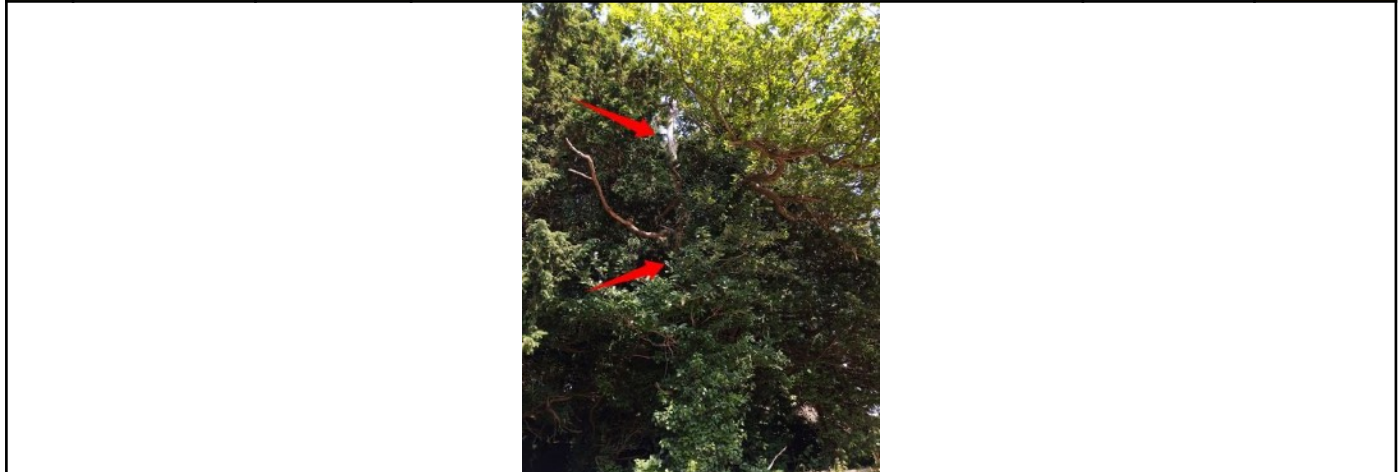
| T020 | Pedunculate oak (Quercus robur) | Roadside tree, Infront of railing | /// dent. distanced. own ers | Height (m): 9 Crown Radius (m): 4 DBH (cm): 60 Life Stage: Mature Life Exp.: 30+ Years | Ivy clad main stem. Stunted form, possibly from previous failure of main stem. Secondary stem dead and standing verticle through canopy. | Remove large dead stem Sever ivy. | 26-Jun-2025 (1 Year) |

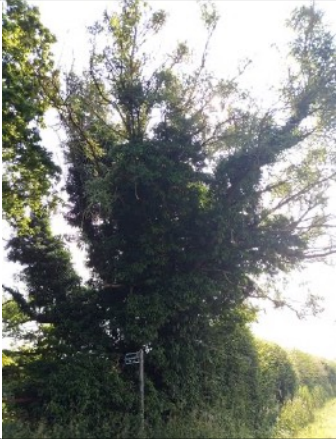
| T022 | Common ash (Fraxinus excelsior) | Roadside tree in hedgerow, a entrance to PROW | /// blues.insurance.some where | Height (m): 13 Crown Radius (m): 5 Life Stage: Mature Life Exp.: 10+ Years | Completely ivy clad. Tips dying back all around canopy, inner canopy fairly thick with vigorous new growth. . Pests and Diseases: Ash Dieback Infection Level 2: 25% to 50% | Review ADB levels and response to ivy severing. | FOR SURVEYOR NOT CONTRACTOR 26-Jun-2025 (1 Year) |

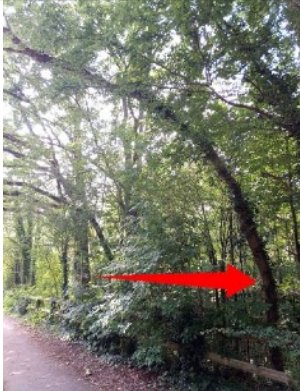
| T025 | Common ash (Fraxinus excelsior) | In woodland edge, set back from road and path. | /// project.painter.blanking | Height (m): 7 Crown Radius (m): 2 DBH (cm): 20 Life Stage: Early Mature Life Exp.: <10 years | Some ivy on main stem. Severe lean over road. On upright growth has died. Poor form with future failure potential. | Fell tree. | 26-Jun-2025 (1 Year) |

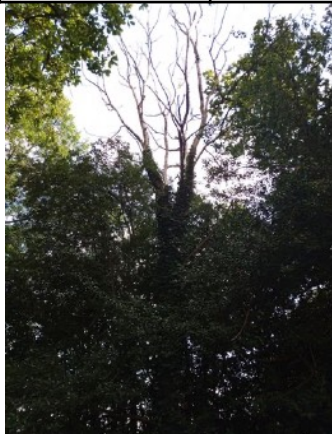
| T030 | Wych elm (Ulmus glabra) | Roadside tree, between holly and hawthorn | /// prep.anim al.limeligh t | Height (m): 7 Crown Radius (m): 2 DBH (cm): 30 Life Stage: Dead | Standing dead tree. Ivy clad main stem | Fell tree. | 26-Jun-2025 (1 Year) |

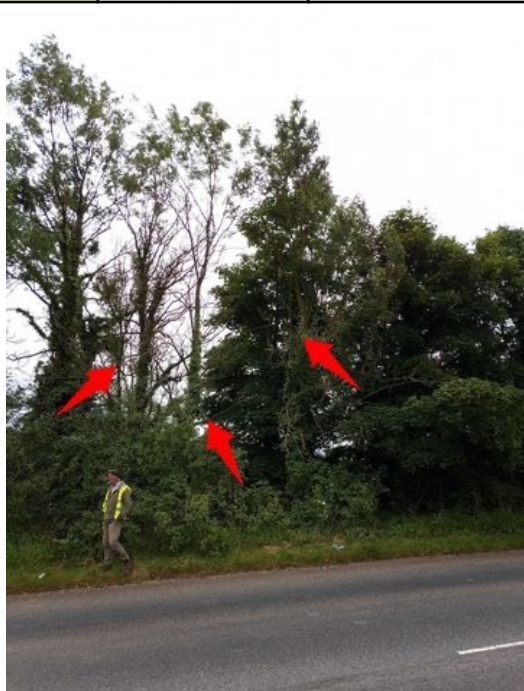
| G007 | Common ash x3 (Fraxinus excelsior) | Roadside trees. Tree next to sycamore group with rose growing at base | /// interviewe r.shots.glu e | Height (m): 10 Crown Radius (m): 3 DBH (cm): 30 Trees: 3 Life Stage: Early Mature Life Exp.: <10 years | One tree multi stemmed. All trees ivy clad. Severely dying back. All three have upright form. One tree almost completely dead. Pests and Diseases: Ash Dieback Infection Level 3: 50% to 75% | Fell trees | 01-Jul-2025 (1 Year) |

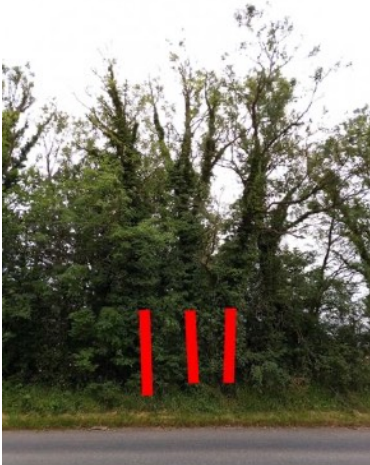
| G008 | Common ash x3 (Fraxinus excelsior) | Row of three road side tree, close together. | /// crumples. demandin g.tomb | Height (m): 14 Crown Radius (m): 4 DBH (cm): 40 Trees: 3 Life Stage: Mature Life Exp.: <10 years | Severely ivy clad. Dying tips, mainly at top, little potential for regrowth. Pests and Diseases: Ash Dieback Infection Level 2: 25% to 50% | Fell trees | 01-Jul-2025 (1 Year) |

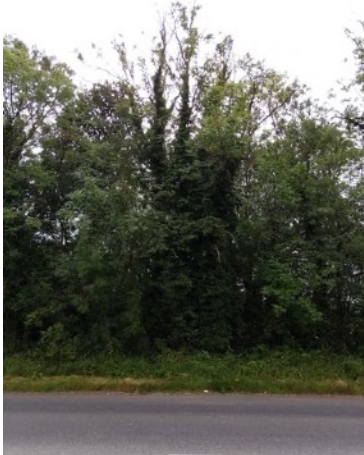
| G009 | Common ash x4 (Fraxinus excelsior) | Tight group of roadside trees, opposite road drain | /// soils.zinc.s treaks | Height (m): 14 Crown Radius (m): 3 Trees: 4 Life Stage: Mature Life Exp.: <10 years | Severely ivy clad, dying at tips, little growth in lower canopy, no epicormic response. Holly growing behind. Pests and Diseases: Ash Dieback Infection Level 3: 50% to 75% | Fell trees | 01-Jul-2025 (1 Year) |

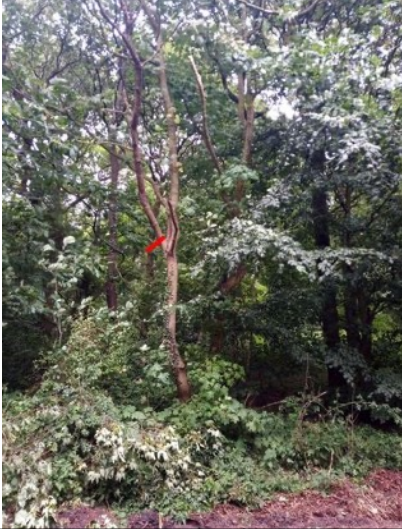
| T043 | Sycamore (Acer pseudoplatanus) | Roadside tree | /// irony.shee p.drilled | Height (m): 8 Crown Radius (m): 3 DBH (cm): 20 Stems: 2 Life Stage: Semi Mature Life Exp.: 30+ Years | Dual stemmed. Snapped out branches over road, one large dead branch on smaller stem with sunken canker at union | Remove dead limb on smaller stem, and remove snapped and hung up branches | 01-Jul-2025 (1 Year) |

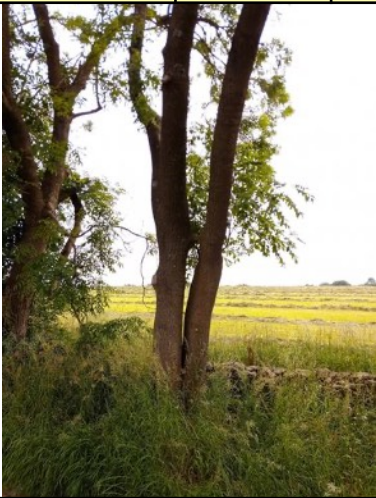
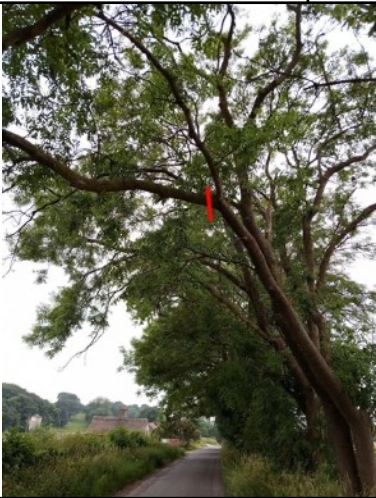
| T005 | Common ash (Fraxinus excelsior) | Dual stemmed roadside tree. Next to wall. | /// oath.moth ering.singl es | Height (m): 14 Crown Radius (m): 5 DBH (cm): 35 Stems: 2 Life Stage: Mature Life Exp.: 10+ Years | Dual stemmed. Slightly weakened canopy, sparse foliage with no internal growth. Smaller stem with wound from previous limb removal, creating split to rear. Also has strong lean over road with poor form, future potential hazard. | Reduce smaller leaning stem back to first major upright branch. | 26-Jun-2026 (2 Years) |

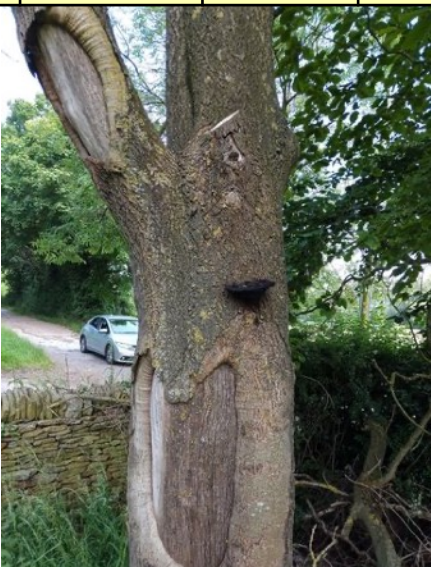
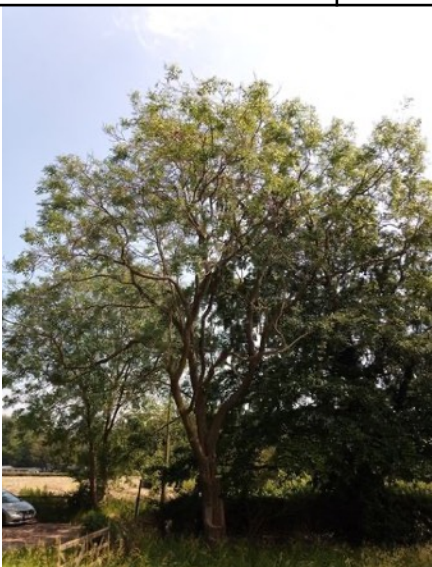
| T014 | Common ash (Fraxinus excelsior) | In corner of field at road and PROW junction. Slightly set back from road | /// coil.plodd ed.nightlif e | Height (m): 12 Crown Radius (m): 7 DBH (cm): 50 Life Stage: Mature Life Exp.: <10 years | Slightly weakening canopy, sparse foliage, some dieback at tips, light. Some smaller branches completely dead. Some recently shed limbs at base. Large wound at base and in first main limb. Mainly sealing well. Fungal bracket on main stem, blackened and old, ID difficult Fungus: Inonotus spp | Resurvey to assess rate of decline and spread of fungal bracket | FOR SURVEYOR NOT CONTRACTOR 01-Jul-2026 (2 Years) |

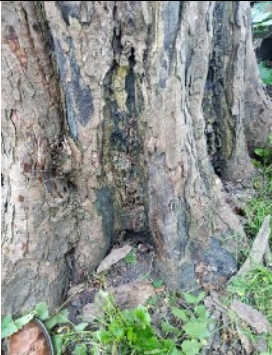
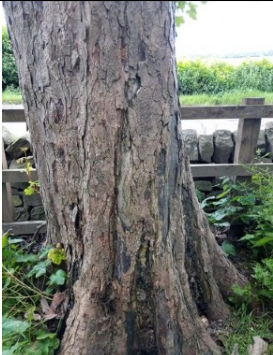
| T037 | Sycamore (Acer pseudoplatanus) | Roadside tree, in lower norcroft farm garden. | /// steadier.u nheated.s nores | Height (m): 17 Crown Radius (m): 5 DBH (cm): 85 Life Stage: Mature Life Exp.: <10 years | Growing in copse of established nature trees. Butteress roots, one damaged in fence installation, some decay in butteresses w side of tree with soft root. Leading to area of necrotic bark with exposed heartwood, large area leaving around 60 percent circumference of live tissue. Multiple dead branches in lower canopy, and heavily crown lifted, some major limbs removed leaving wound areas, good habitat. Sparse open upper canopy some deadwood. Slight lean NW away from road. | Monitor tree vitality, spread of decay. | FOR SURVEYOR NOT CONTRACTOR 01-Jul-2026 (2 Years) |

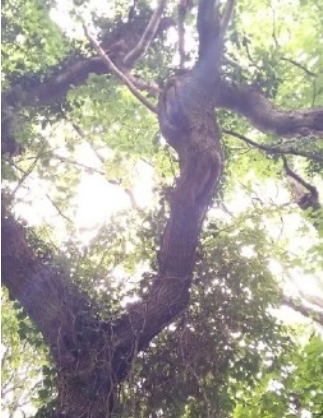
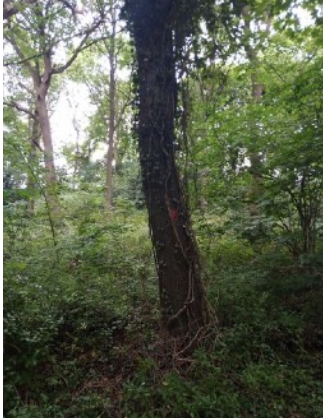
| T057 | Pedunculate oak (Quercus robur) | North side of road. Road side tree. | /// bill.stack.e lectrode | Height (m): 9 Crown Radius (m): 7 DBH (cm): 45 Life Stage: Mature Life Exp.: 30+ Years | Strong lean S. Climbers up main stem. Lowest branches with wound from historic tear outs, branches further from wounds are long and horizontal with heavy end weight. Strange form due to competition. Little potential for improvement. | Fell tree. | 01-Jul-2026 (2 Years) |
