BS 5837 Arboricultural Report

& Method Statement

**The Three Horse Shoes
Barnsley Road
Brierly
S72 9JT**

**Dated
21st March 2017**

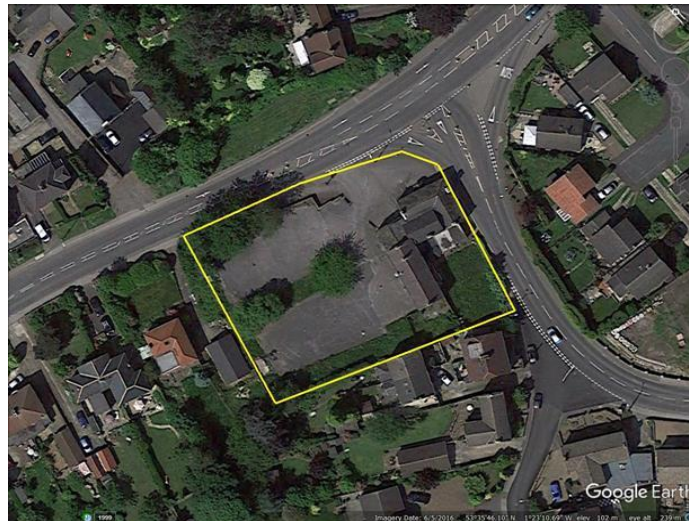
Figure 1 Extent of the survey (image is not current).

2.3.1. Our survey covered the area indicated in Figure 1.
