**Purpose of Issue**  
Planning

**Project**  
Tower Street, Barnsley

**Drawing**  
Rendered street elevation window study

**Drawing No**  
23-122-118

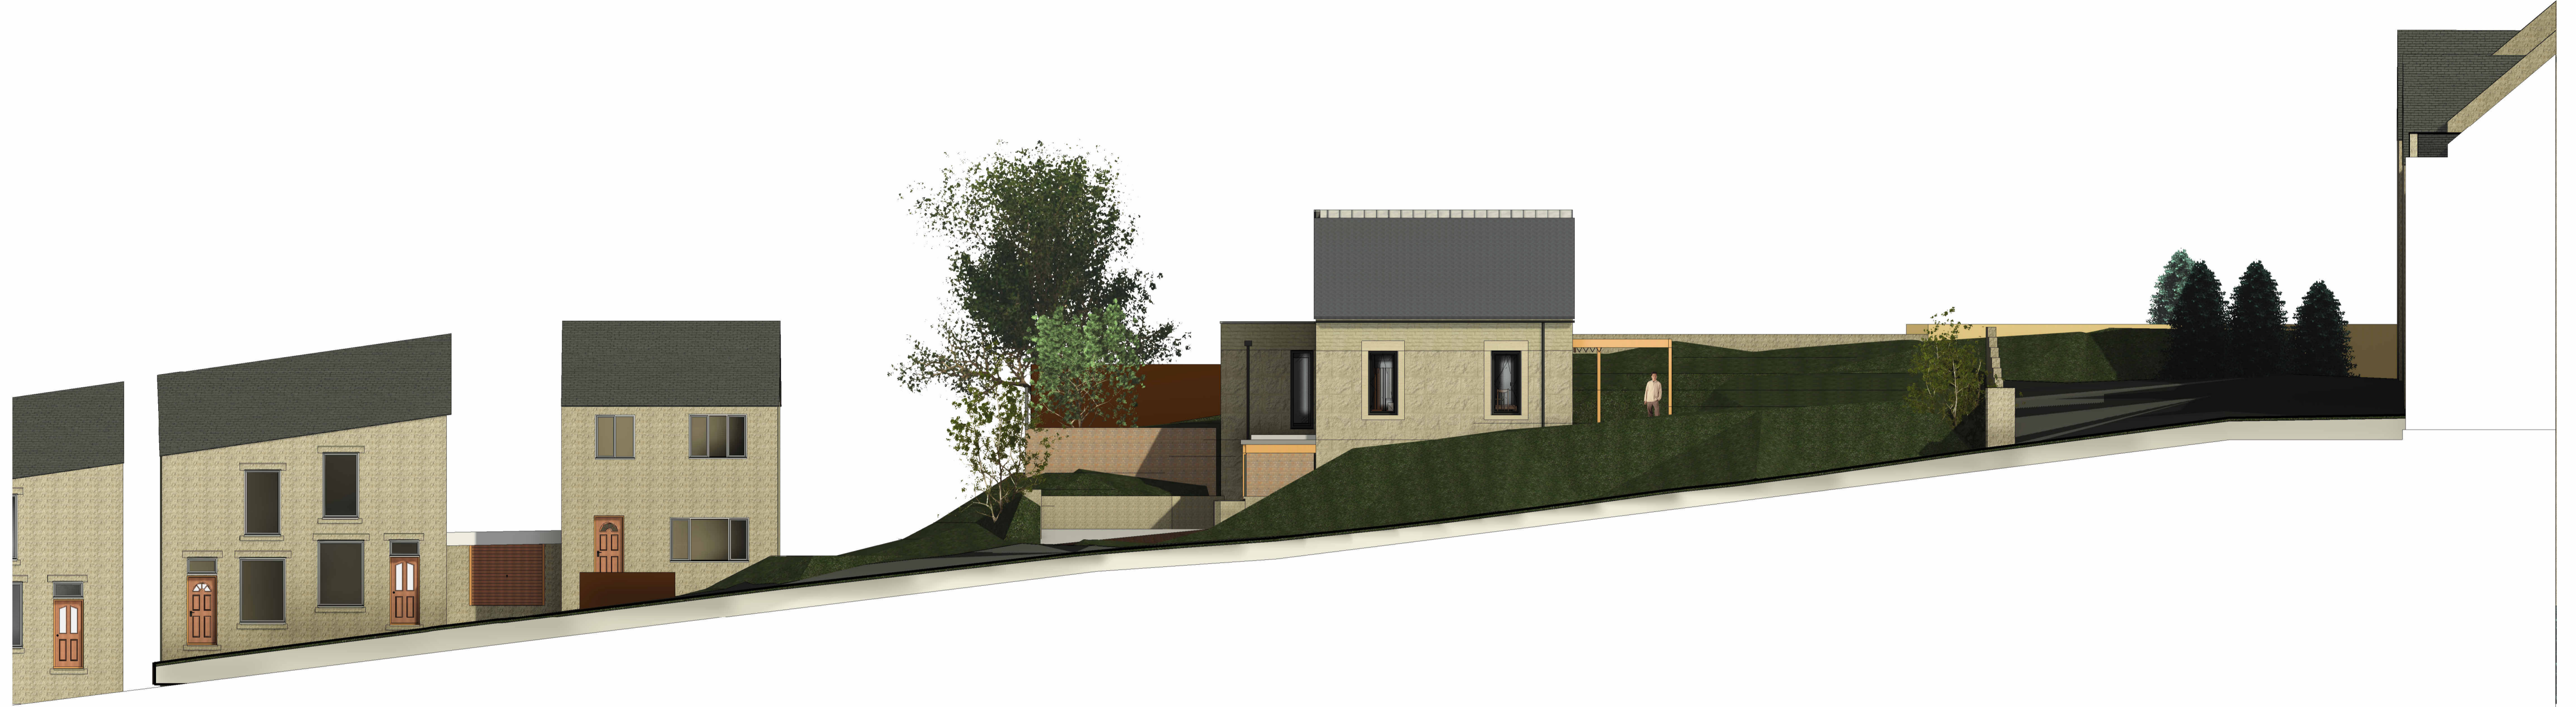
**1** Section 9  
1 : 100

Replacement modern windows, stone head and cills

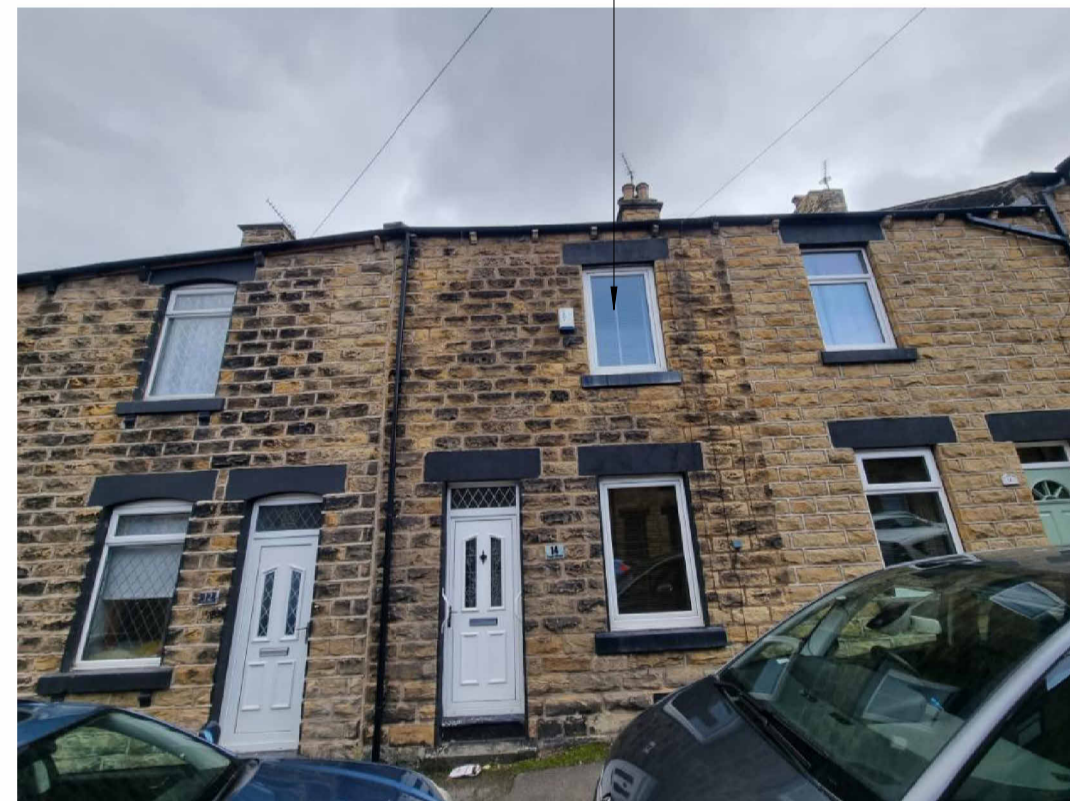
Variety of fenestration patterns

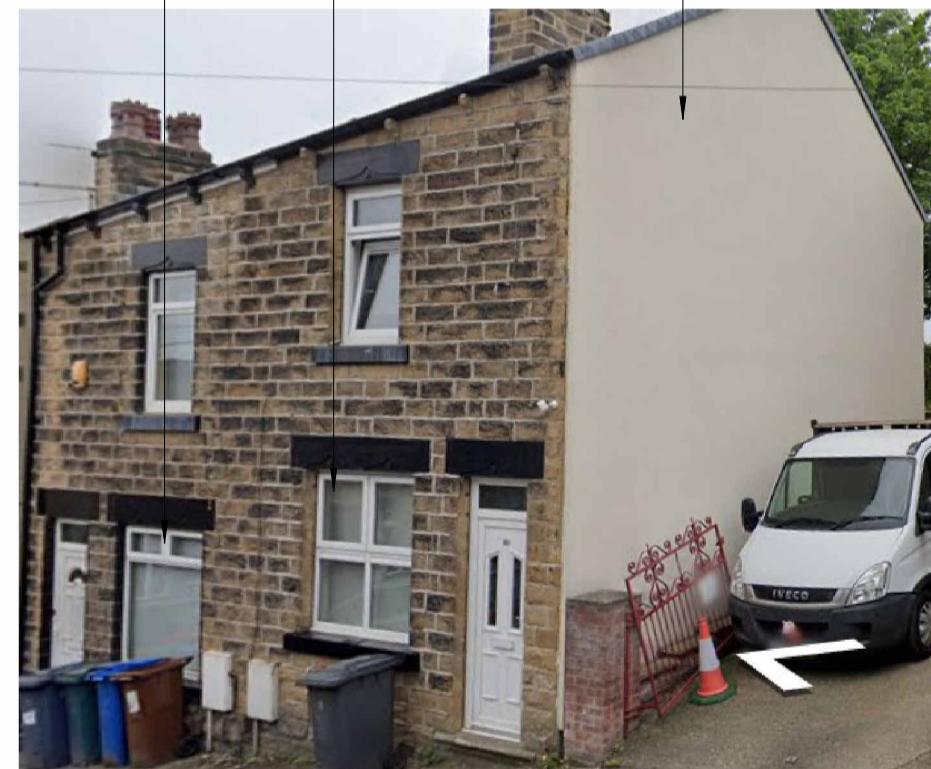
Modern replacement windows

Rendered gable wall visible from head of Tower Street

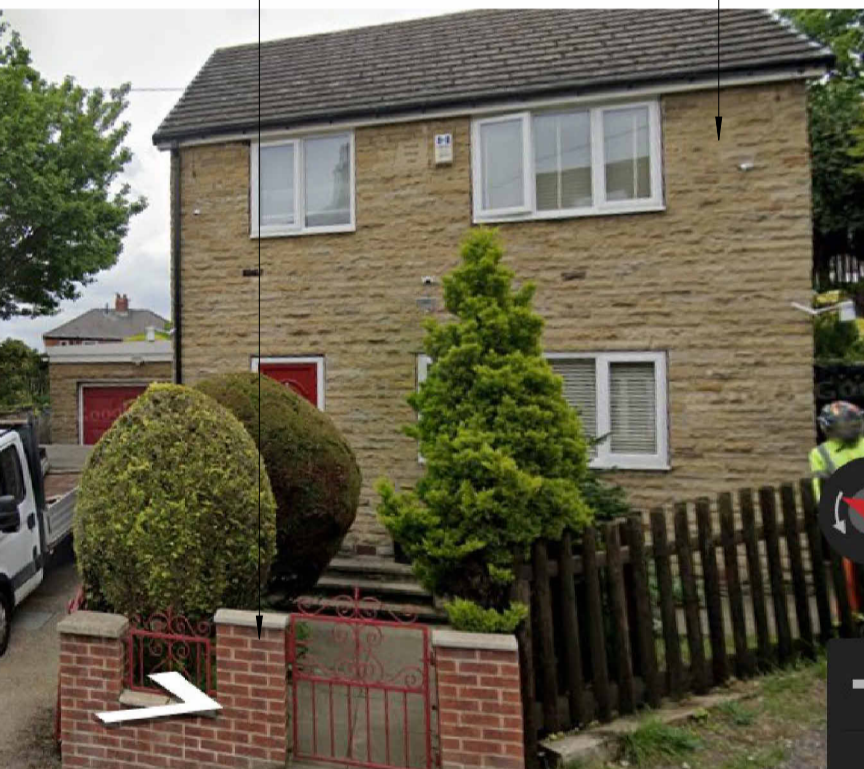
Red brick boundary wall

52 Tower street set back from building line of terraced houses. Modern window configurations. Stone facing materials, no stone cills or lintels

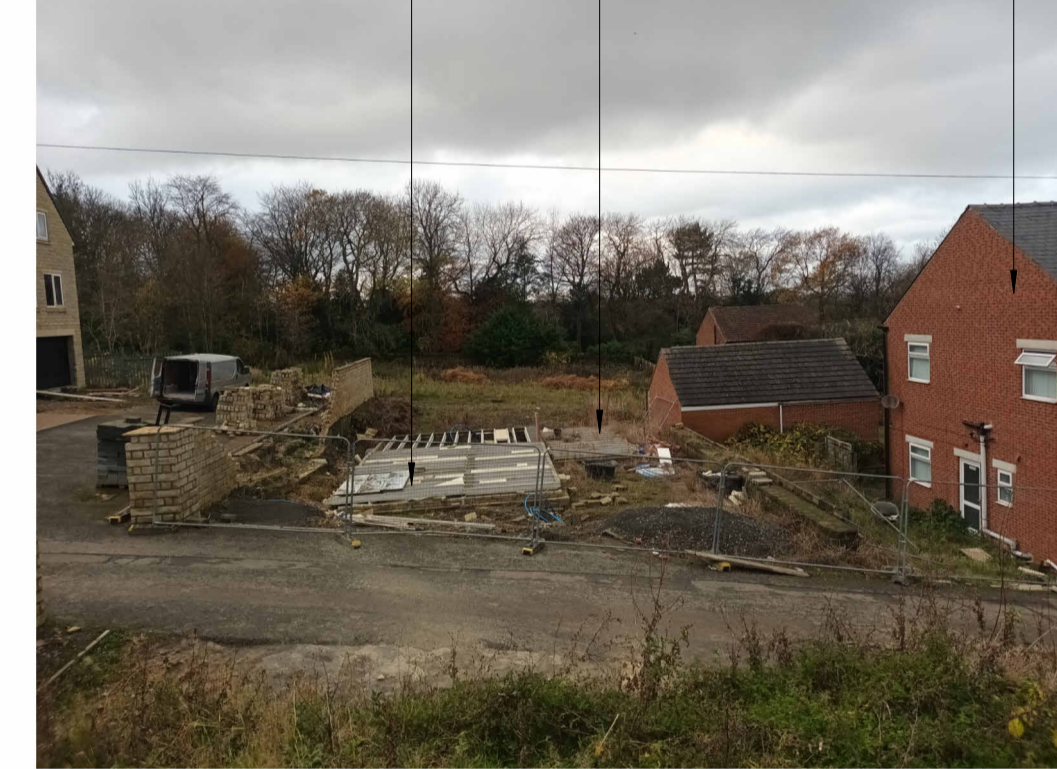
Gable with habitable windows facing townhouses

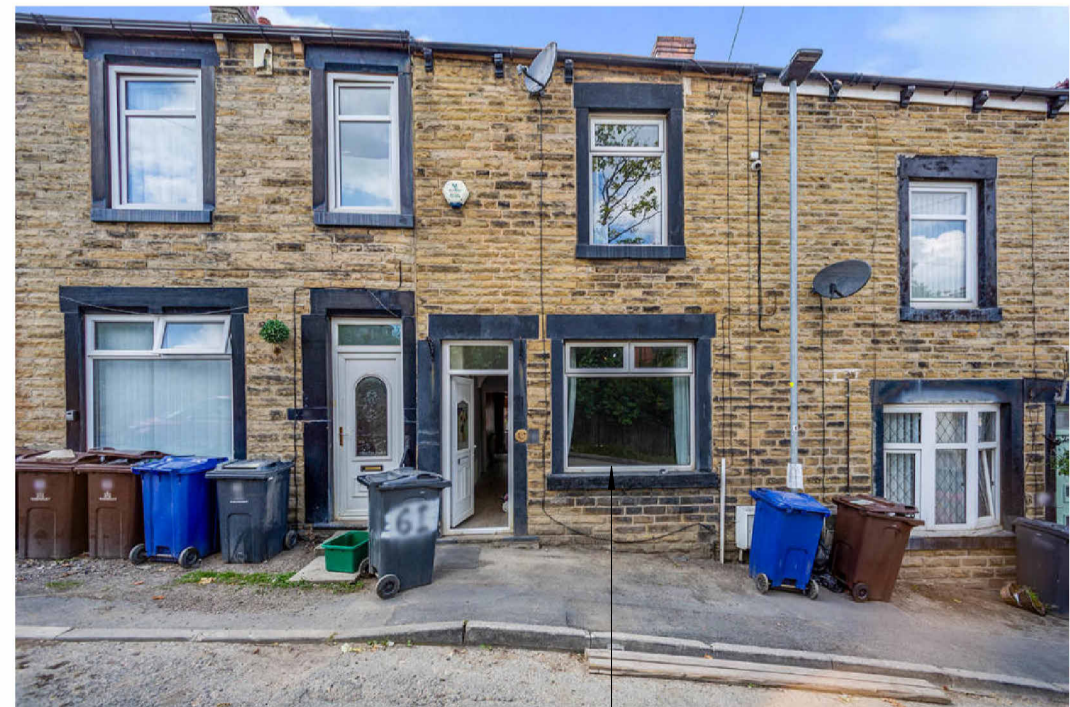
Stone window surrounds

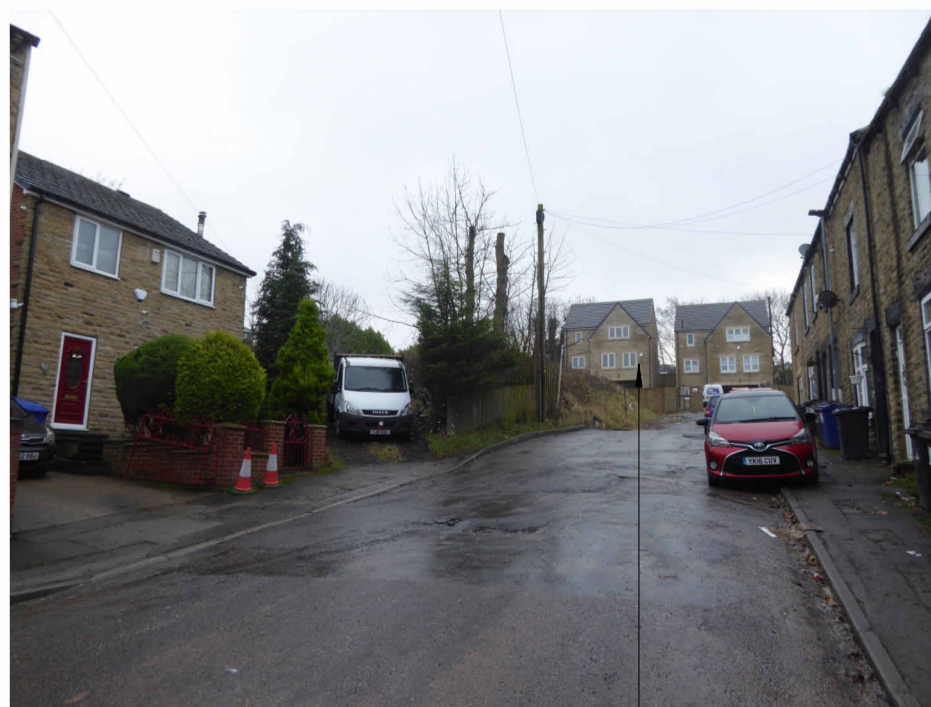
Tower Street town houses with modern window configurations

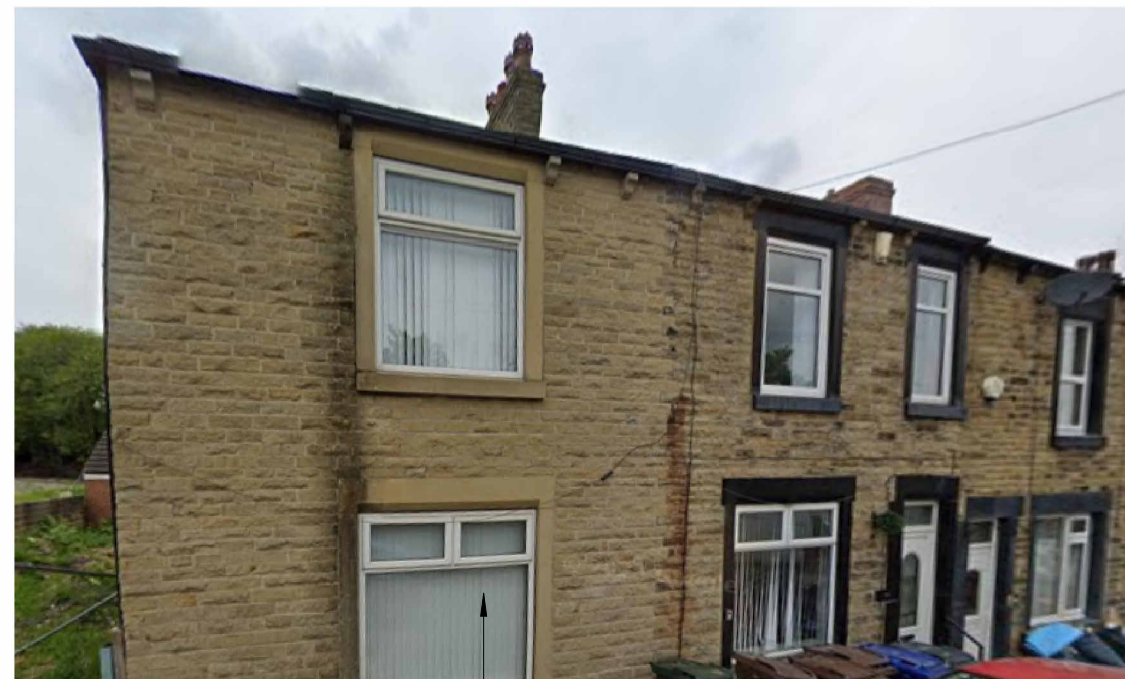
No 63 opposite the proposed dwelling with side extension to form double fronted dwelling, stone window surrounds.
