Visual Impact Assessment.

3DVS have undertaken this Visual Impact Assessment study on behalf of *Mr J Key*, which is intended to form part of an application for the determination of the erection of a 15m wind turbine at Garfield House Farm, Midhopstones, Stocksbridge. The report identifies the visual impact of this turbine through photography.

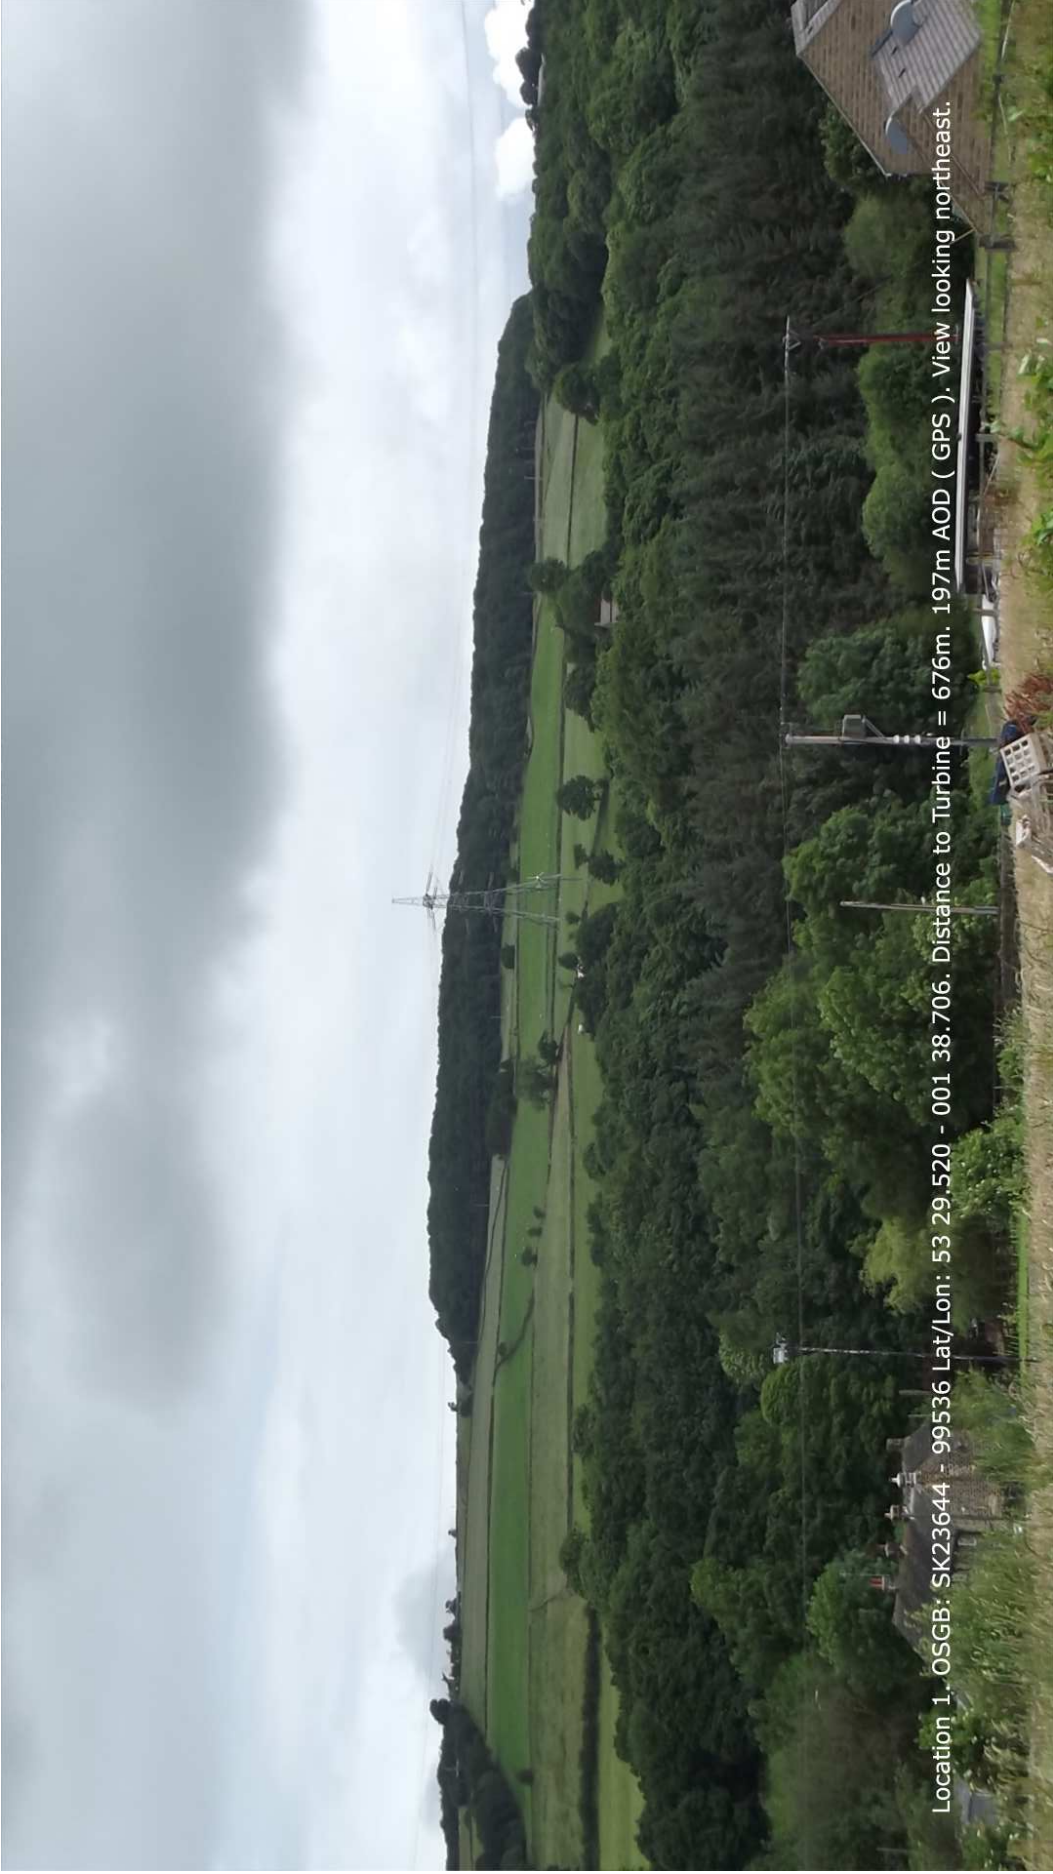
Location 1. OSGB: SK23644 - 99536 Lat/Lon: 53 29.520 - 001 38.706. Distance to Turbine = 676m. 197m AOD (GPS). View looking northeast.

Chapel Lane, Midhopstones. The turbine is small and narrow in construction (15m High). The proposed turbine has been placed in a position near to a pylon, so that its form blends visually into the structure of the much larger pylon. The turbine is not on the skyline but against the hillside. Views to the turbine from lower levels are blocked by the wooded areas below. The same situation occurs with views from above.

Visual impact from this point is of medium sensitivity and moderate impact. This is due to some (not all) of the properties in the village having views to the site.

Cumulative Impact is classed as combined.

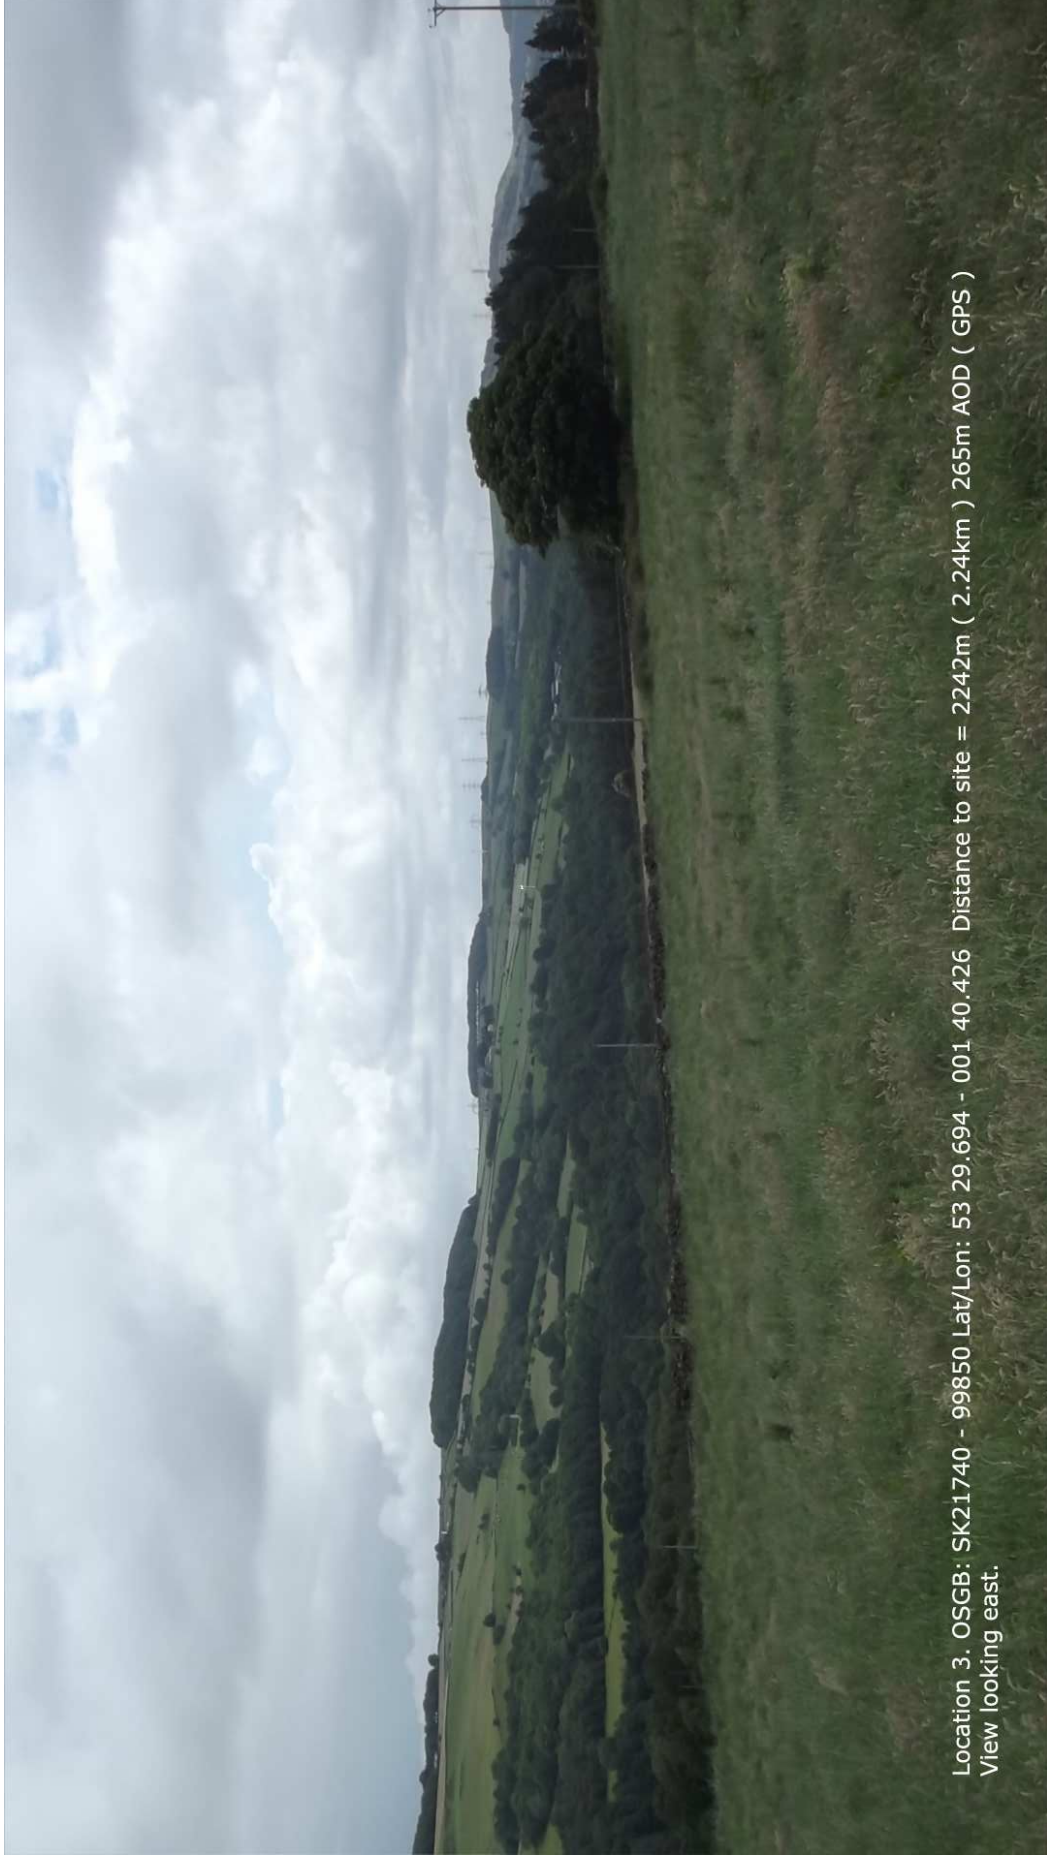
Location 3. OSGB: SK21740 - 99850 Lat/Lon: 53 29.694 - 001 40.426 Distance to site = 2242m (2.24km) 265m AOD (GPS)
View looking east.

Midhope Cliff Lane looking 2242m (2.24km) east to the site. From this viewpoint the turbine is seen as a small low feature on the landscape. At this distance several

tall and dominant features appear in the landscape, approx 15 in number, including the 25m Endurance turbine which sits clearly on the skyline – and is marked on the photomontage. Visual impact is slight. Cumulative impact is combined due to the number of more dominant vertical structures.

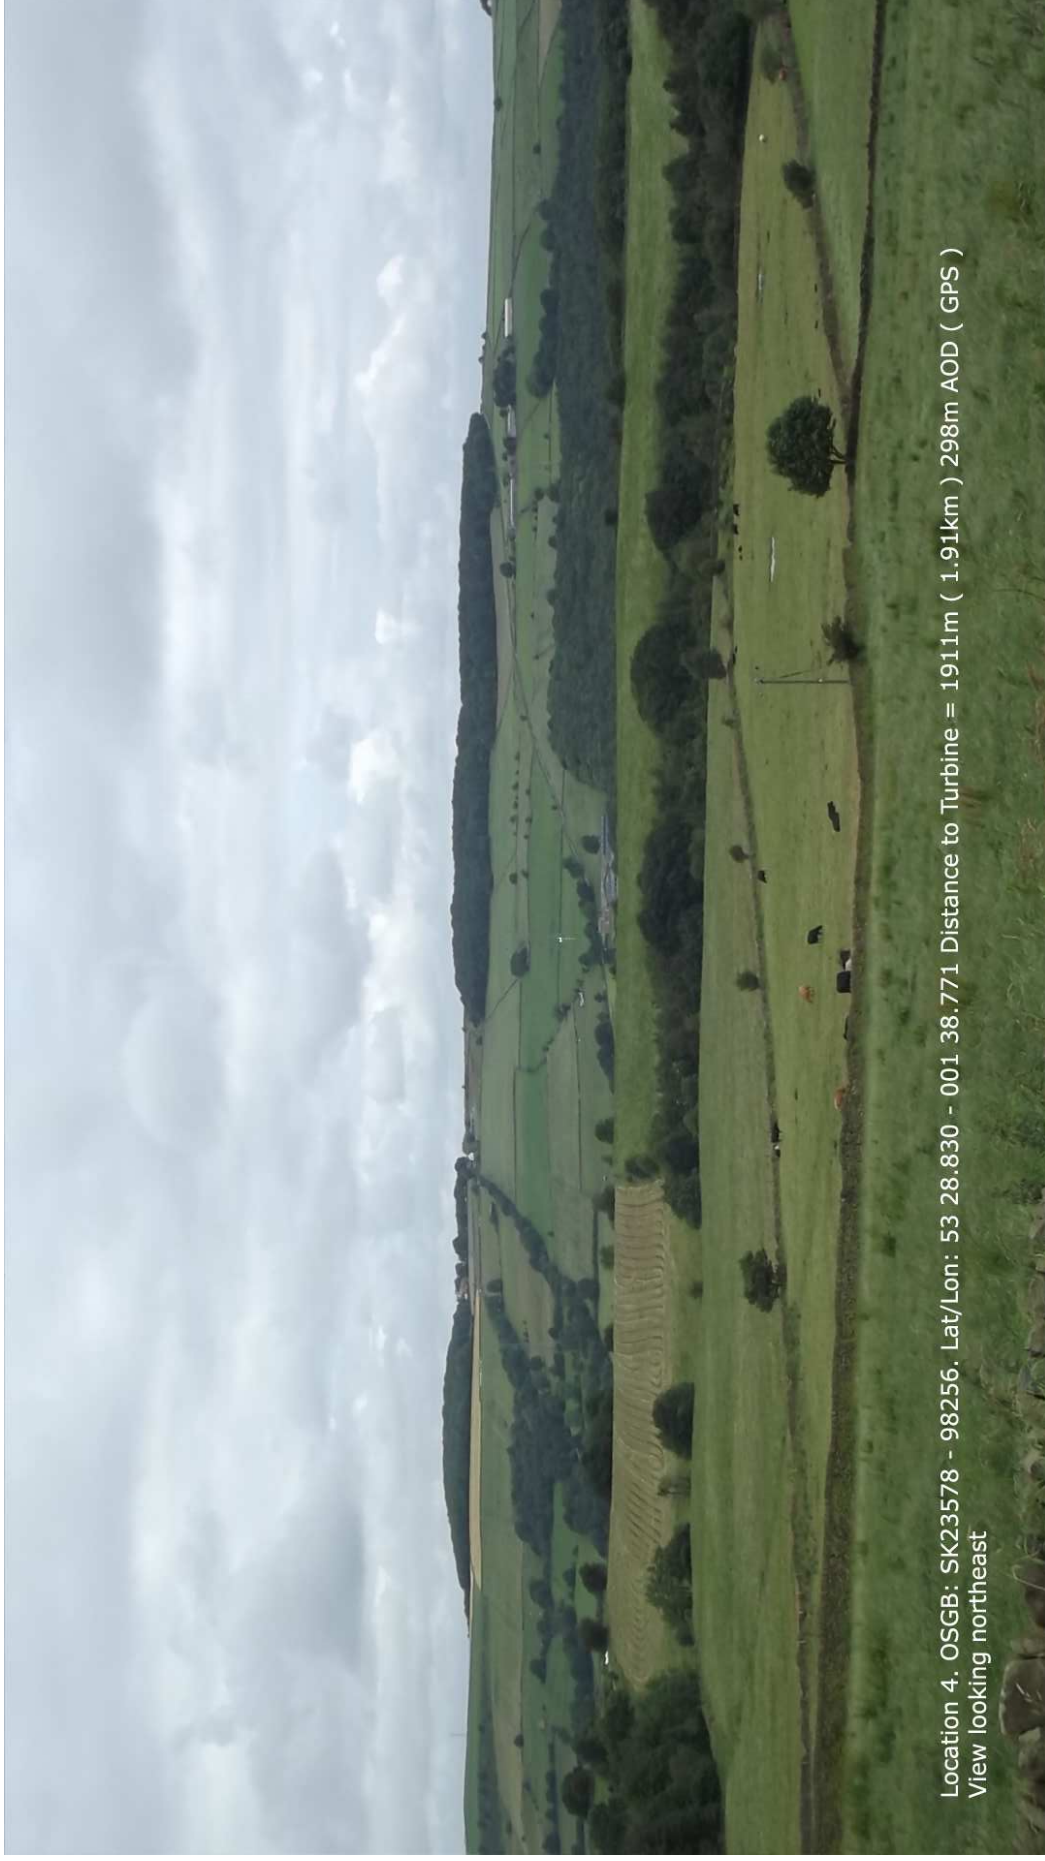
Location 4. OSGB: SK23578 - 98256. Lat/Lon: 53 28.830 - 001 38.771 Distance to Turbine = 1911m (1.91km) 298m AOD (GPS)
View looking northeast

Mortimer Road looking north. The proposed site is 1995m (2km) away.

Mortimer road forms part of the boundary for the Peak District National Park. The proposed turbine is seen as a small thin vertical structure slightly below a much taller and more dominant pylon. The turbine is against the background hillside. Examination of the photomontage clearly shows the turbine in scale and symmetry against other buildings in this view.

Visual impact is slight. Cumulative Impact is in combination with other elements and there is no increase in visual harm.
