PHASE 2 SITE INVESTIGATION - EXISTING BARN (BUILDING 1) RESIDENTIAL CONVERSION

Hill End Farm, Hill End Road, Mapplewell, Barnsley, S75 6DU

Report Ref: TH/Hill End/Bldng1/Class Q/PHASE2/Mar2023/v01

11th March 2023

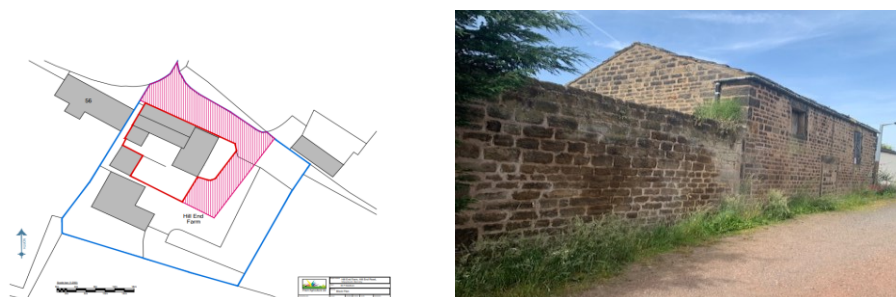
With respect to this specific approved development, it is evident that the existing structure (Building 1) is a traditional stone-built barn dating back at least two centuries that has been agricultural in the past.

Fig 2 – Existing Barn: Block Plan and Photo of Barn Front – as viewed off Hill End Road looking southwest.

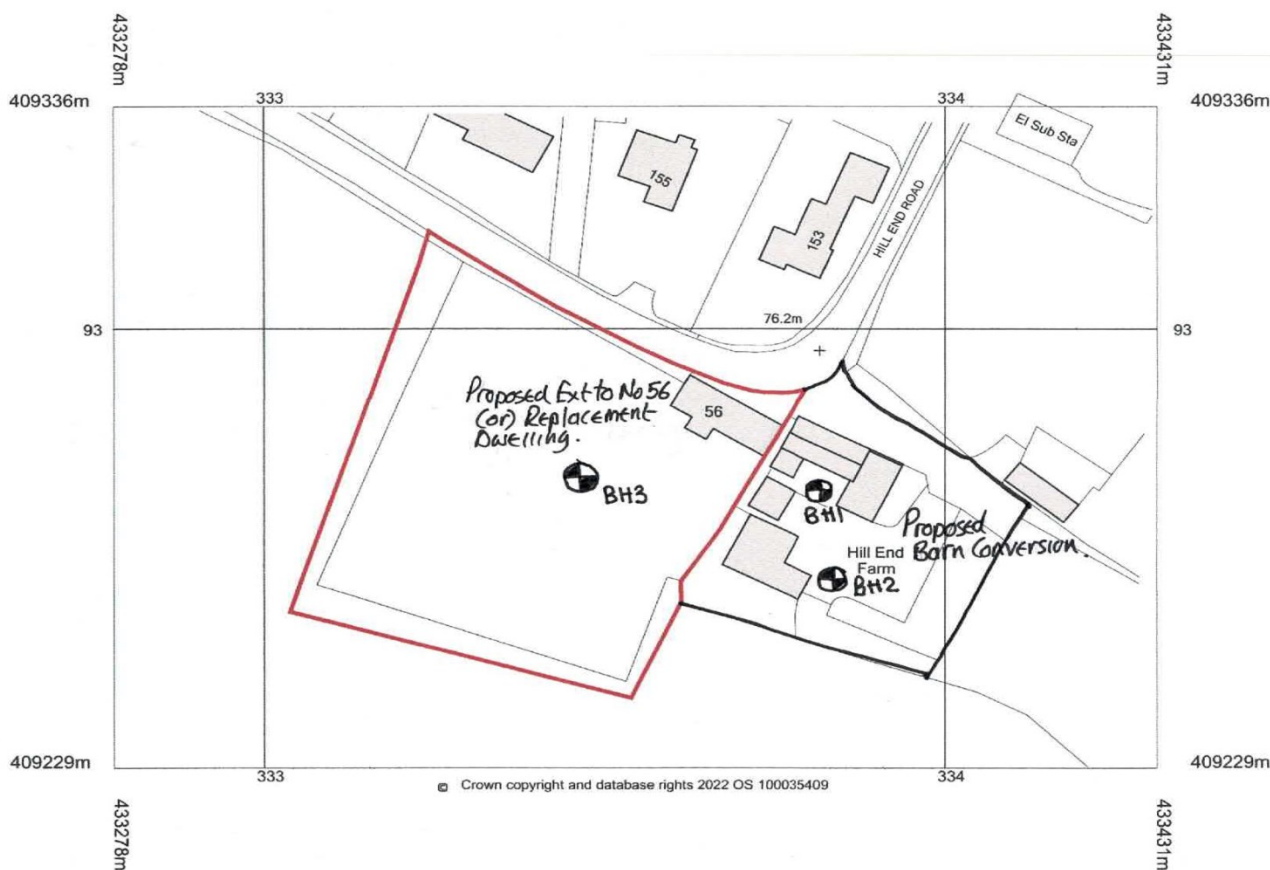
Fig 3 – BH Location Plan - Hill End Farm, Mapplewell.

On this basis, it was considered appropriate to commission **3No. rotary boreholes to 30m deep** across the whole site area to identify any unstable zones, coal seams etc., with a qualified watching brief to ensure that if made ground is also observed (with anthropogenic debris) or if visual/olfactory (malodorous) evidence of fuel/oil type contamination is identified, then **contamination screening** and more detailed laboratory testing and/or human health risk assessment can be undertaken as required.

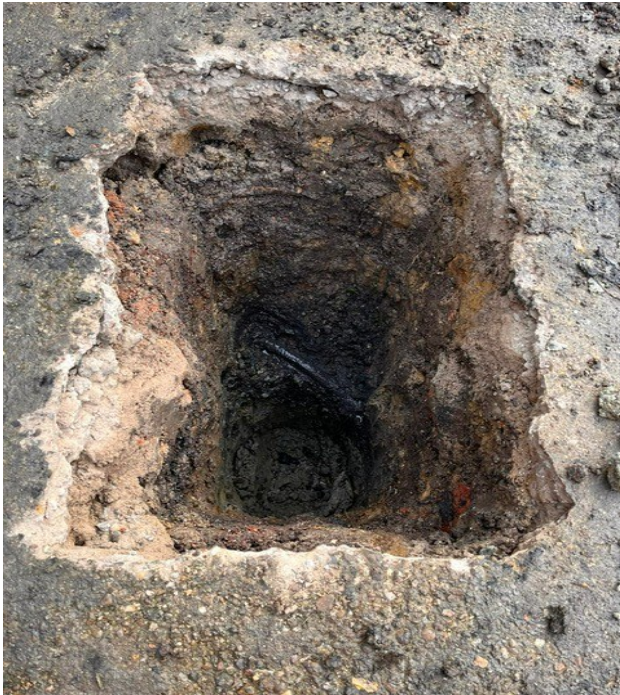
Fig 5 – Pre-drilling Test Pit – Borehole BH1

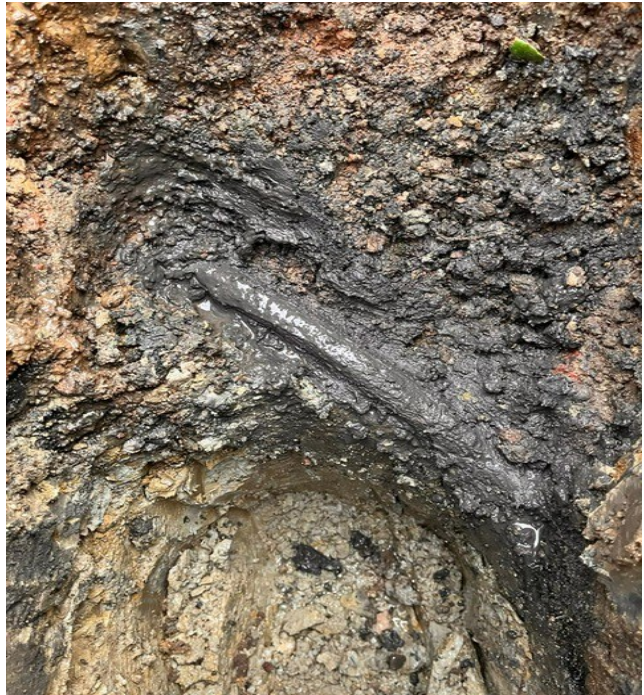
Fig 6 – Pre-drilling Test Pit – Borehole BH1

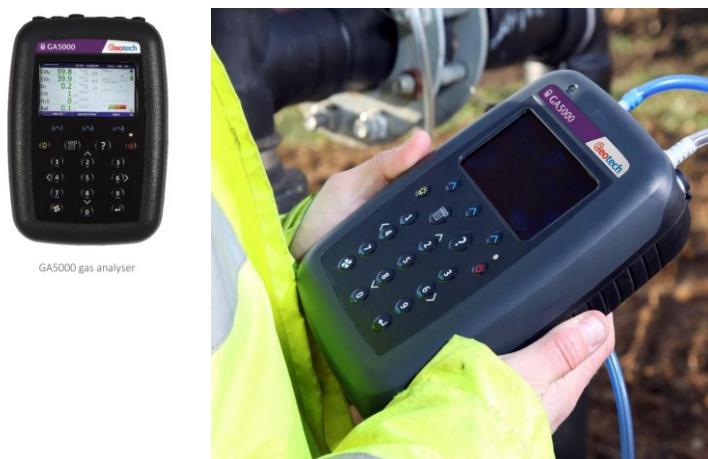
Nonetheless, in accordance with the recommendations in the Phase I Desk Study and the CMRA, standpipe piezometer tubes were installed in BH1 and BH3 and a structured phase of Ground Gas monitoring was carried out for a duration of 6 weeks from 7th January 2023 to 18th February 2023 using a **Geotechnical Instruments GA5000** which is used to monitor landfill gas extraction systems and is designed to meet all current demands for landfill & Brownfield site monitoring protocols set by government legislation in Europe and the UK. It measures % CH₄, CO₂ and O₂ and barometric pressure.

Fig 7 – Earth Tech’s *Geotechnical Instruments GA5000* sampling system used at Hill End Farm, Hill End Road, Mapplewell, S75 6DU

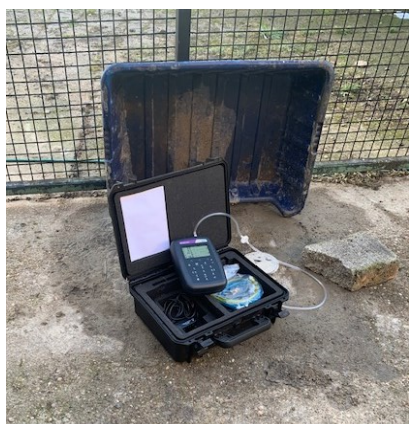
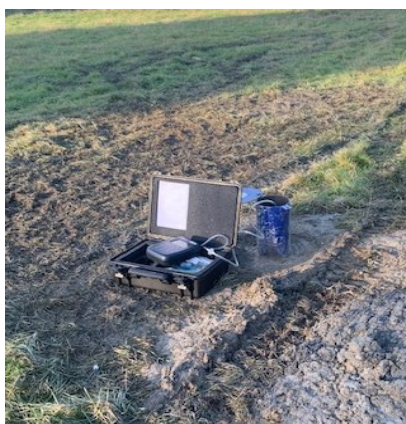
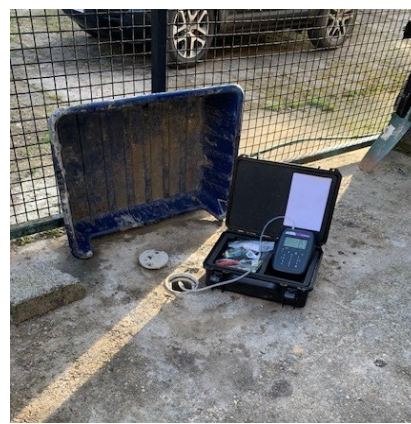
BH1 and BH3 were fitted with the necessary equipment to allow ground gas monitoring to be carried out over the course of 6 to 8 week period. Gas monitoring standpipe zones were set at the position of the Coal Seams +/- 2m in each case.
