**Far Westhorpe Farm**  
Heritage Statement  
Cottage - internal wall and  
first floor chimney  
**24-001-301**

Revision B – Issued for approval 18-02-26

**Far Westhopre Farm**  
**Penistone**  
**S10 2FX**

**Structural inspection**  
**9 September 2025**

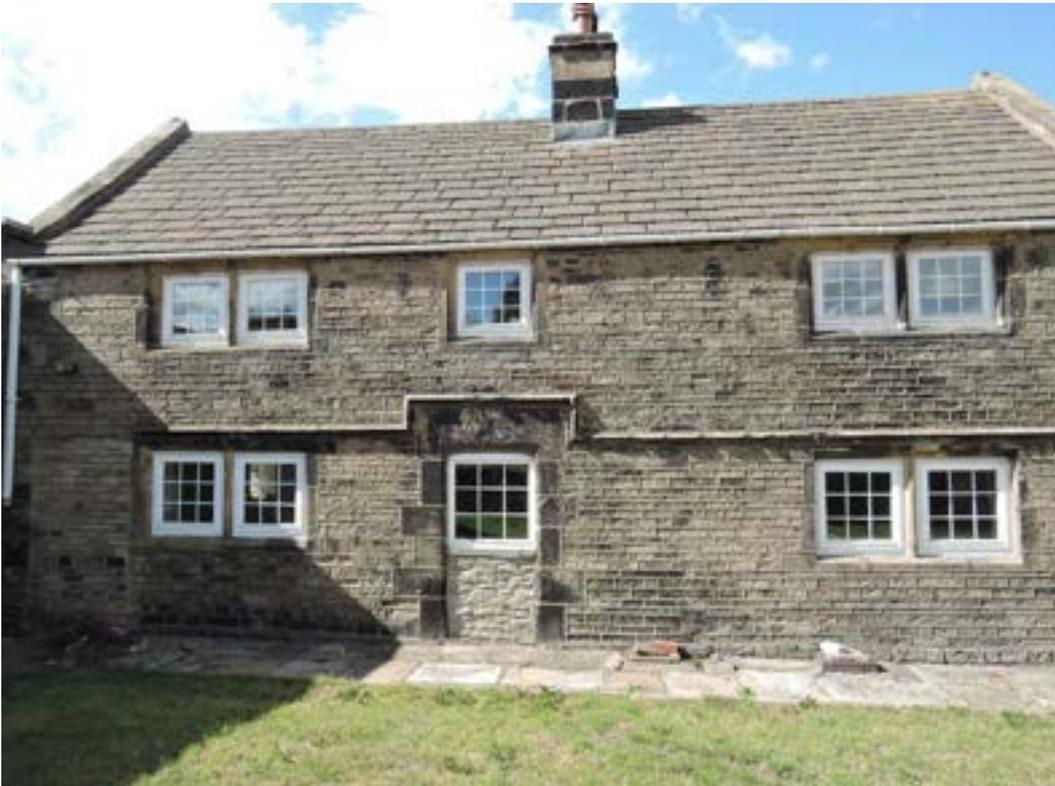
Garden elevation

In the garden elevation above it can be seen that the masonry is in very good order as is the roof with flat planes and straight lines and a very level ridge.

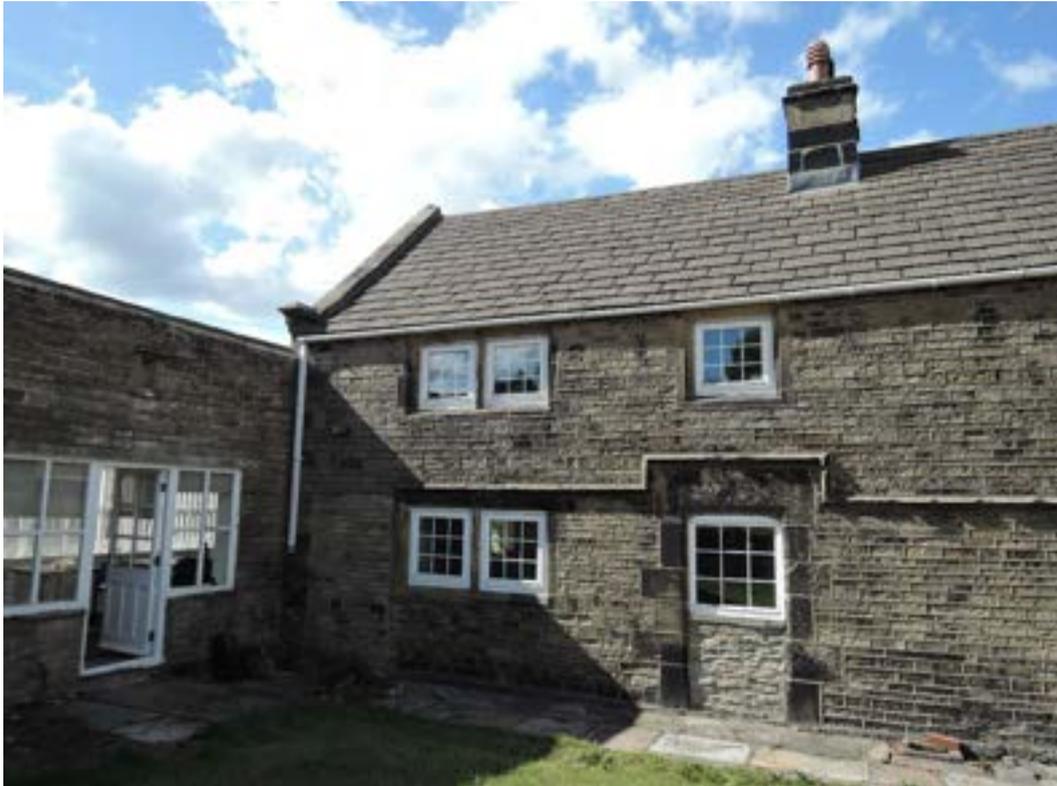
Left end of garden elevation. Extension on left to be replaced

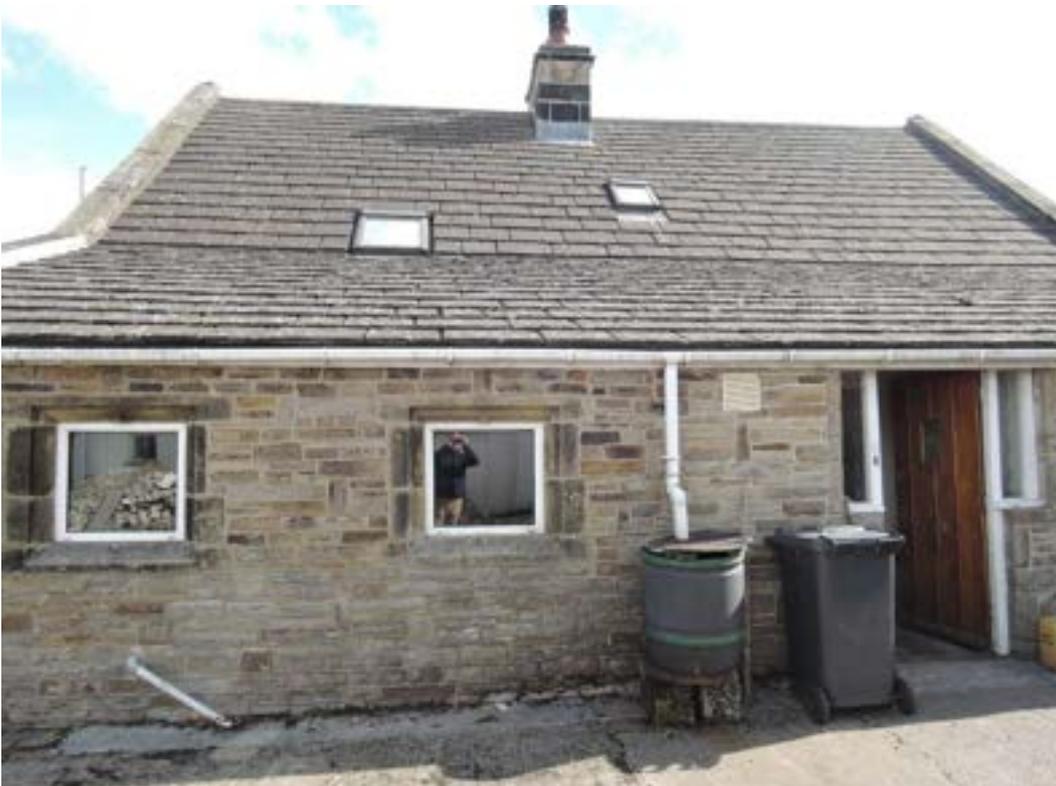
Farmyard side, single storey extension. First floor extension proposed on top

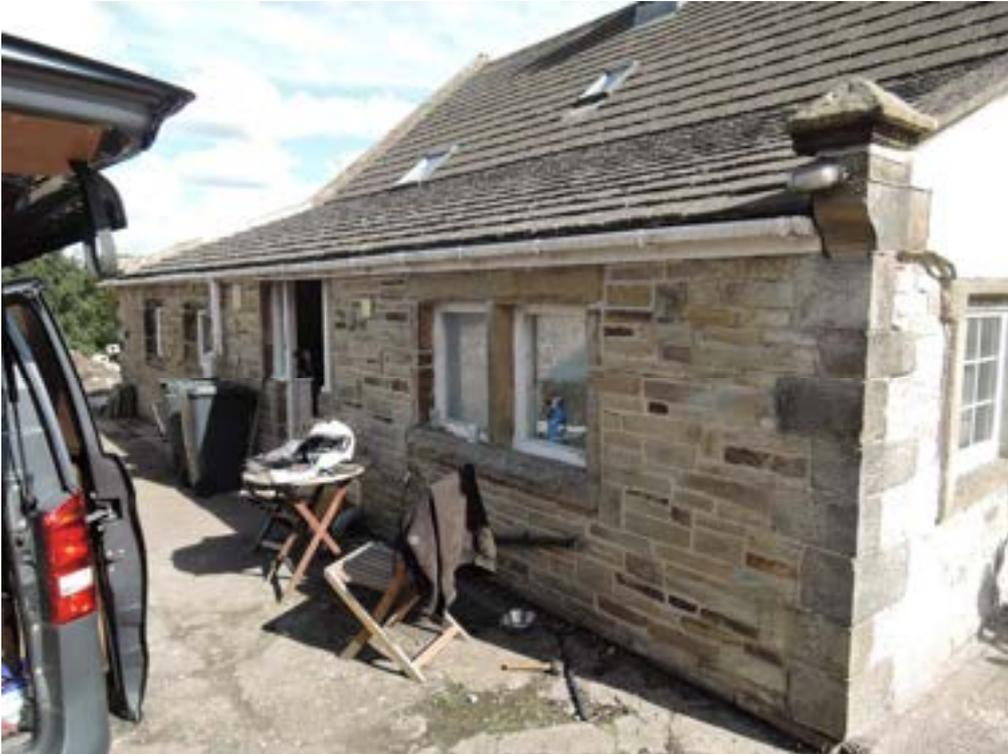
Farmyard side, single storey extension, no signs of distress.

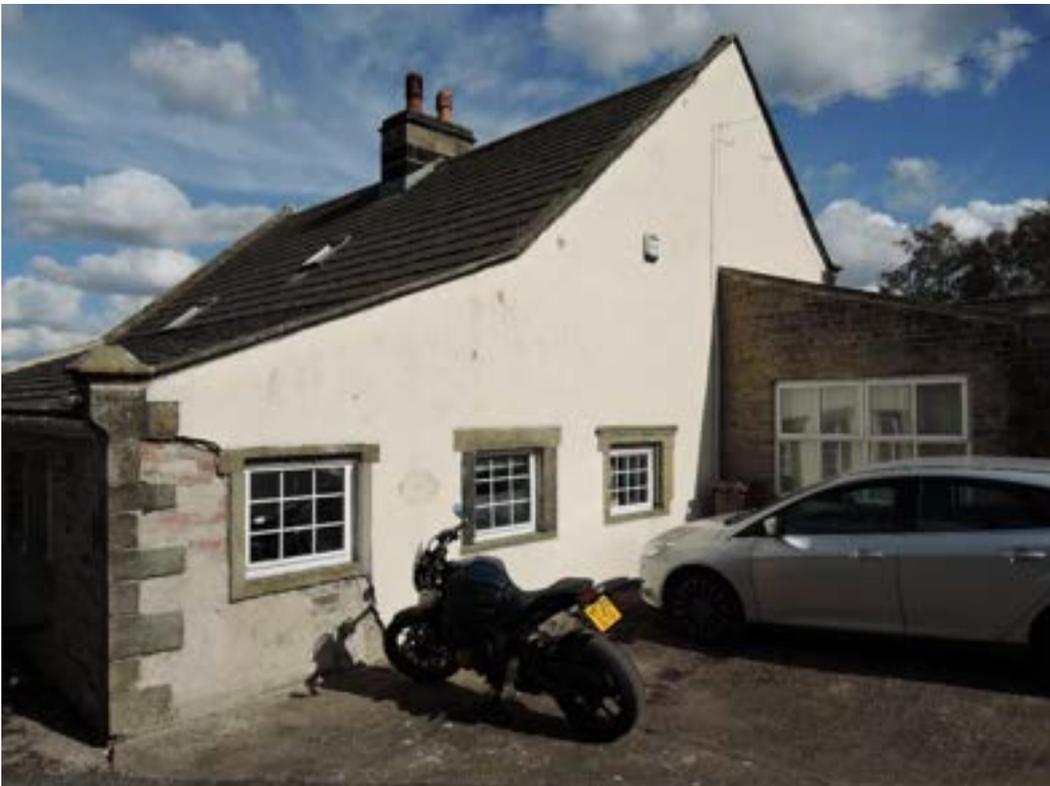
Southwest gable. Brickwork revealed under render to extension

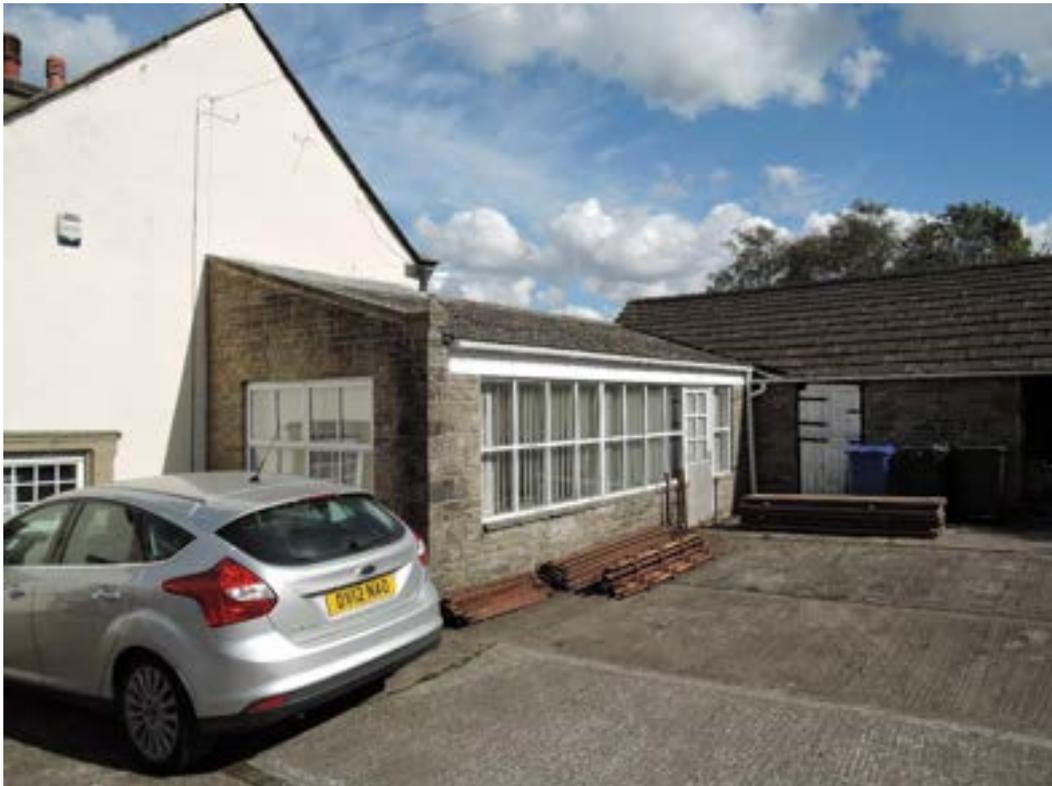
Single storey extension in yard, to be replaced.

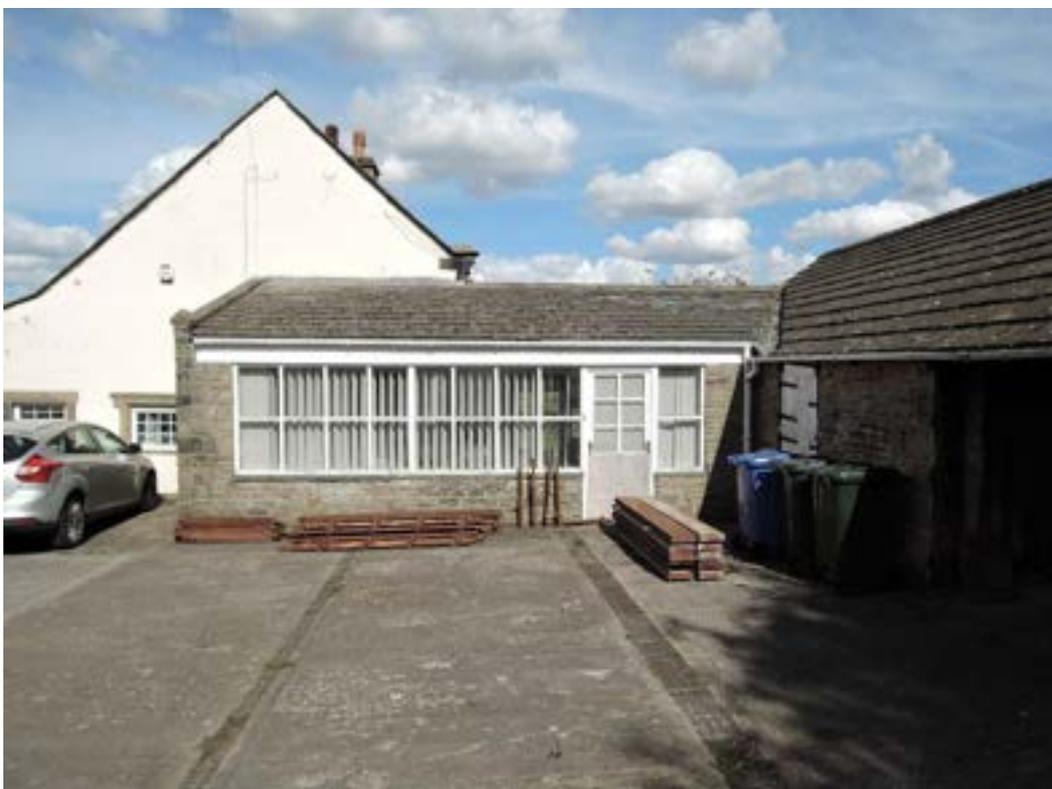
Single storey extension in yard. Cottage gable in good order

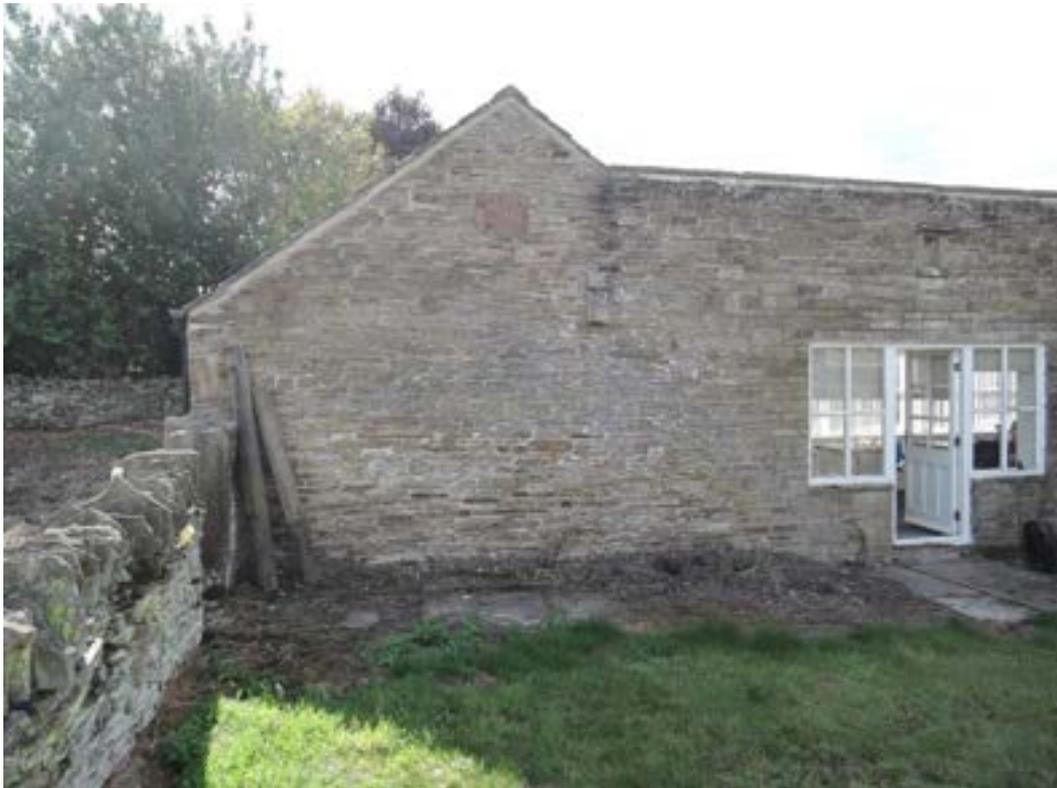
Gable to shed/garage in good order

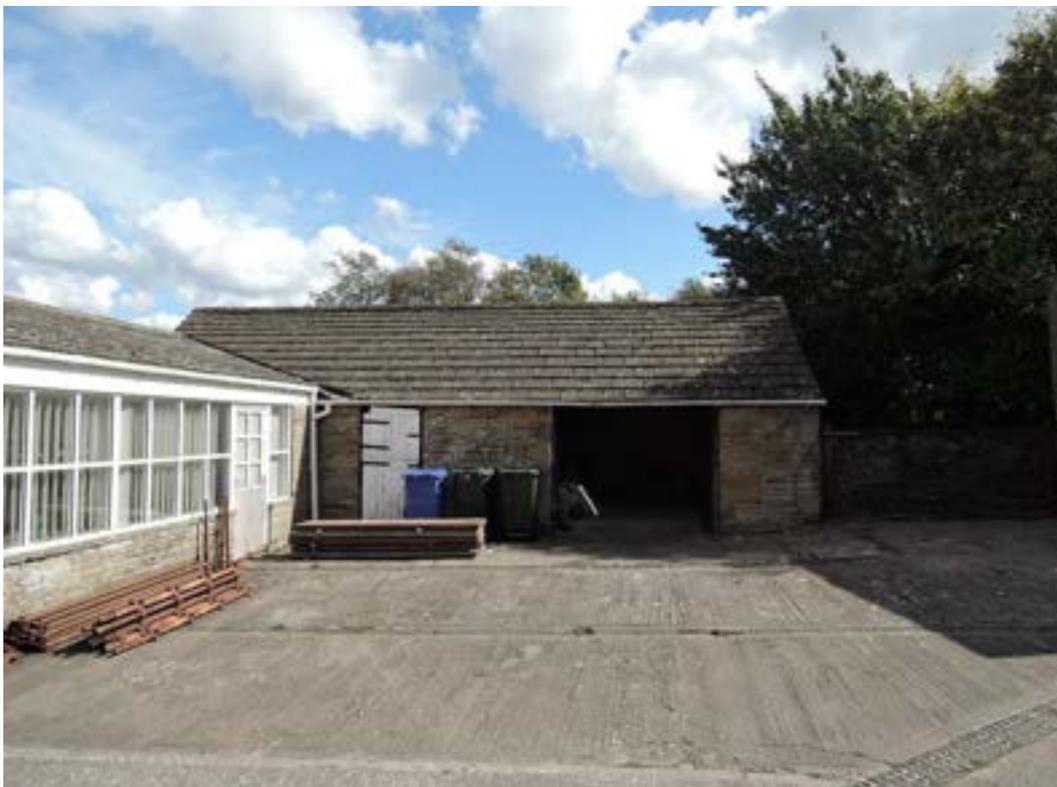
Garage/shed in good order

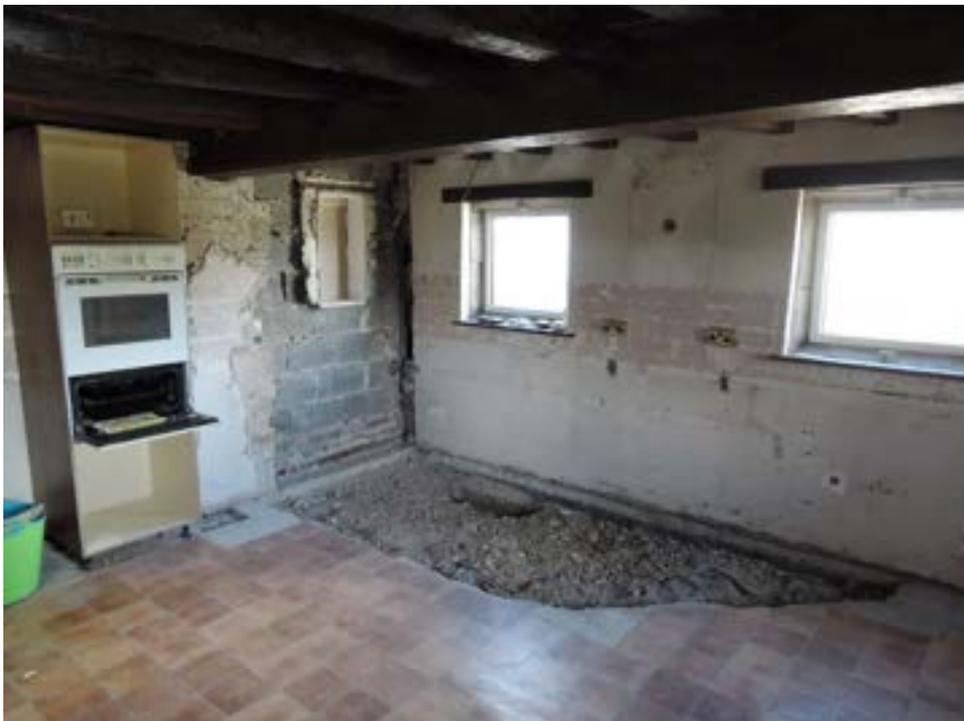
Kitchen: Trial pit revealing foundation to single storey extension

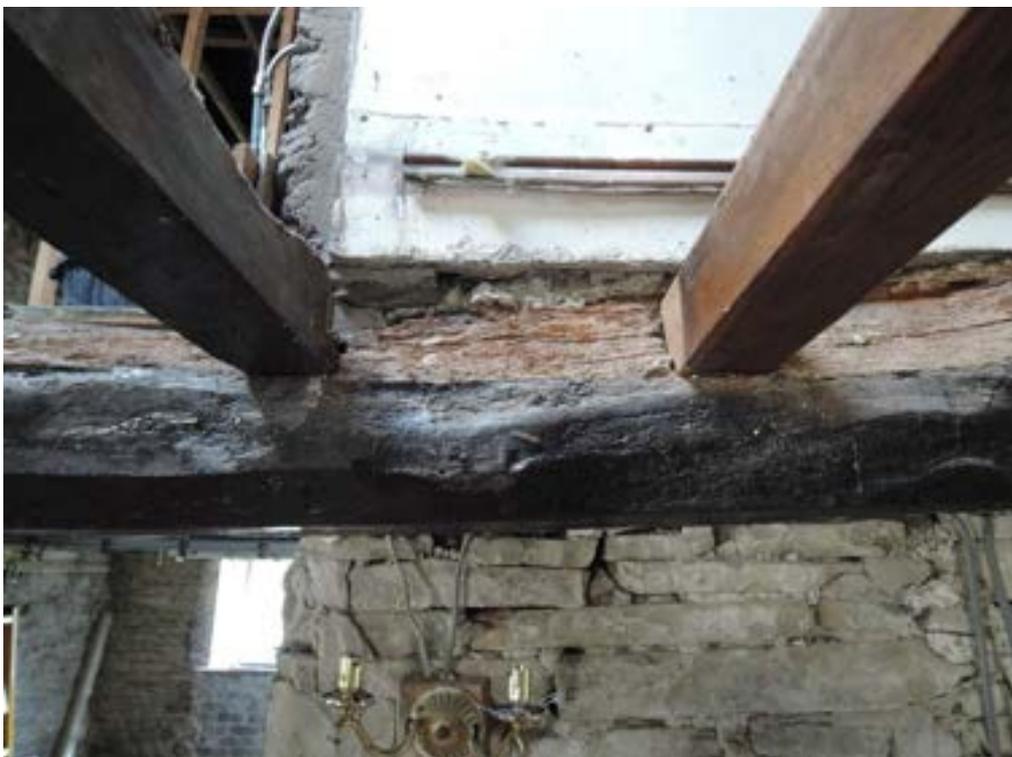
Close up

Beam with woodworm on kitchen/dining wall line. Unstable non load bearing wall (see comments under top photo page 9)

The bathroom floor over the single storey extension has extensive woodworm (photos on pages 10 -12 inc) and so all beams and joists in that bay should be replaced with new floor joists as part of the first-floor extension works.

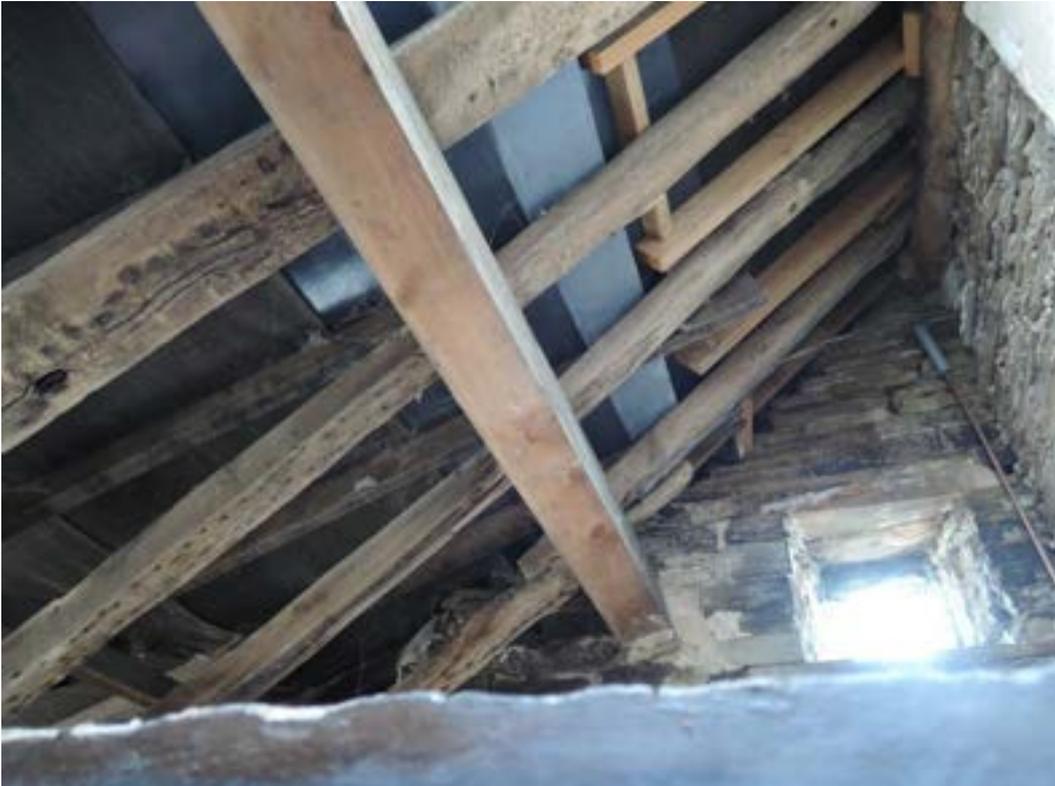
Roof over OK but to be replaced with new storey

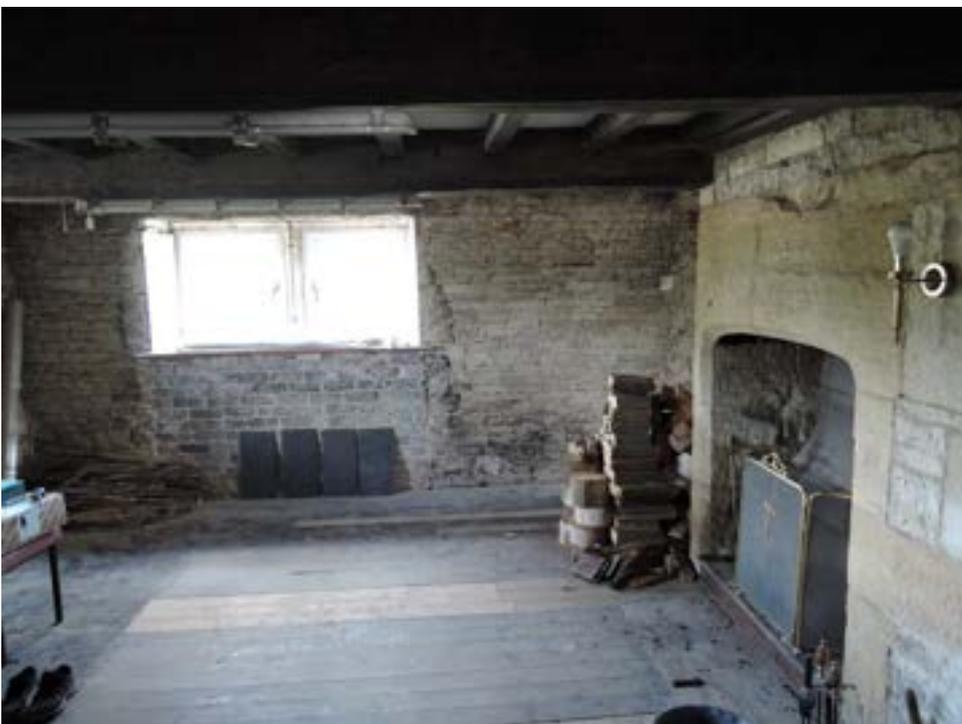
Dining room

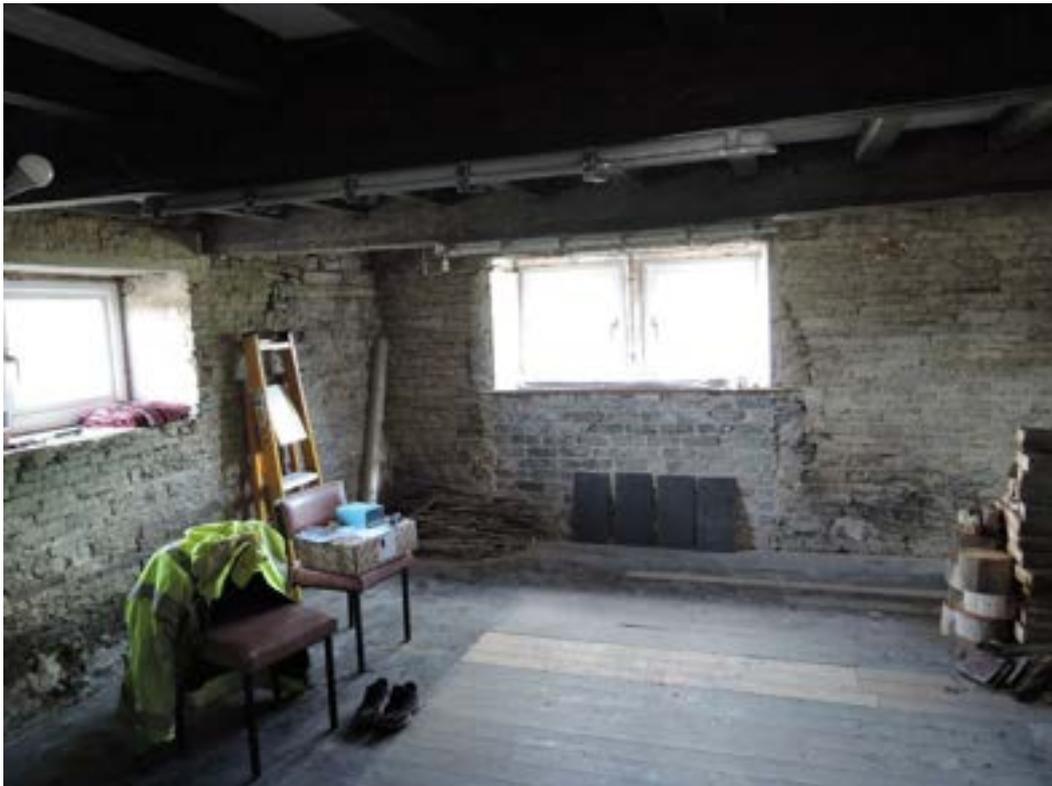
Dining room

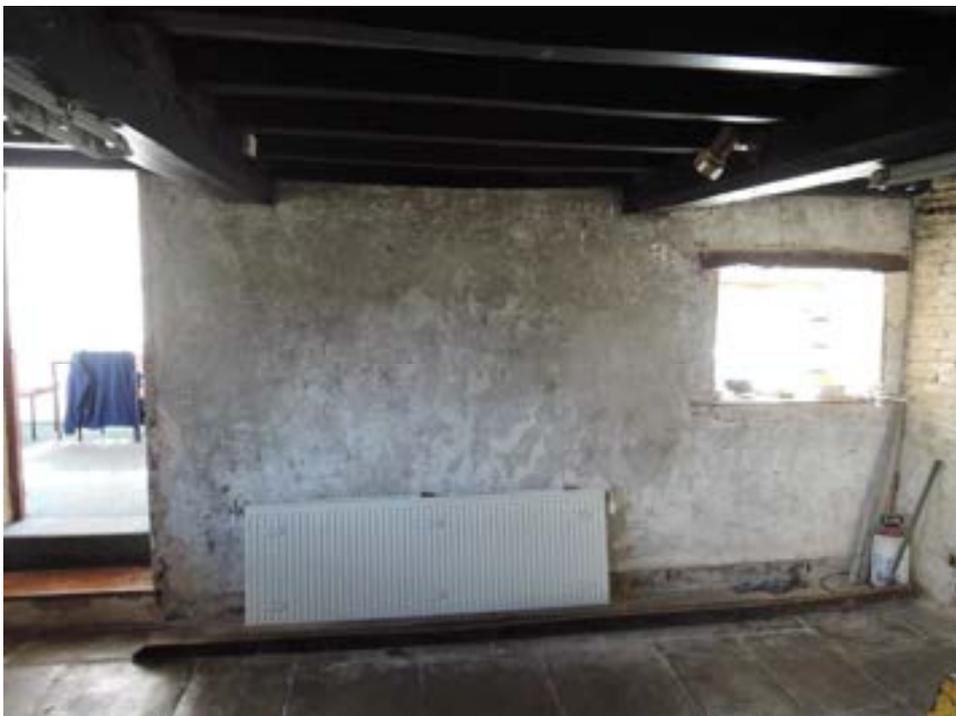
Dining room rear wall looking southwest.

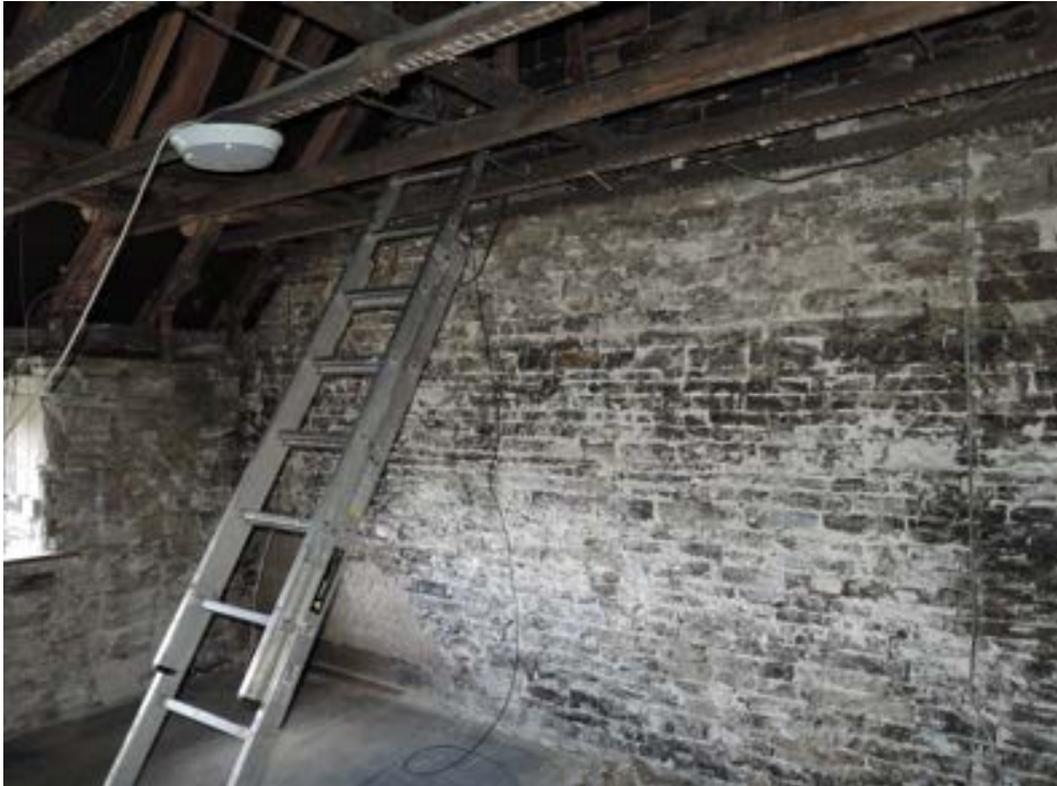
Inside southwest gable

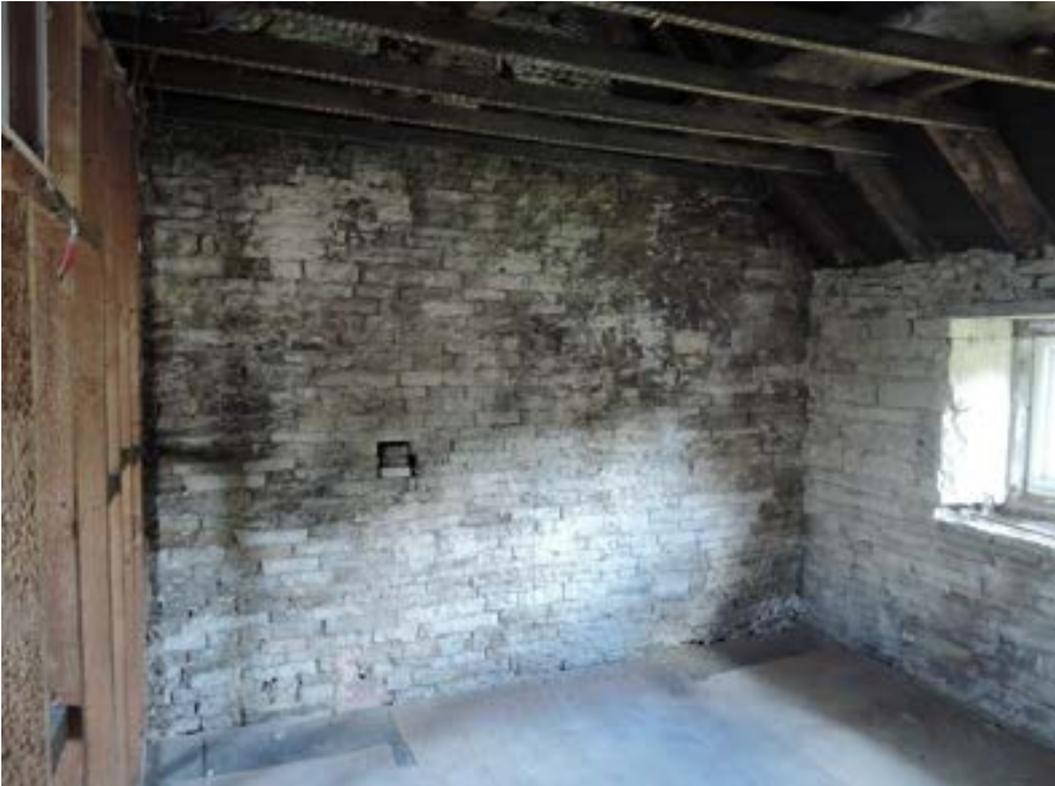
Northeast bedroom gable end. Good.

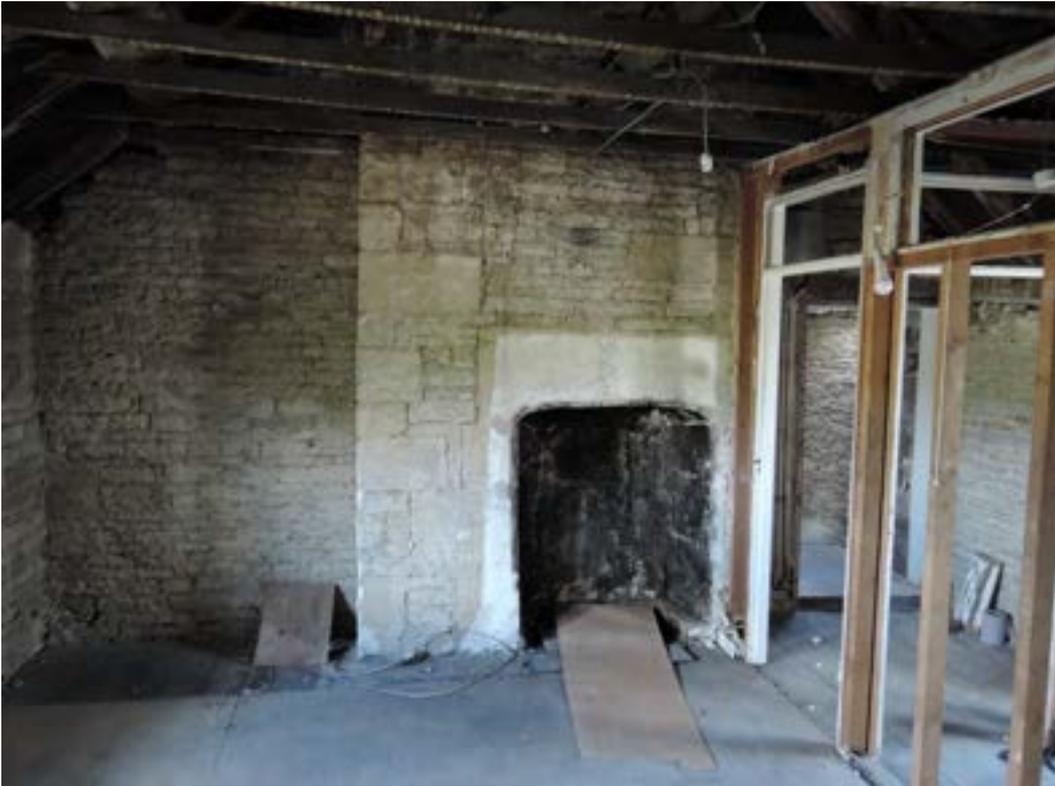
Fireplace in bedroom party wall. Good

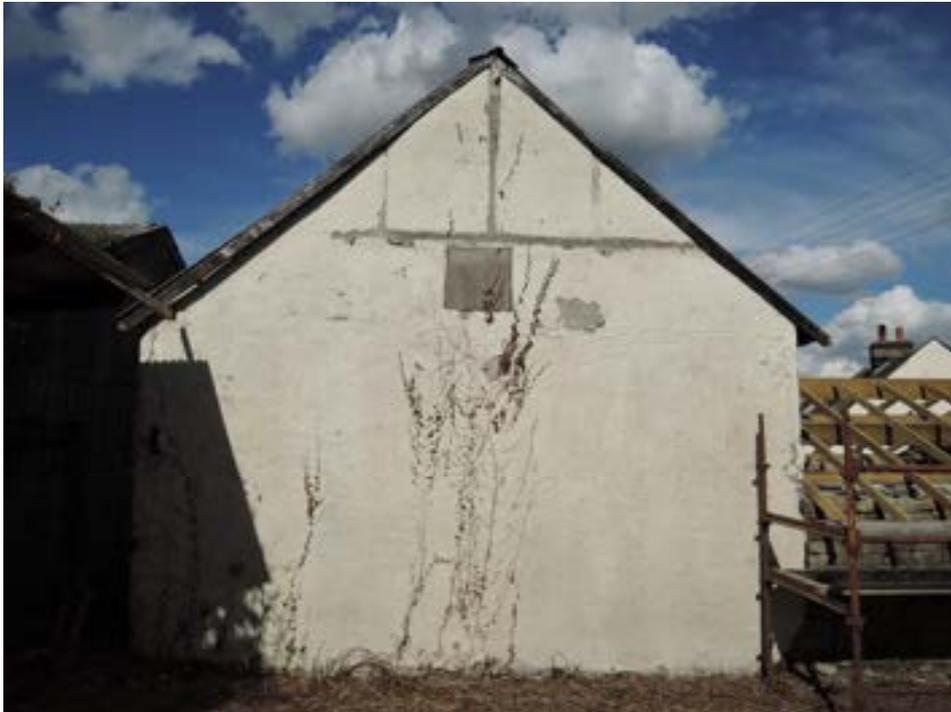
South gable large barn

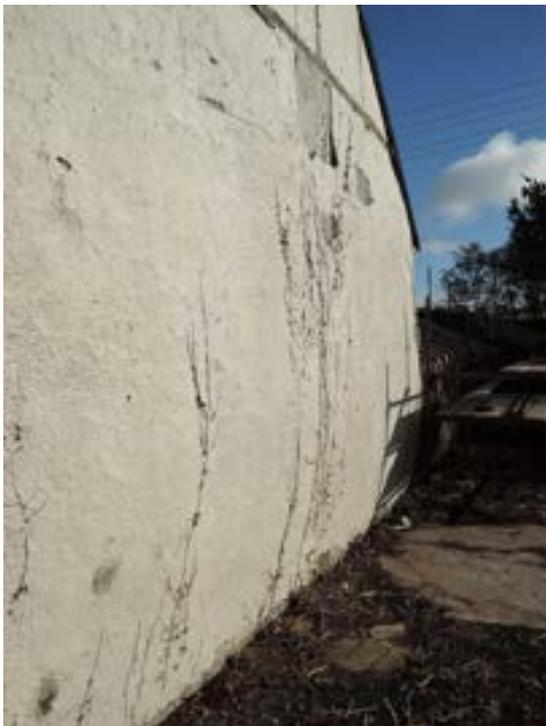
Severe outward bulge in same wall. Take down and rebuild

There is an outward bulge and serious crack mid height in the south gable wall (arrowed in photo on page 30) where the flank wall has released the gable. A small amount of dismantling and rebuilding will be required. The bulge is too large to lock in place by masonry stitching (Helifix or the like).

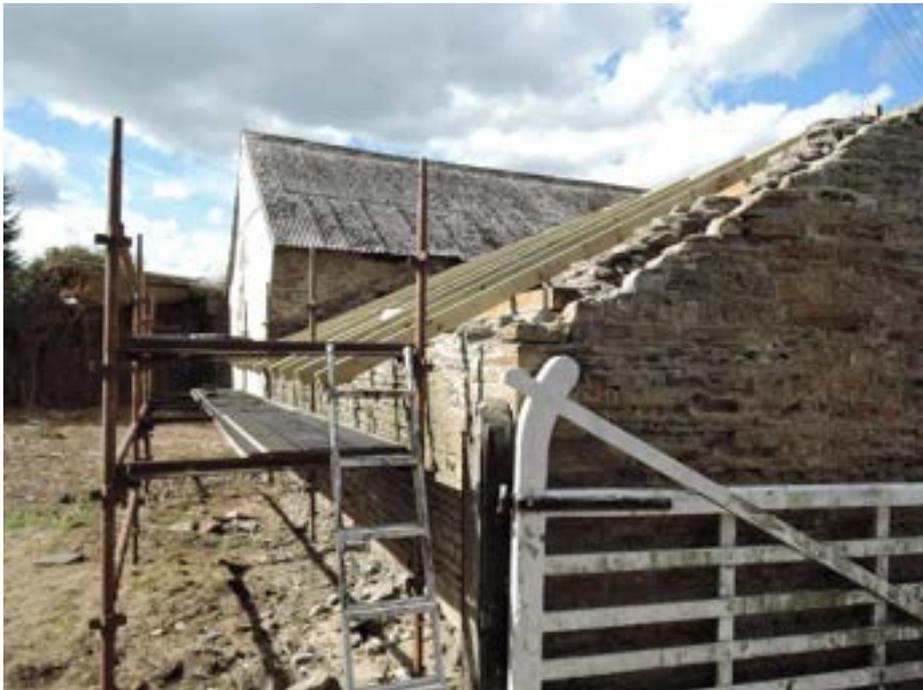
Low level shed under repair receiving new roof. Large barn in background.

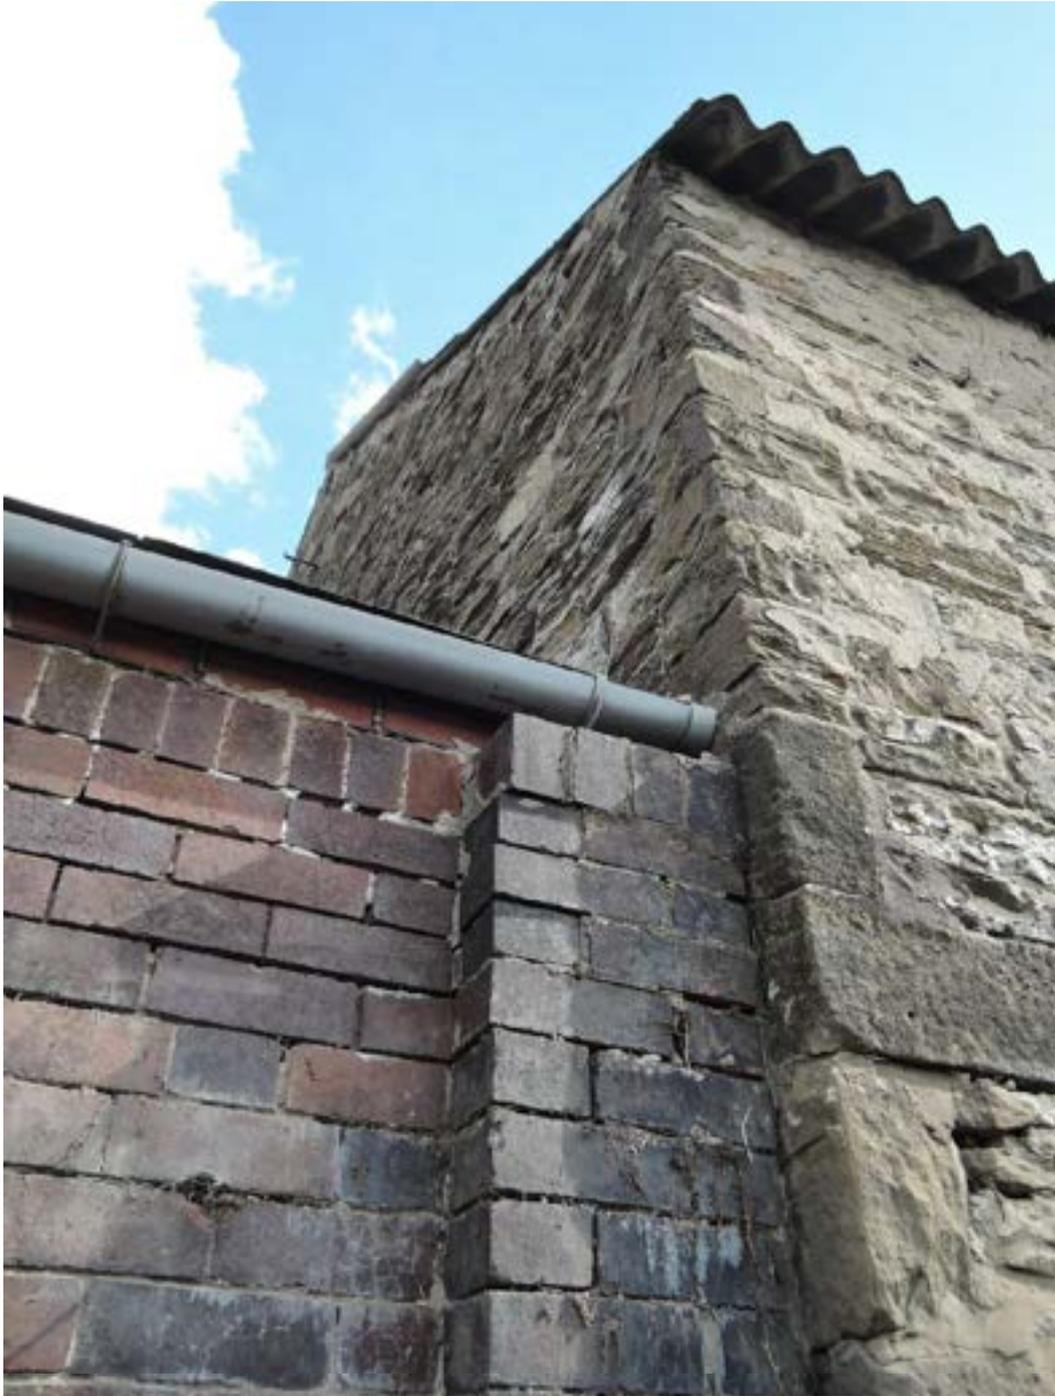
Smaller barn north gable. Brick barn on left to be demolished

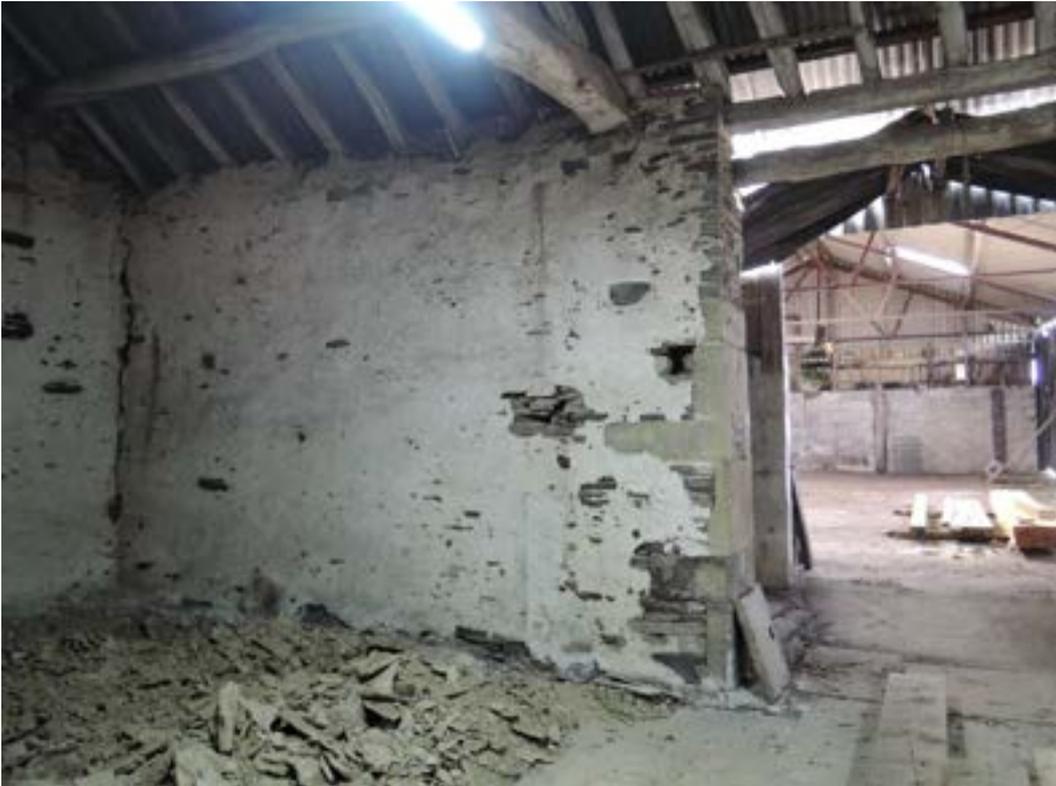
Flank wall (gable on left) entrance to barn to be demolished.

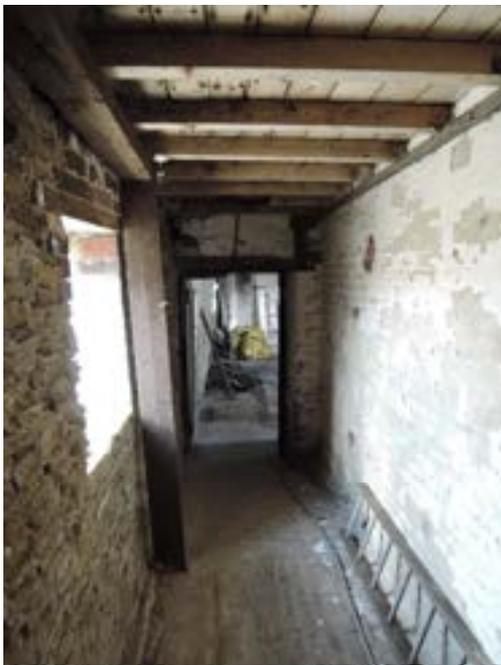
Corridor small barn. Secondary timber propping rescuing reduced bearings from outward leaning west wall.

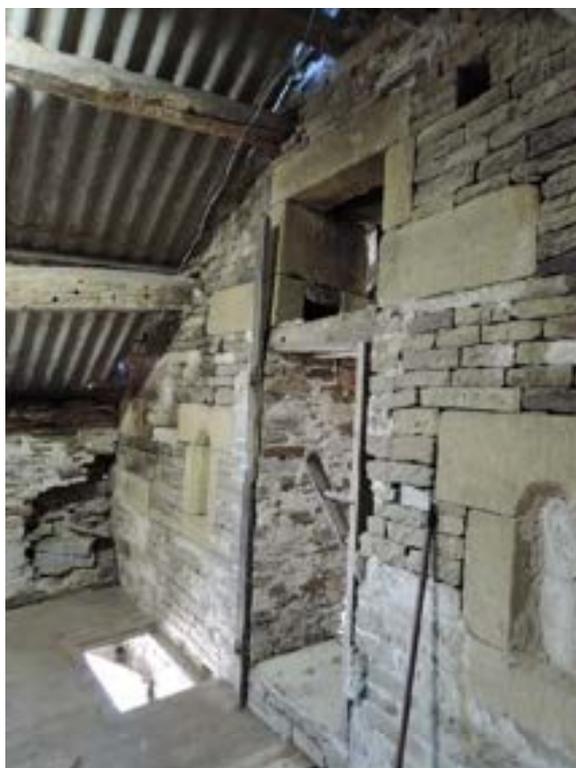
1st floor small barn. Pronounced lean of gable wall of large barn. Take down and rebuild

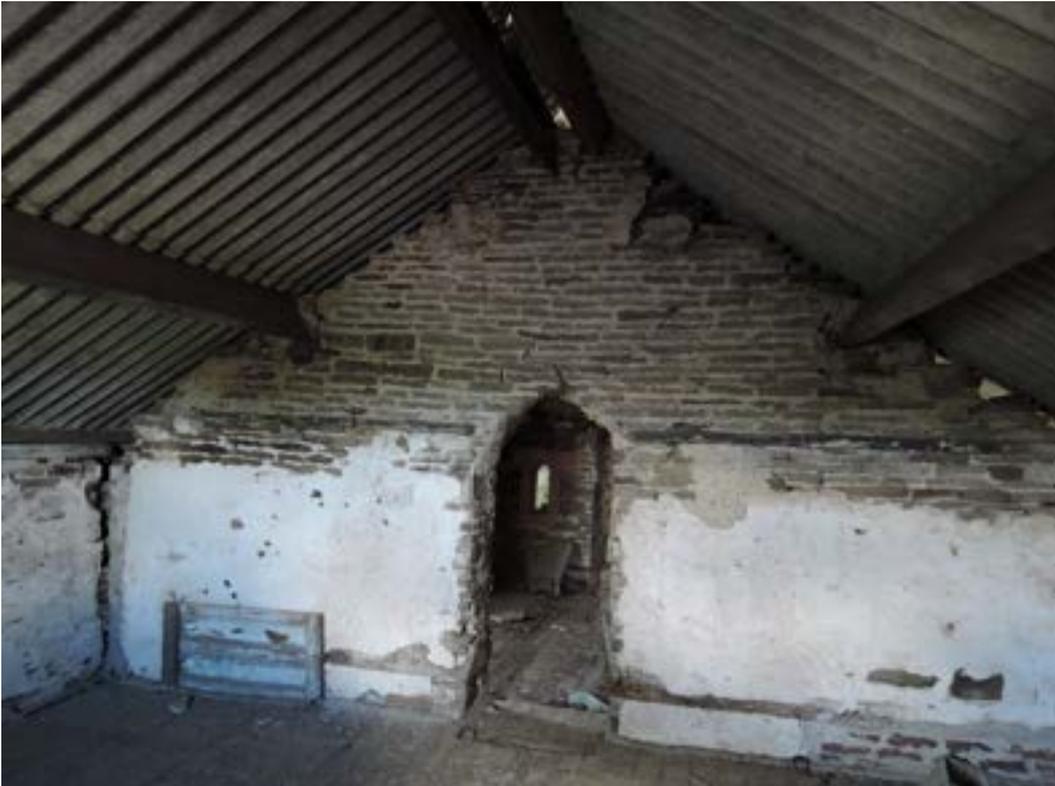
1st floor intermediate wall small barn (same wall as previous pic)
