# Wentworth Castle

## Plaster Ceiling Survey

02/08/2024

| <b>Nature of project:</b> | Plaster ceiling survey for multiple rooms |

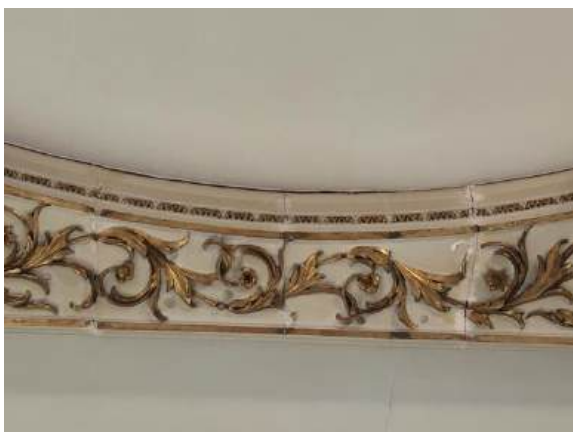
- Multiple hairline fractures were noted along the enriched decorative beams in equally spaced sequences. These also appeared to be deliberate cuts which could have been from the previous stabilization work to the upper side of the ceiling. Evidence supporting the insertion of deliberate cuts is aided by the visible presence of multiple bolts found between each fractured section. (Figure 11). These were found mirrored on both the East and West ends of the central decorative oval (Figure 12). These bolts match to the stabilization bolts viewed from the upper ceiling (Figure 13).

*Figure 10. Equally spaced fractures which could be deliberate cuts from upper ceiling stabilization work.*

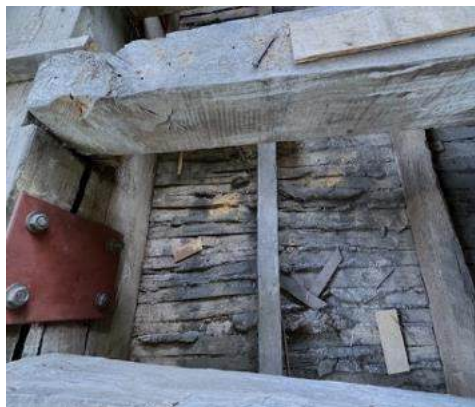
- There are signs of previous interventive works such as metal joist hangers which are found to be too rigid. Additionally, multiple steel plates were found inserted in the oak beams where they have split over time. None of these methods have assisted in supporting the plasterwork.
- There are signs of wood worm, heavily decayed and loose/springing lath, and loose joists.
- Tight laths with no keys were found to be present.
- Where the reverse of the ceiling is exposed, the limited haired lime grinning through the lath, that have mostly been originally installed too close to each other, shows 'very little or no key/nibs' at all. It seems that when the void was potentially cleaned out some time back, all the key/nibs were scrapped-off and removed along with the pugging layer etc resulting in a ceiling which is unstable and requires stabilization.

*Tight lath and minimal key, previous interventions visible.*

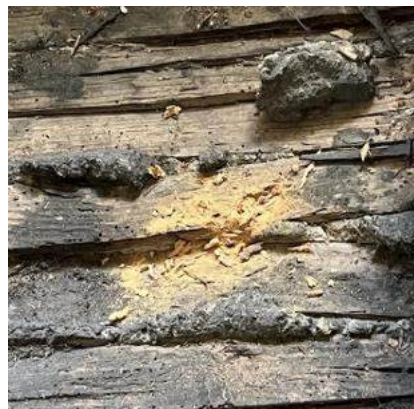
*Insect presence visible.*

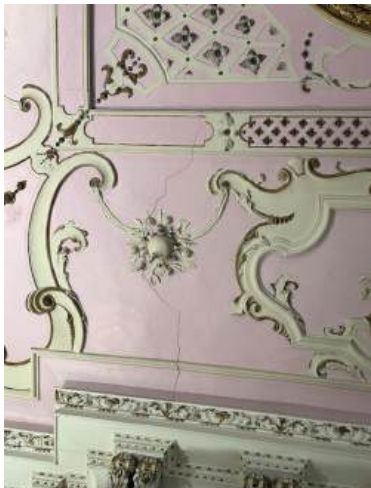
- The ceiling had multiple hairline fractures and cracks visible throughout the expanse of the ceiling, cornice, and decorative elements (Figure 39).
- An area of splitting was observed on the East wall cornice (Figure 40). Splitting was also found in multiple areas on the South wall cornice and between the ceiling and cornice at the corner of the South and East walls (Figure 41).

*Figure 39. Hairline cracks visible throughout the ceiling and cornice.*

Plaster repairs using lime /plaster of Paris or other approved to any cracks or defects.

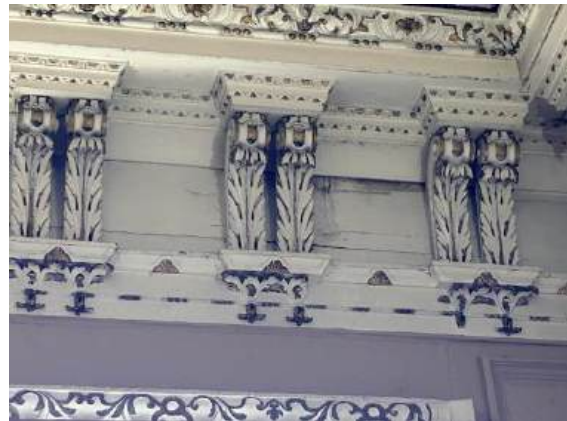
*Figure 40. Splitting and ingress visible on the East wall cornice.*

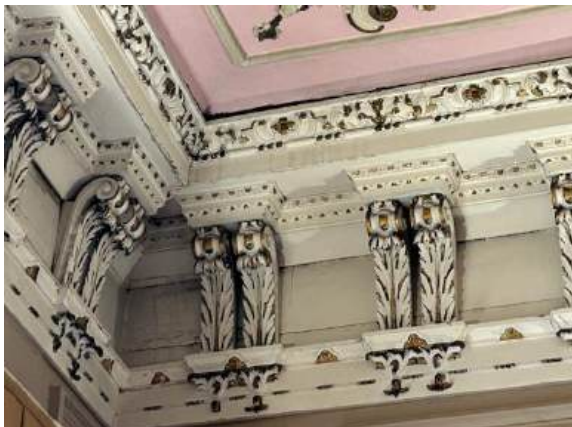
- What appears to be water ingress was visible on the East wall (Figure 41). Additionally, some paint loss was noted in the area of localized damage on the East wall. Possible water ingress was also visible on the South wall cornice (Figure 42).

*Figure 41. Splitting and ingress observed on the South wall cornice and ceiling.*

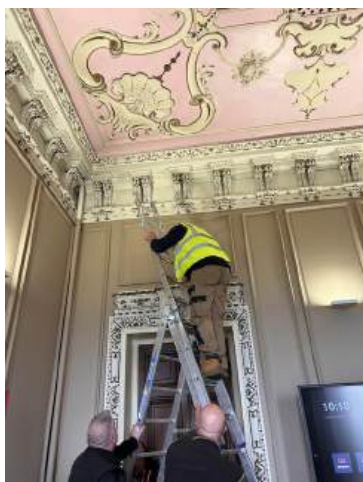
- There were multiple embellishments missing from the cornice (Figure 42).
- One loose embellishment was removed during the survey as it was found to be a hazard to visitors to the room (Figure 44 & 45). A second embellishment on the West wall was found to be loose but not deemed dangerous or urgent to remove.

*Figure 43. A loose embellishment was removed above the West wall during the survey due to being a hazard to visitors to the room.*

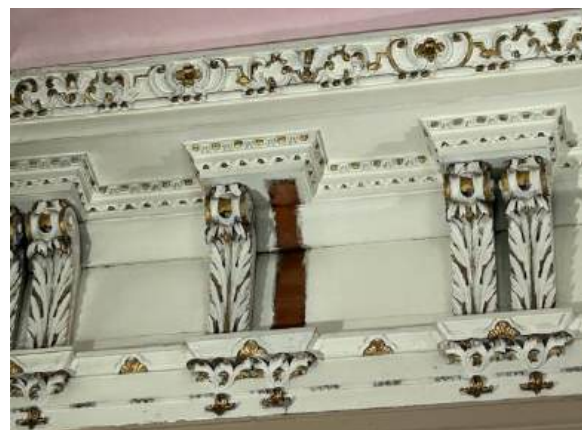
- The cornice and embellishments appear to be made from timber. Removal of the loose embellishment confirmed the materials was made of timber (Figure 45).

*Figure 44. Removed loose embellishment revealing the cornice to be made of timber.*

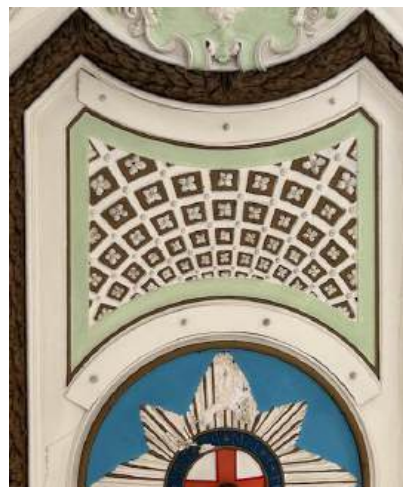
*Figure 50. Support straps attached with bolts.*

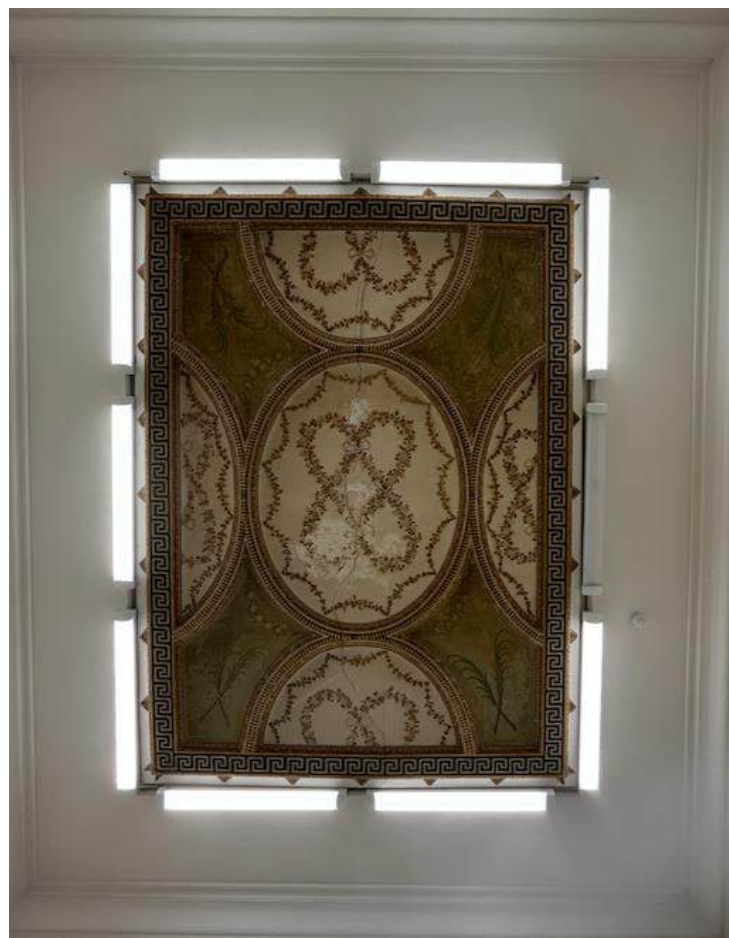
Figure 93. I.C.T Teaching Room 2 Ceiling.

- Multiple fractures observed throughout the ceiling expanse with a significant fracture running through the central panel from East to West. Multiple hairline fractures form out of the larger significant crack (Fig.94).
- Possible water ingress was observed resulting in discolouration of the painted detail (Fig.95)
- Areas of paint loss, flaking, and fading were noted throughout the painted ceiling panel (Fig.96).
- The perimeter ceiling could be composed of a different material from the inner painted ceiling, however, this requires further assessment.

- A closer in-depth tactile survey is recommended to fully understand the level of damage and stability of the structure of the ceiling.
- If possible, it would be beneficial to access the upper side of the ceiling to fully understand the condition of the ceiling structure and support system.
- It is important to understand if the ingress is ongoing and requires intervention or is stable.

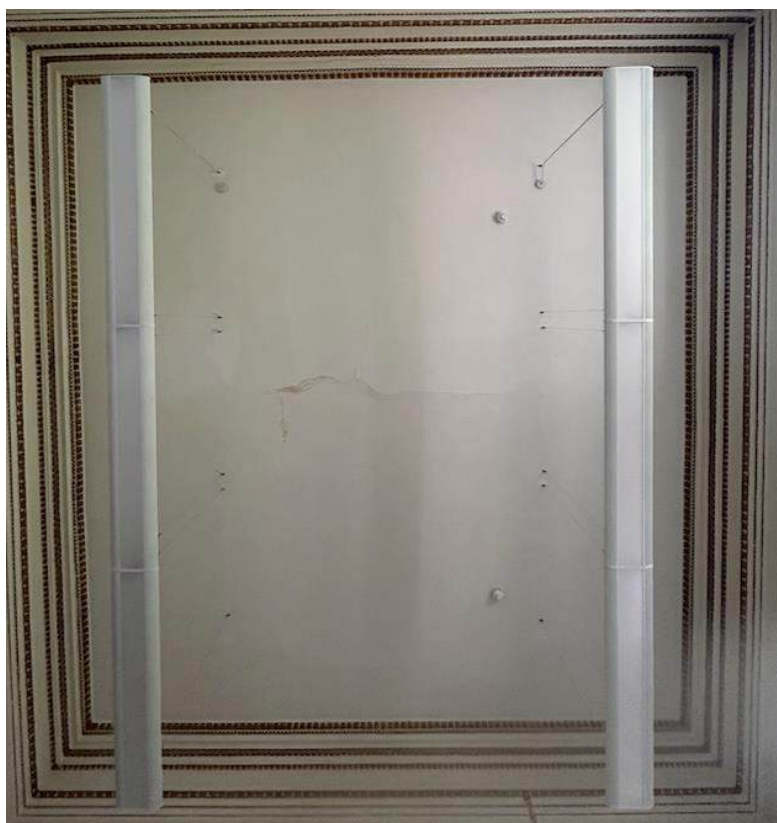
Figure 98. I.C.T. Teaching Room 3 Ceiling.

- Multiple fractures were observed throughout the ceiling expanse (Fig.99). Fractures were found on the mitred corners and along the cornice (Fig.100 and Fig.101).
- Deflection was noted along multiple fracture lines.
- Possible water ingress and staining was observed (Fig.102).
- Tactile push test revealed some movement was present in the ceiling.
- Previous repairs were found in the form of some localized areas which had been previously filled.

- A closer in-depth tactile survey is recommended to fully understand the level of damage and stability of the structure of the ceiling.
- If possible, it would be beneficial to access the upper side of the ceiling to fully understand the condition of the ceiling structure and support system. Additionally, this would aid in pinpointing the possible cause of movement in the ceiling and inform the best course of action for stabilization, if required.
- It is important to understand if the ingress is ongoing and requires intervention or is stable.

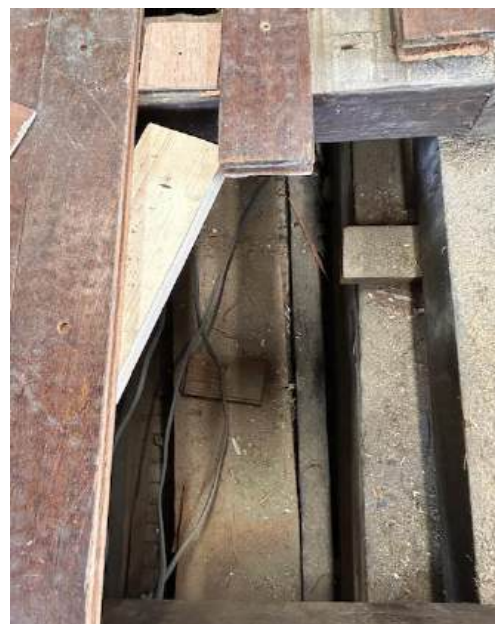
- Nibs were found to be present but were found to be in poor condition (Fig.118).
- Nibs were found to be intermittent with some missing (Fig.119).
- Laths were found to be tightly spaced but were not found to be springing.
- Timber boards were found resting directly on top of the plaster laths and nibs adjacent to the main beams, their purpose and reason for placement is unknown.

*Figure 118. View into the upper side of the Principal's Office ceiling.*

- Consolidation methods can be employed to ensure the stability of the ceiling due to the lack of solid nibs and laths.
- The boards found in the underside of the ceiling should be removed if found to have no securing purpose.
