# **ADOPTED HIGHWAY DELAPIDATION SURVEY REPORT**

Development Name: Land off Calver Close, Dodworth and Smithywood Lane, Dodworth

Date of Survey: 2<sup>nd</sup> October 2024

Report Completed 10<sup>th</sup> October 2024

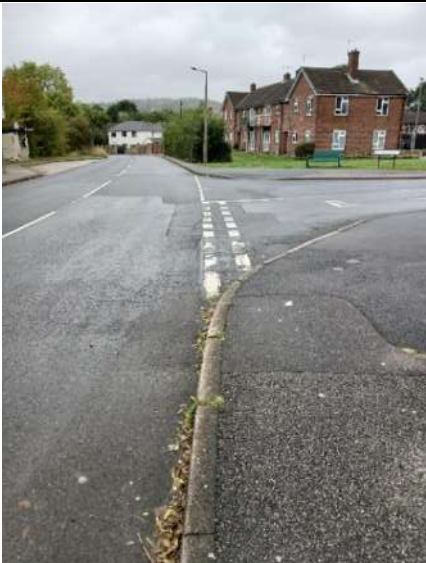
Photo Reference and Road Name	Photo	Comment
<p>Photo 1 Saville Road / Gilroyd Lane</p>

<p>Footway and carriageway scarring. Minor kerb damage.</p>
<p>Photo 2 Saville Road / Gilroyd Lane</p>

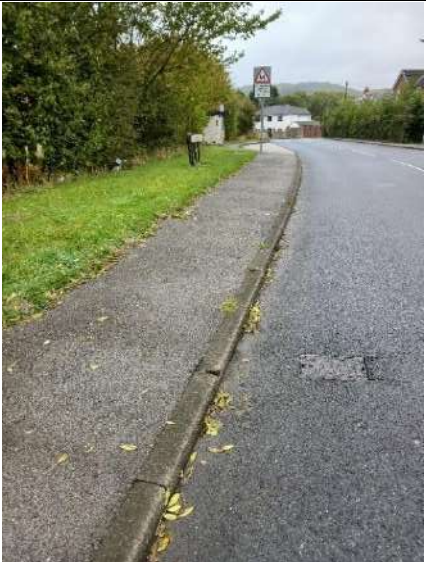
<p>Kerb damage. Surface course damage around chamber.</p>
<p>Photo 3 Saville Road / Gilroyd Lane</p>	 	<p>Kerb damage. Slight sign of wear to surface course.</p>

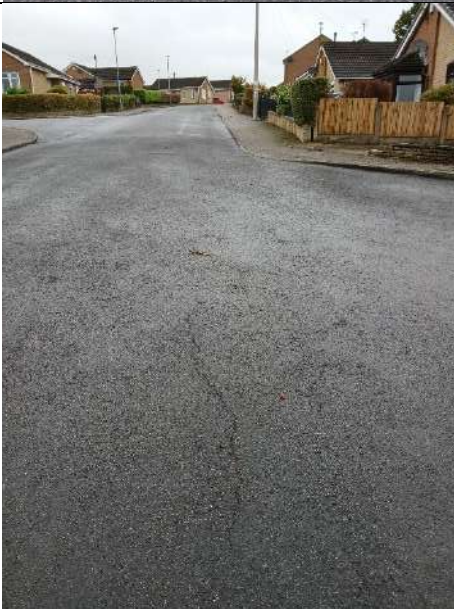
Photo 11  
Calver  
Close

Surface cracking and uneven levels.

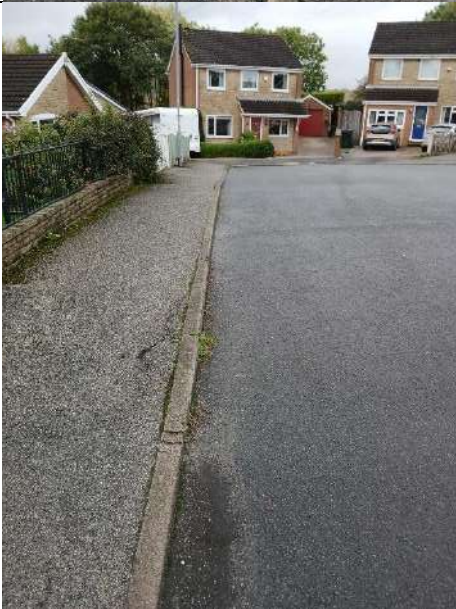
Photo 17  
Calver  
Close

Footway and kerb damage. Uneven carriageway surface.

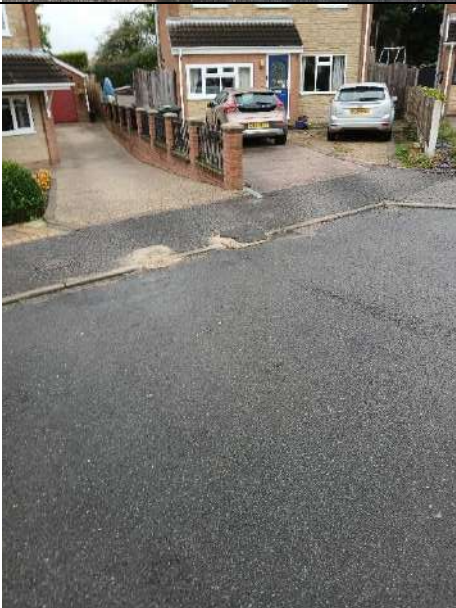
Photo 18  
Calver  
Close

Kerb damage. Minor carriageway surface course damage.

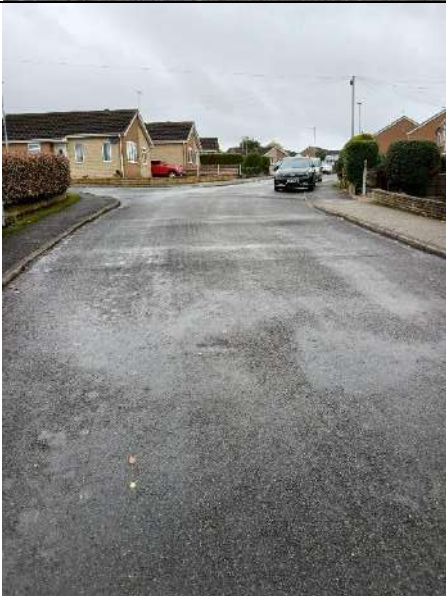
Photo 20  
Calver  
Close

Uneven carriageway levels.

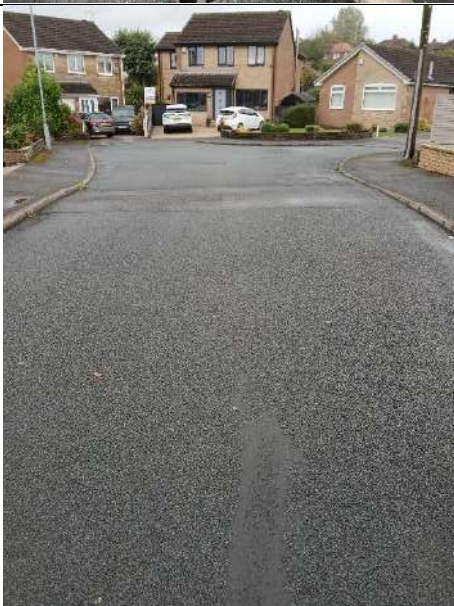
Photo 24  
Calver  
Close

Carriageway scarring.

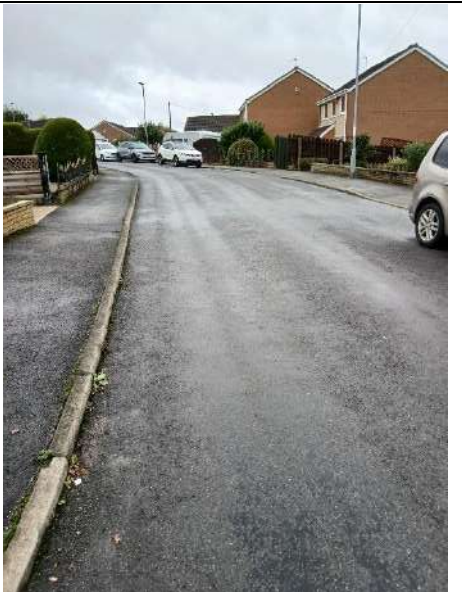
Photo 27  
Calver  
Close

Minor kerb damage.

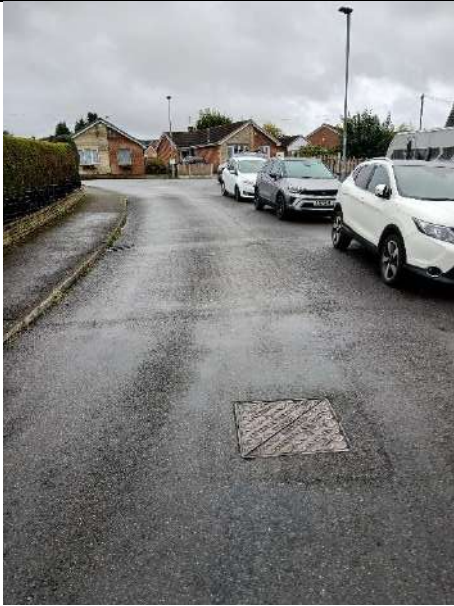
Photo 28  
Calver  
Close

Uneven carriageway levels. Slight surface course damage.

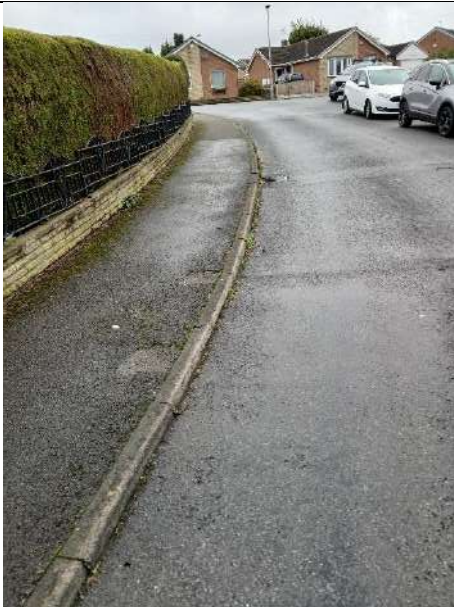
Photo 29  
Calver  
Close

Footway and carriageway damage. Uneven levels.

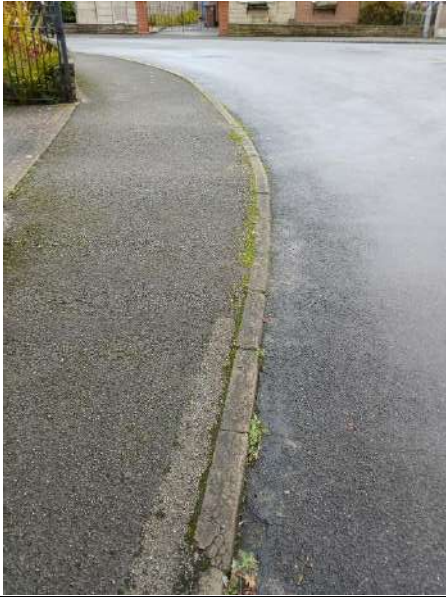
Photo 31  
Calver  
Close

Kerb damage. Minor surface course damage.

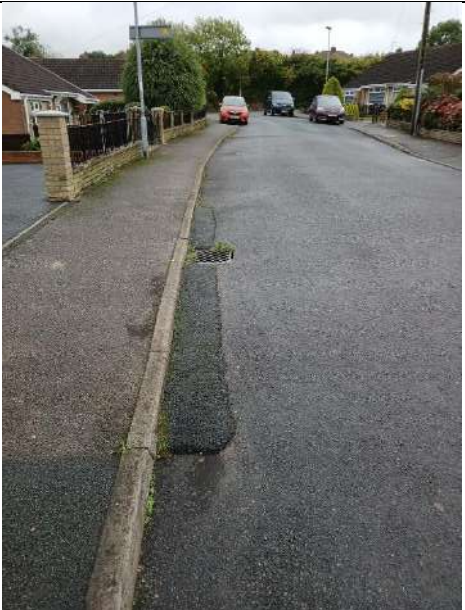
Photo 36  
Bradwell  
Avenue

Carriageway scarring.

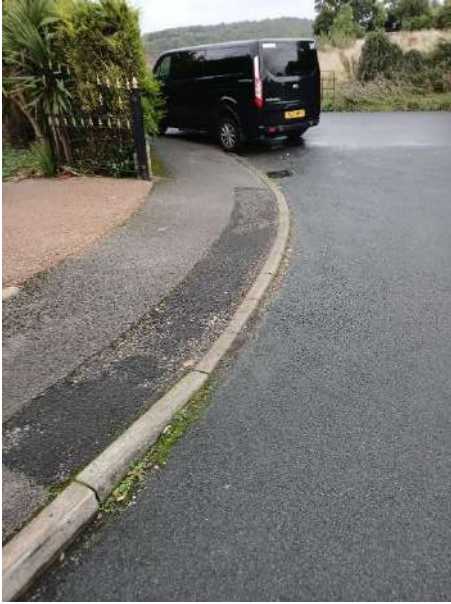
Photo 43  
Bradwell  
Avenue

Footway scarring, deteriorating surface course.

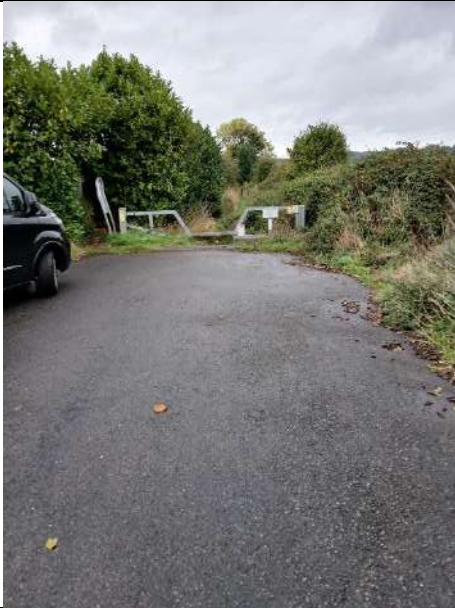
Photo 46  
Smithy  
Wood  
Lane

Overgrown vegetation on to adoptable carriageway.  
Possible damage to wearing course.

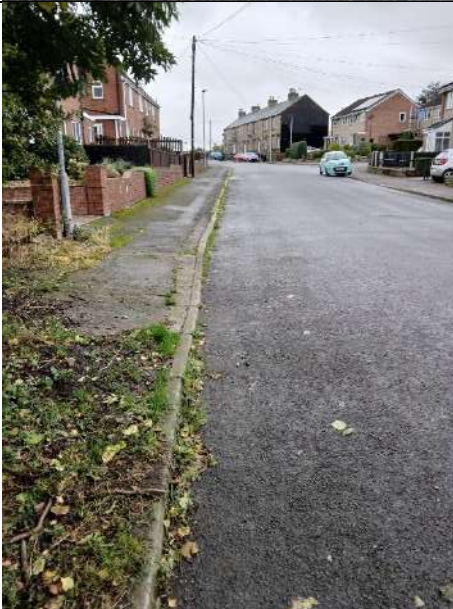
Photo 50  
Smithy  
Wood  
Lane

Minor kerb damage. Footway scarring.

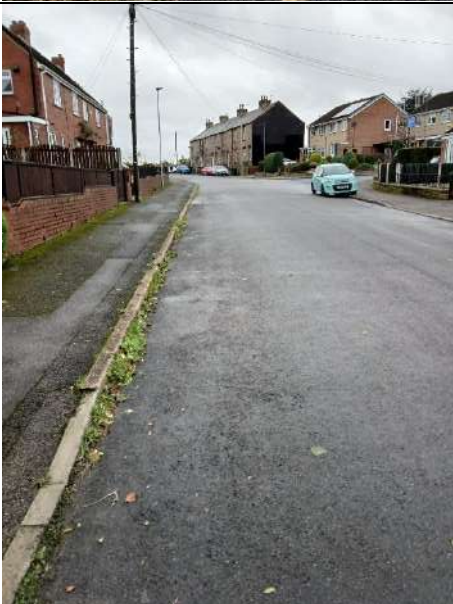
Photo 51  
Smithy  
Wood  
Lane

Kerb damage. Footway scarring. Minor carriageway damage to surface course.

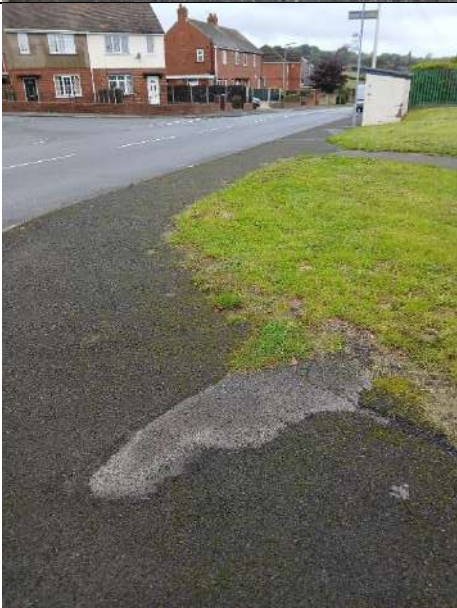
Photo 69  
Saville  
Road

Footway scarring.

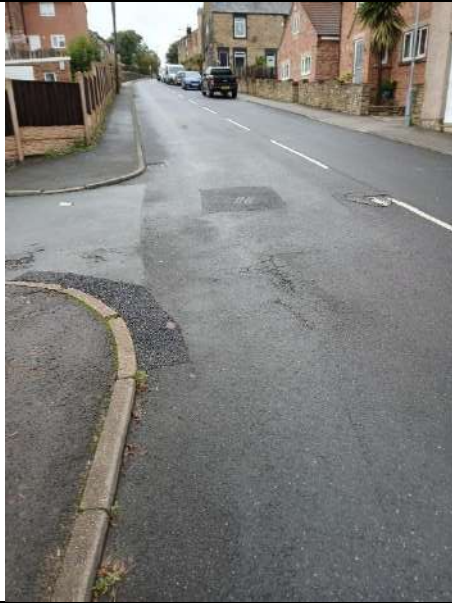
Photo 82  
Stainborough Road

Carriageway surface cracking and scarring. Footway scarring.

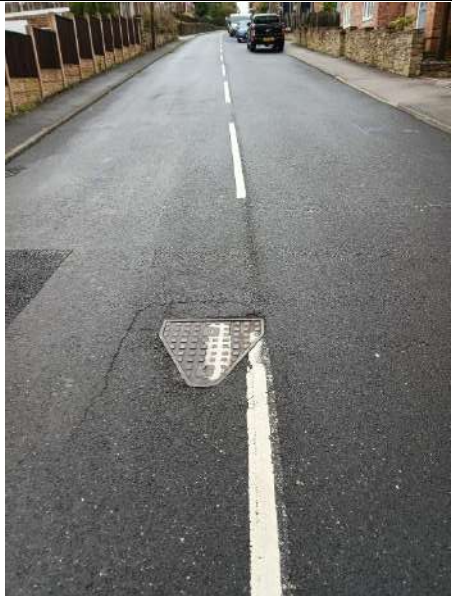
Photo 83  
Stainborough Road

Carriageway surface course cracking / sinking around chamber.

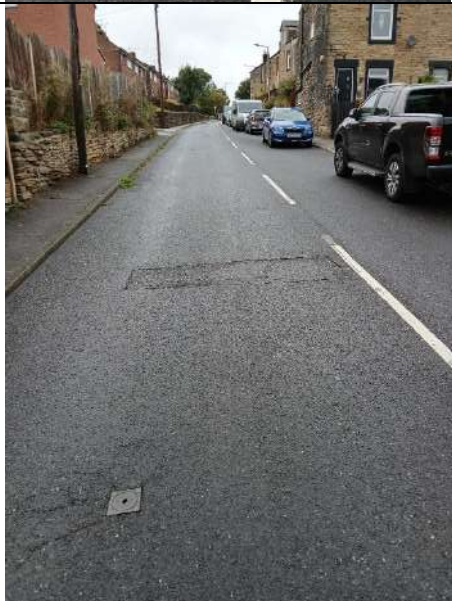
Photo 84  
Stainborough Road

Carriageway scarring.

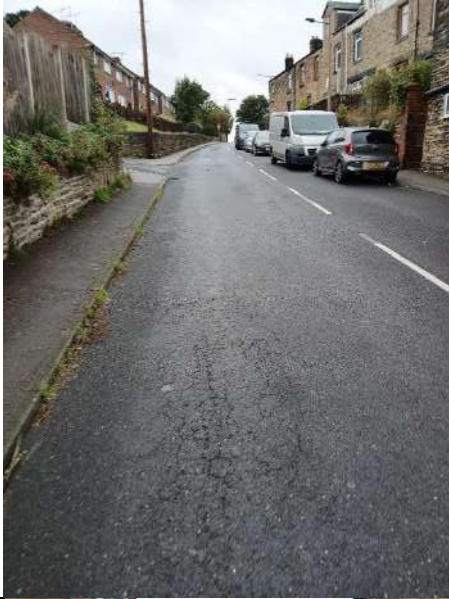
Photo 85  
Stainborough Road

Carriageway surface course cracking.

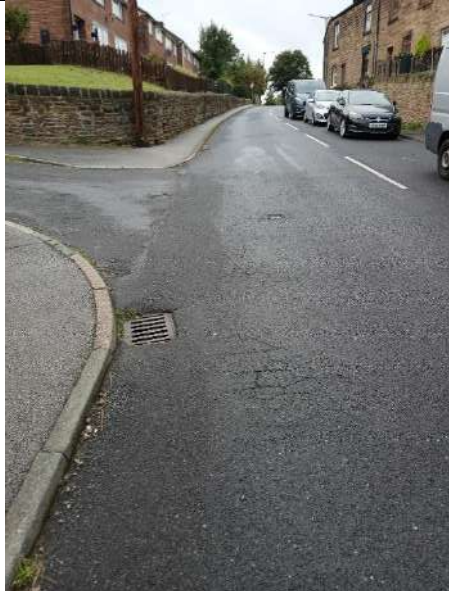
Photo 86  
Stainborough Road

Carriageway surface course cracking.

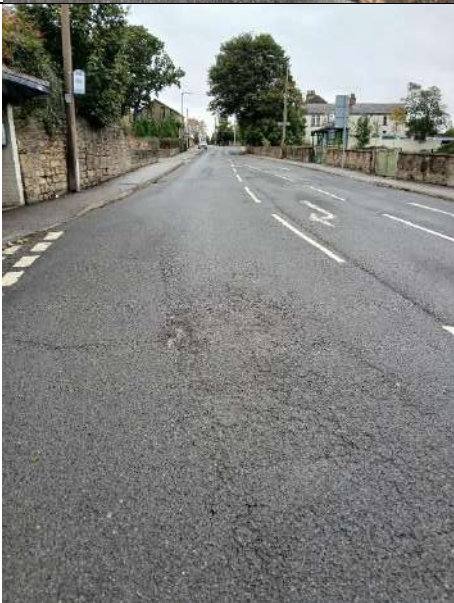
Photo 96  
Keresforth Road

Carriageway surface course deterioration.

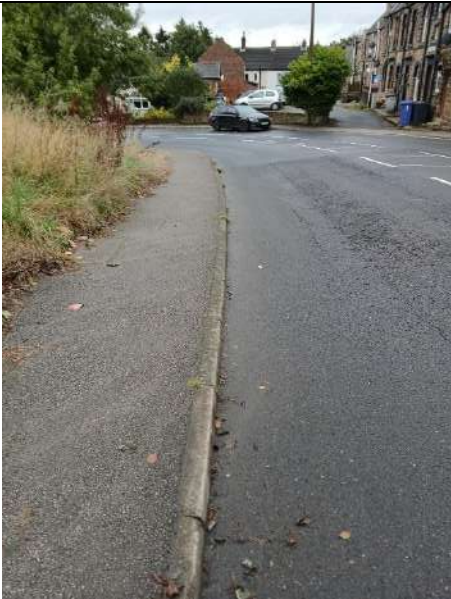
Photo 99  
Keresforth Road

Carriageway surface course deterioration.

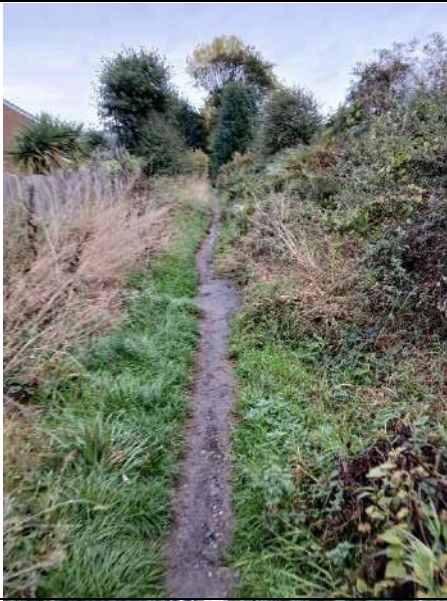
Photo 106  
Smithy  
Wood  
Lane  
(track)

Overgrown vegetation and uneven / unmade surface.

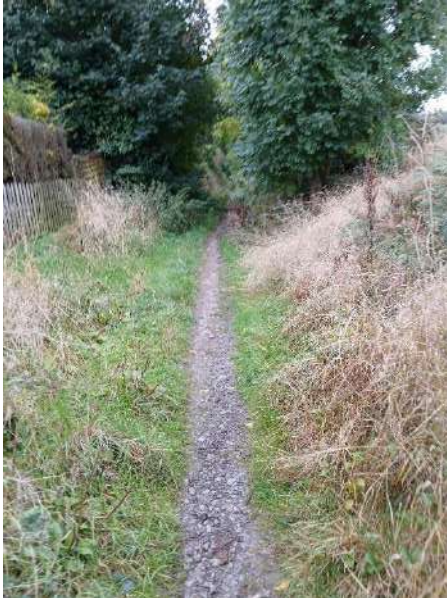
Photo 107  
Smithy  
Wood  
Lane  
(track)

Overgrown vegetation and uneven / unmade surface.

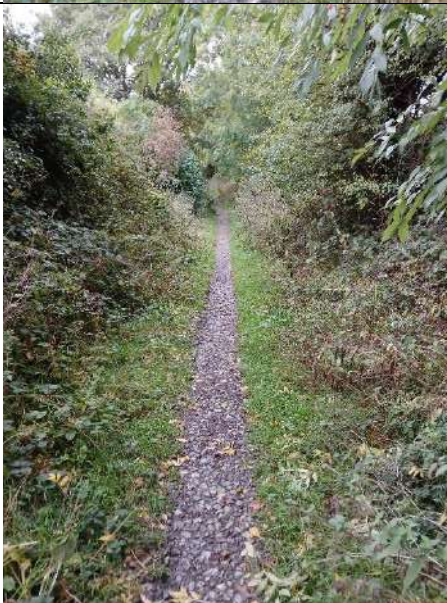
Photo 108  
Smithy  
Wood  
Lane  
(track)

Overgrown vegetation and uneven / unmade surface.

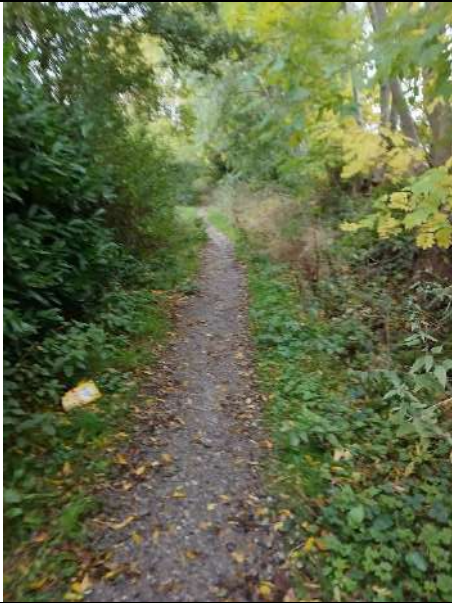
Photo 109  
Smithy  
Wood  
Lane  
(track)

Overgrown vegetation and uneven / unmade surface.

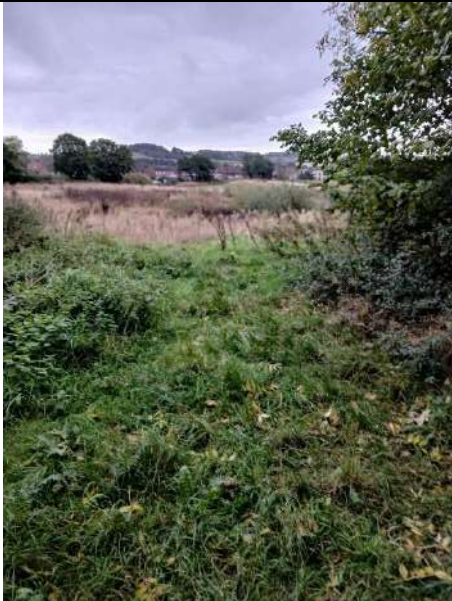
Photo 110  
Smithy  
Wood  
Lane  
(track)

Existing gap in vegetation with view of site from south west boundary.

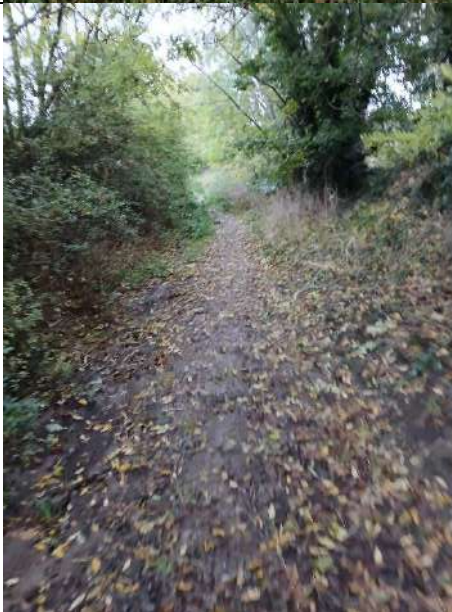
Photo 111  
Smithy  
Wood  
Lane  
(track)

Overgrown vegetation and uneven / unmade surface.

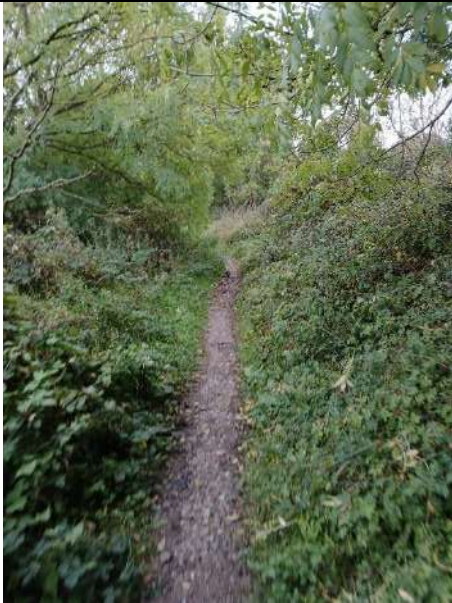
Photo 112  
Smithy  
Wood  
Lane  
(track)

Overgrown vegetation and uneven / unmade surface.

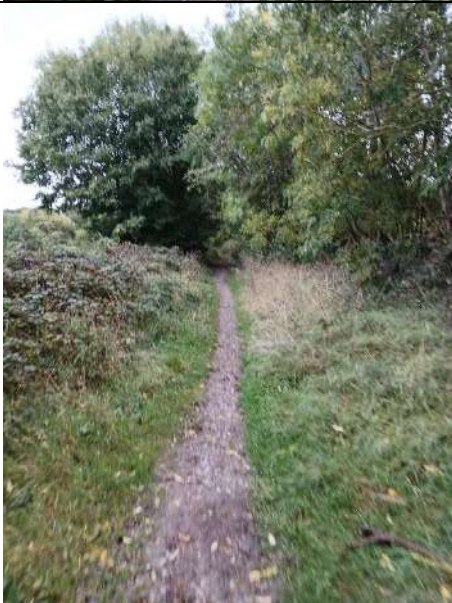
Photo 113  
Smithy  
Wood  
Lane  
(track)

Overgrown vegetation and uneven / unmade surface.

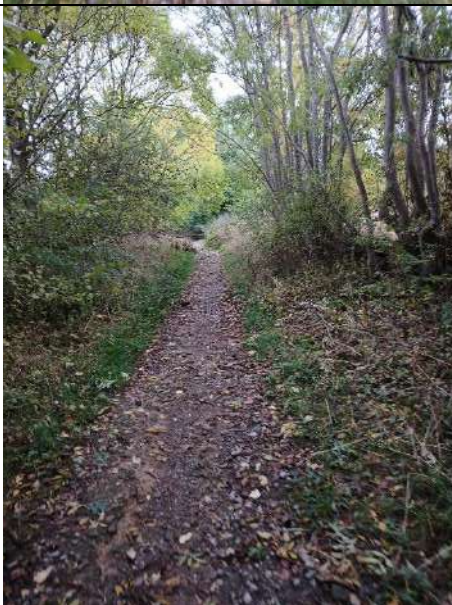
Photo 114  
Smithy  
Wood  
Lane  
(track)

Overgrown vegetation and uneven / unmade surface.

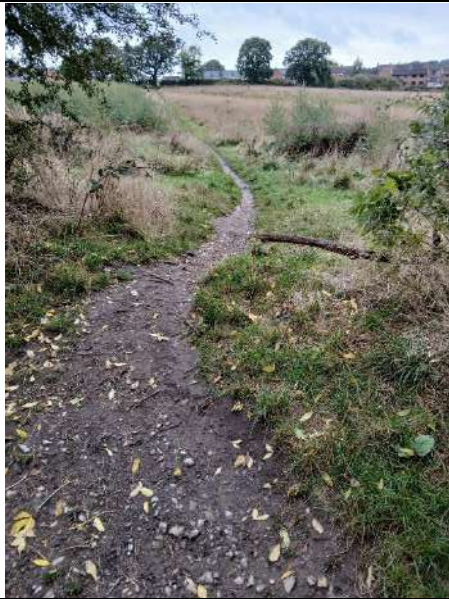
Photo 115  
Smithy  
Wood  
Lane  
(track)

Uneven / unmade surface.

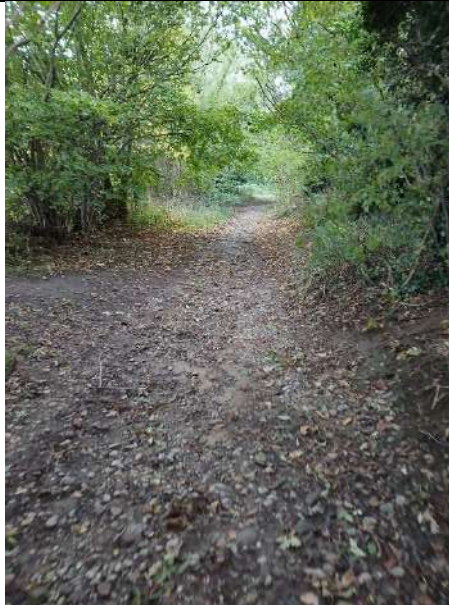
Photo 116  
Smithy  
Wood  
Lane  
(track)

Uneven / unmade surface.

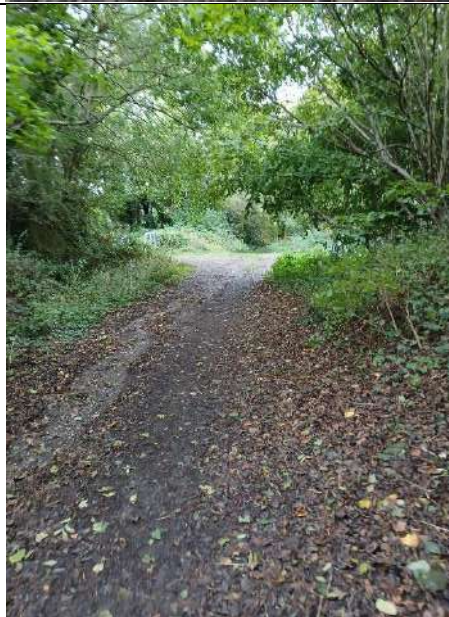
Photo 117  
Smithy  
Wood  
Lane  
(track)

Uneven / unmade surface.

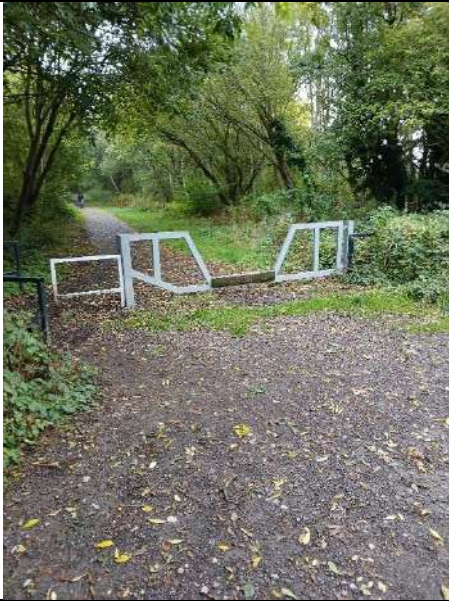
Photo 118  
Smithy  
Wood  
Lane  
(track)

Uneven / unmade surface.

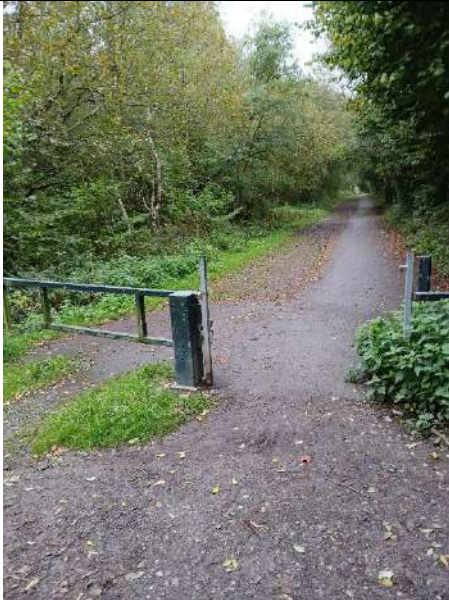
Photo 119  
Smithy  
Wood  
Lane  
(track)

Uneven / unmade surface.

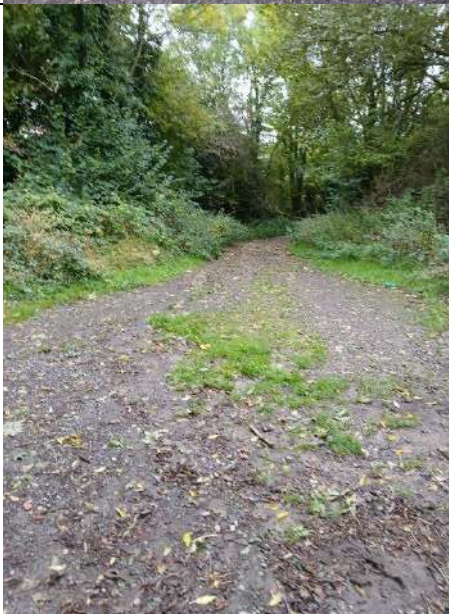
Photo 120  
Smithy  
Wood  
Lane  
(track)

Uneven / unmade surface.
