**Lower Eastfield Farm  
Thurgoland, Sheffield  
Existing Farm and Outbuildings  
Visual Structural Survey**

Visual Structural Survey of Existing Farm and Out Buildings

At Lower Eastfield Farm, Thurgoland, Sheffield

Ref : dp2 / 1718

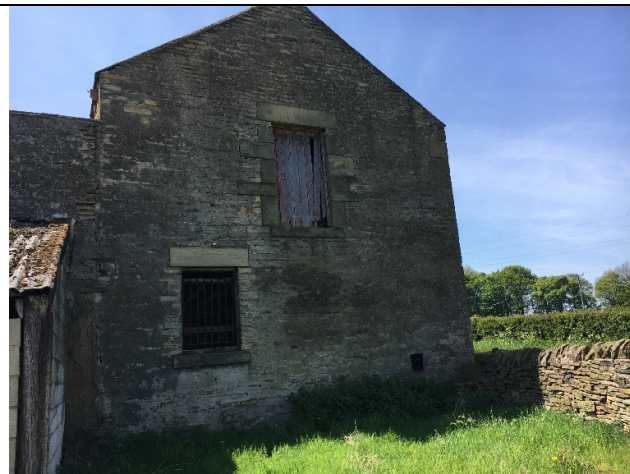
Side elevation

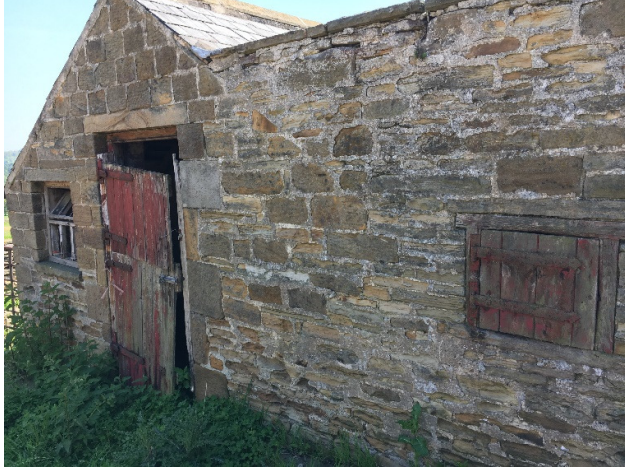
| Location | Description |
|---|---|
| | <p>This outbuilding consist of three smaller buildings joined together. There is the main long barn, an extension to the end gable and a garden shed to the side.</p> |

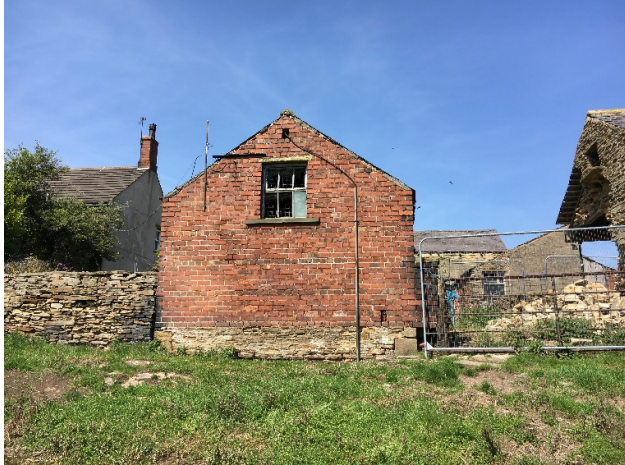
| Location | Description |
|---|---|
| | <p>End gable of the small extension to the end.</p> |

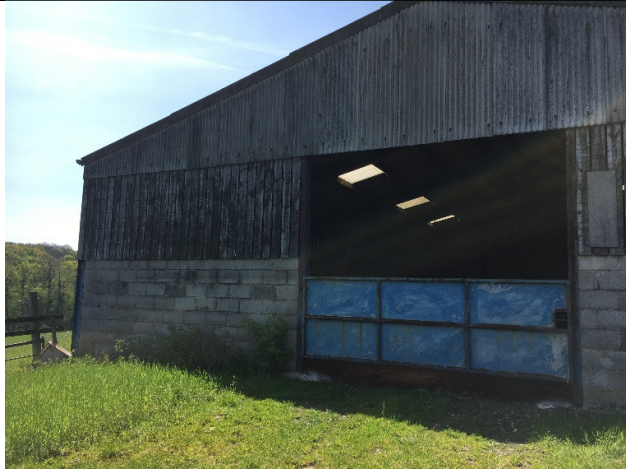
The barn features large openings and slatted cladding. These help minimise the wind loading on to the structure.

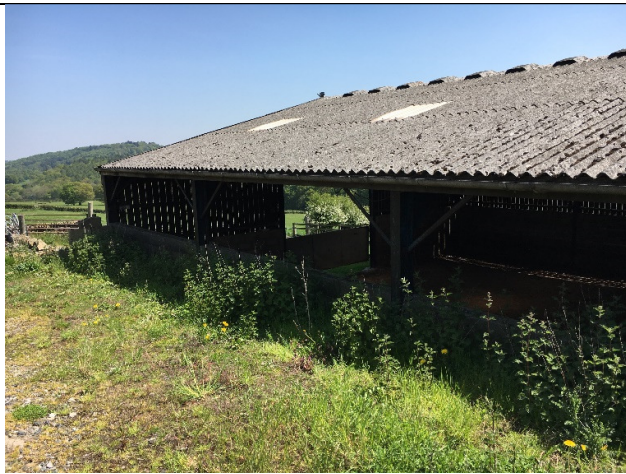
Open side and retaining wall to elevation.

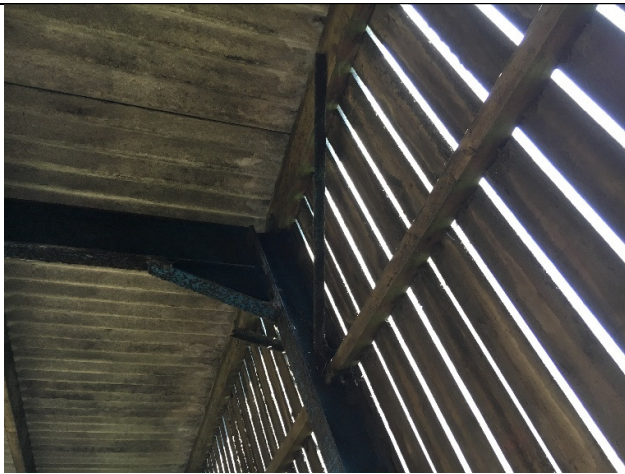
Open sided elevation.
