Wakefield Road, Smithies, Barnsley

Visual Condition Survey

GLEESON DEVELOPMENTS LIMITED

Ref: 22-137-003.01

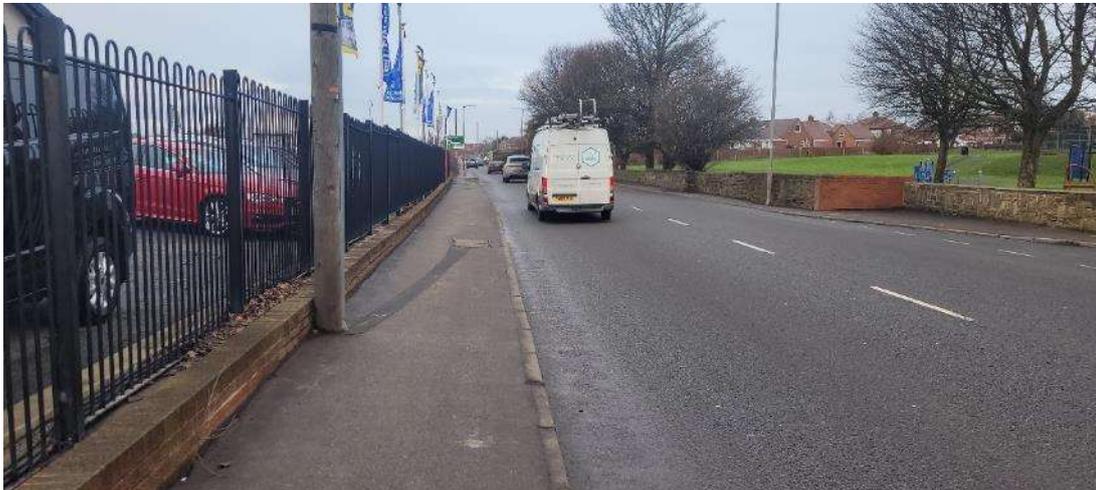
Photo 2

Scars present around utilities in footway

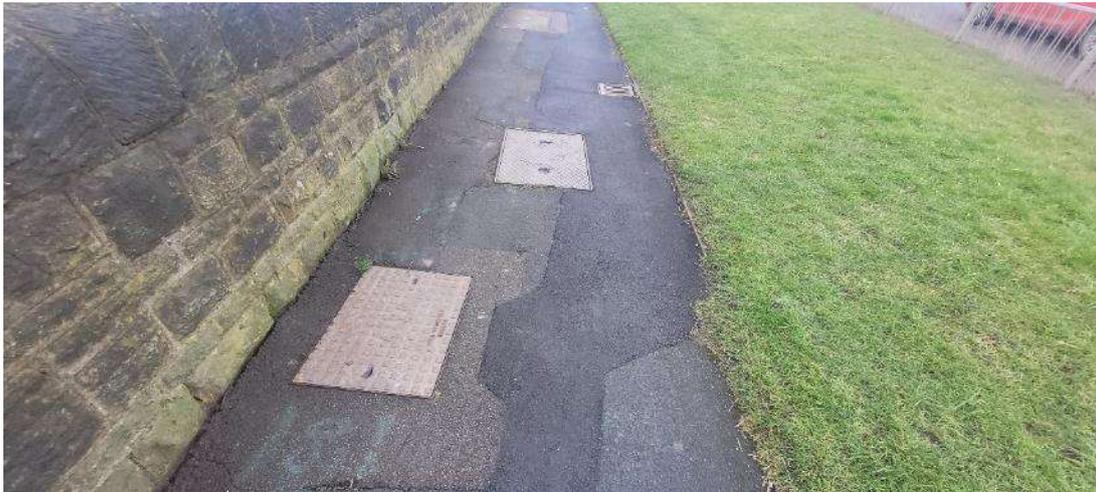
Photo 13

Visible scars in footway, plucked surface around gully.

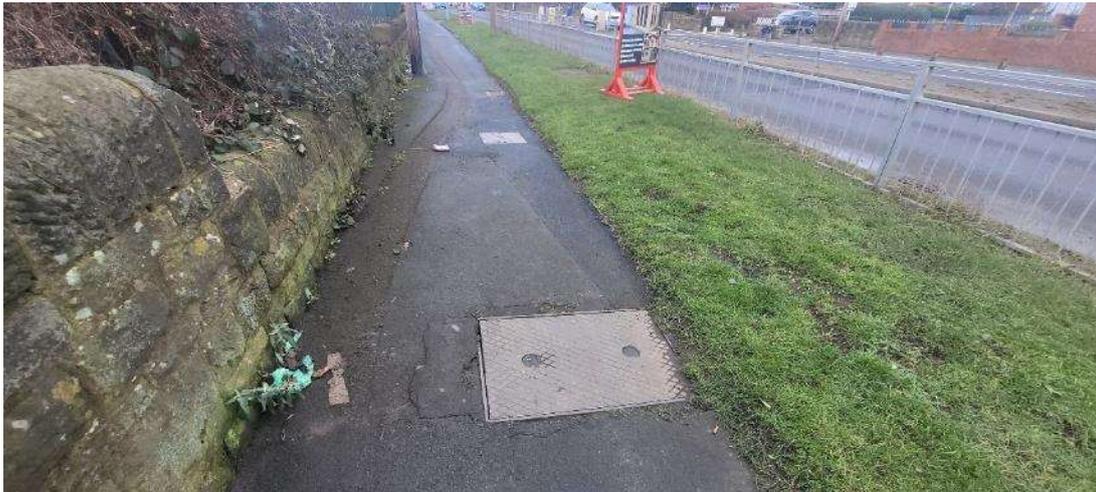
Photo 17

Visible scars in footway, uneven surface around inspection chambers.

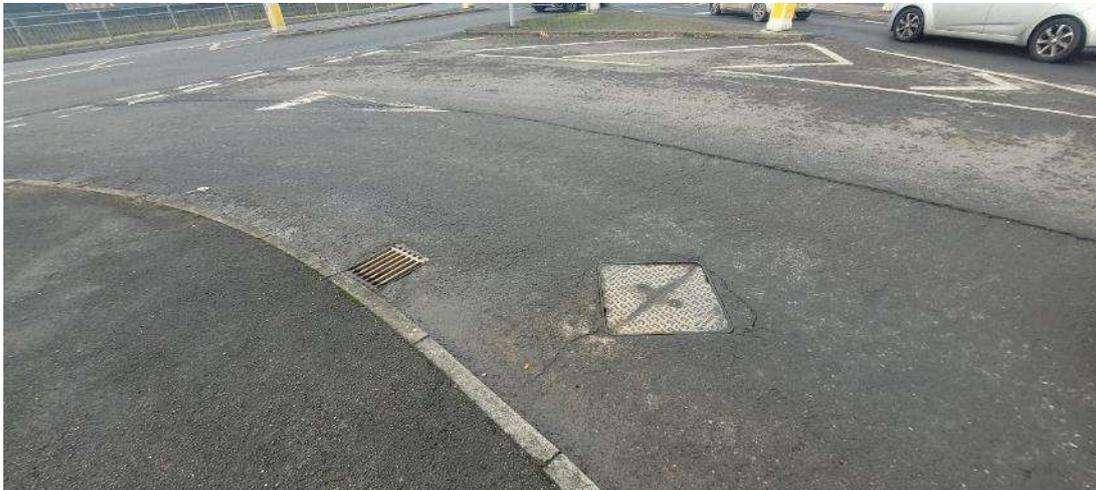
Photo 58

Footway gully at low point of drainage channel needs clearing of debris. Drainage channel full of debris and need clearing. Visible scars in footway due to utilities.

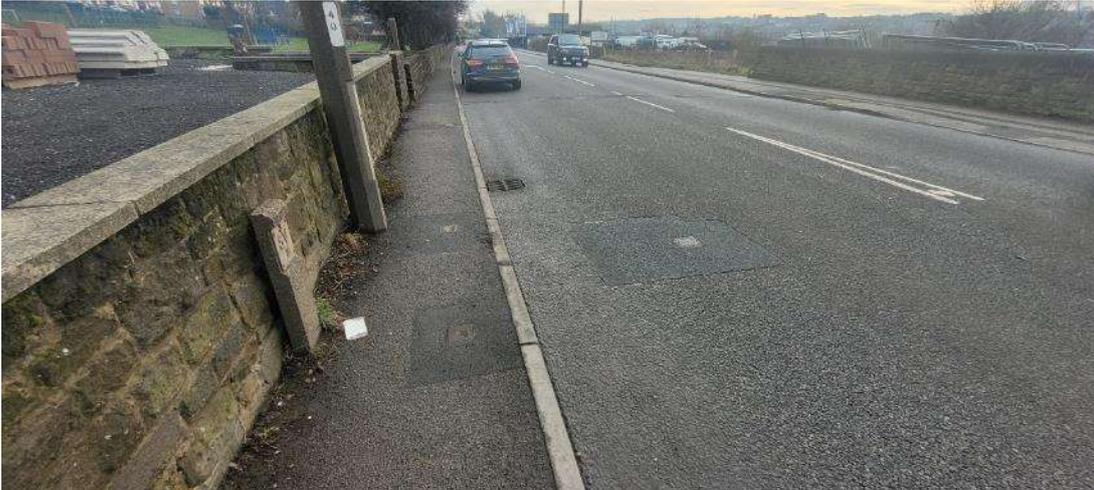
Photo 63

Carriageway plucked with water egress.

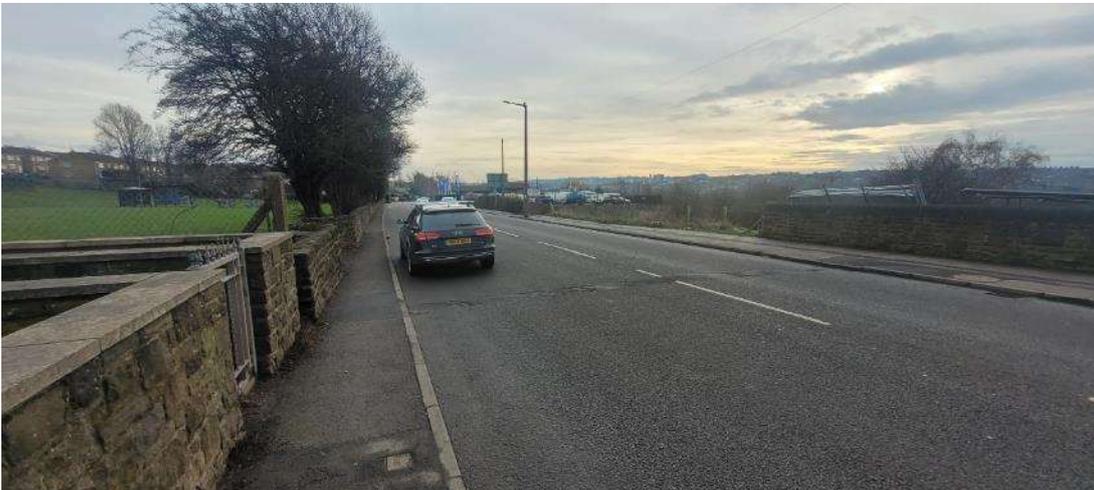
Photo 64

Visible reinstatement scar in carriageway. Visible scars in footway due to utilities. Gully badly silted and need clearing of debris.

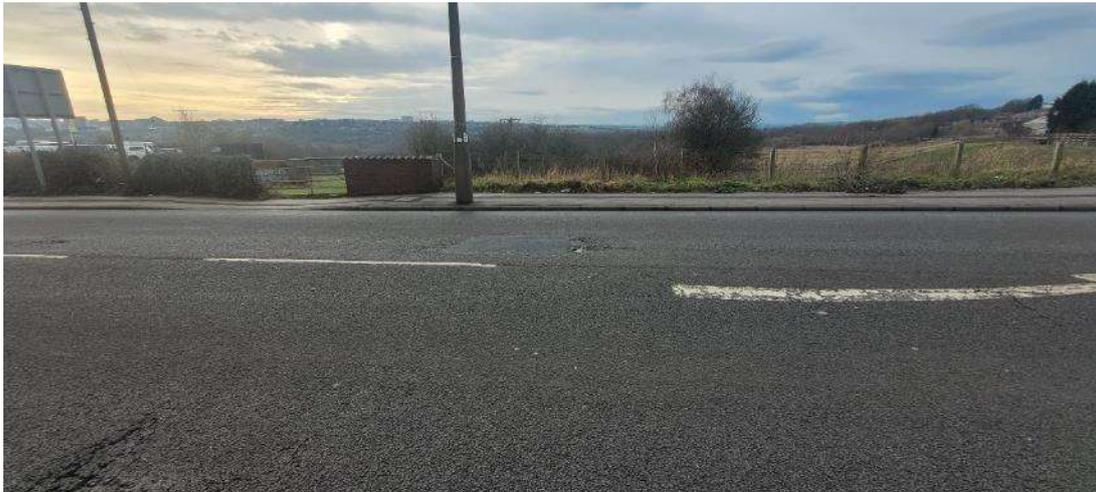
Photo 65

Visible duct crossing reinstatement scar in carriageway. Visible scars in footway due to utilities.

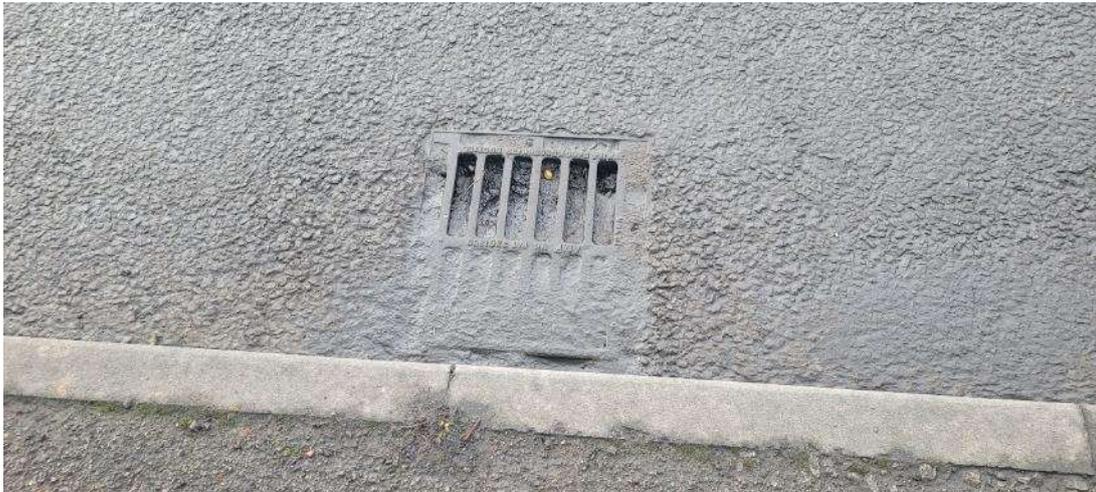
Photo 67

Gully badly silted, detritus needs to be cleared and jetted.

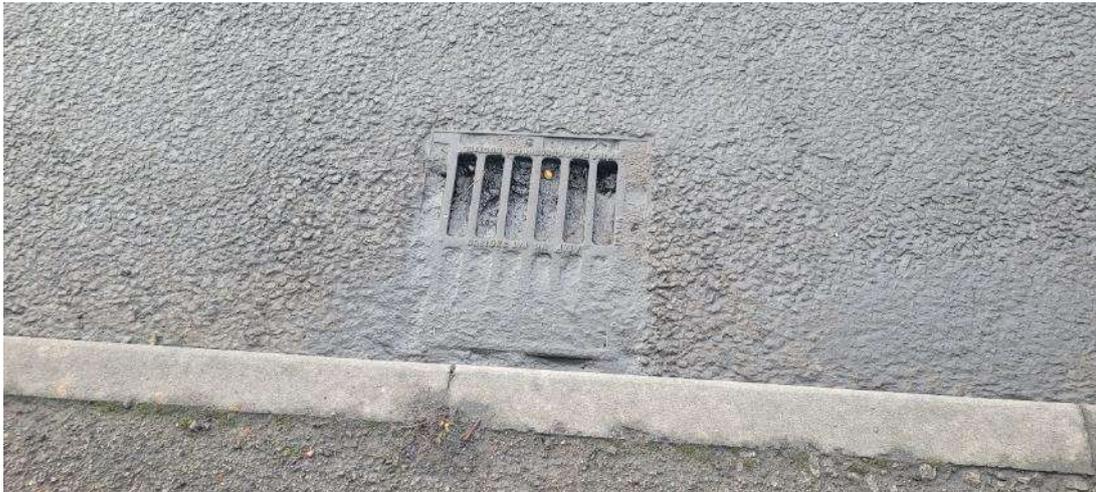
Photo 69

Gully badly silted, detritus needs to be cleared and jetted.

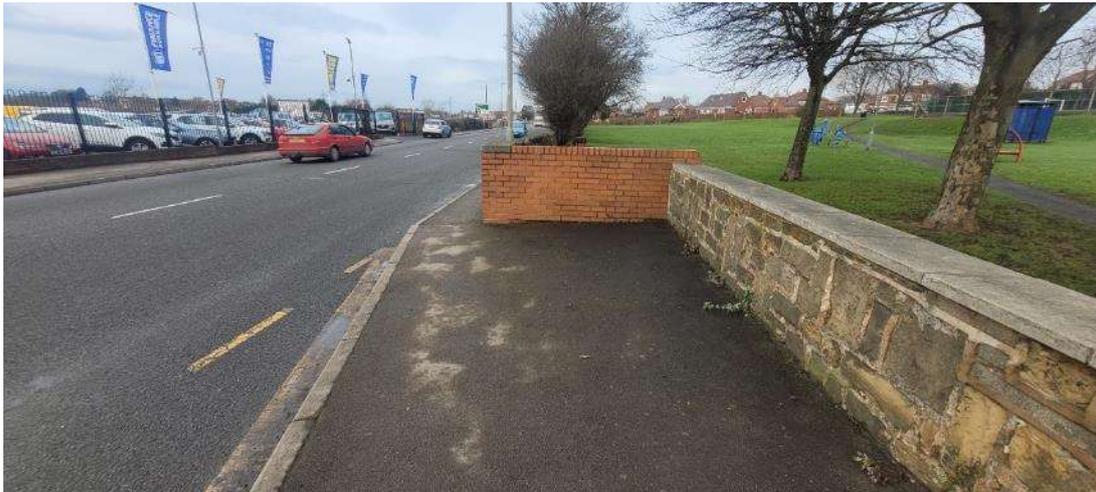
Photo 71

Visible scar within carriageway with water egress, poor reinstatement works.
