# DRAINAGE INVESTIGATION REPORT

CLIENT E2A Designs Ltd

SITE BONDFIELD DAY CENTRE -  
WOMBWELL - S73 8TX

DATE 21/11/2012 JOB No. 4826

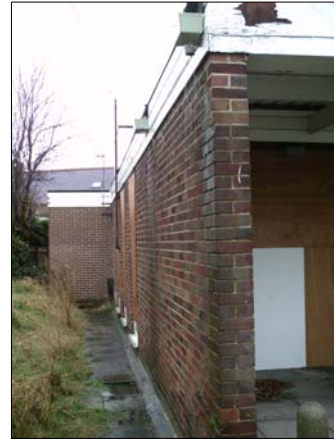
Title: GP22

Description: RAIN WATER PIPES  
(DISCONNECTED AT GUTTER) - BUILDING 2

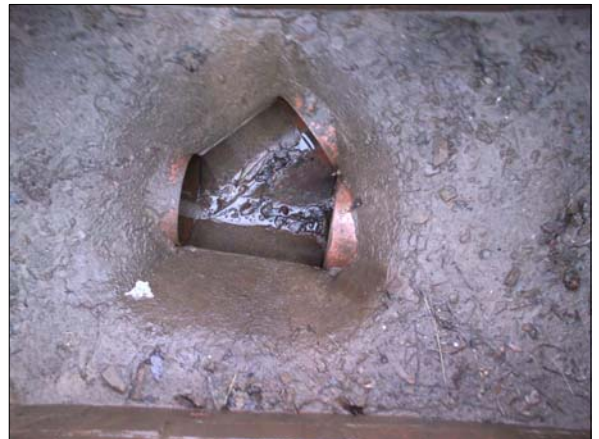
Title: GP40

Description: HIGHWAY MANHOLE 2

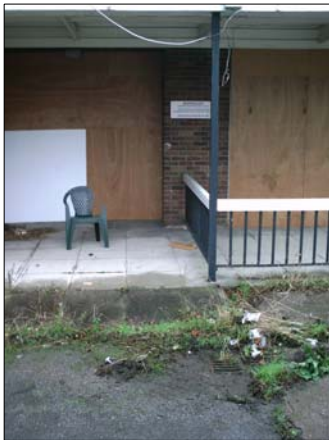
Title: GP41

Description: YARD GULLY - LOCATION  
(BUILDING 2 NR. RWP1)

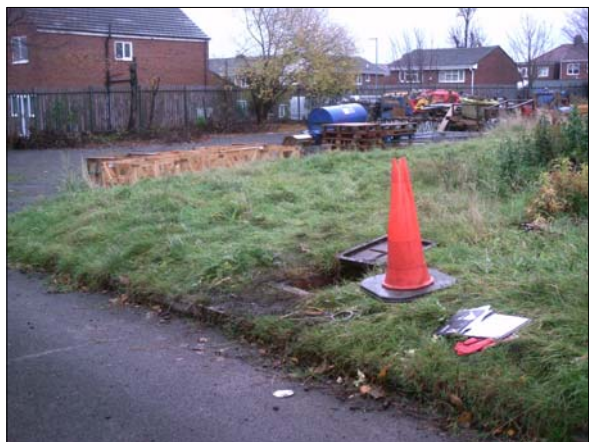
Title: GP43

Description: EDS8 - LOCATION

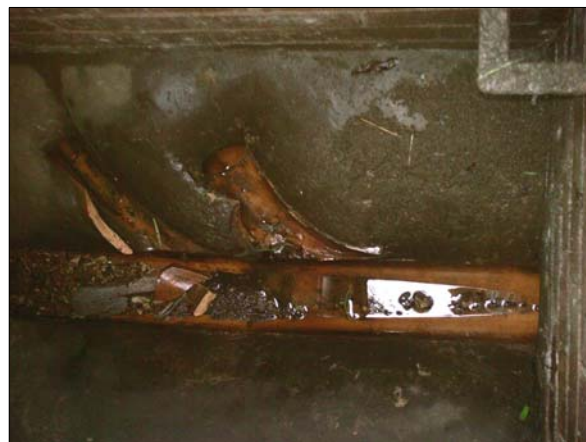
Title: GP44

Description: EDS8

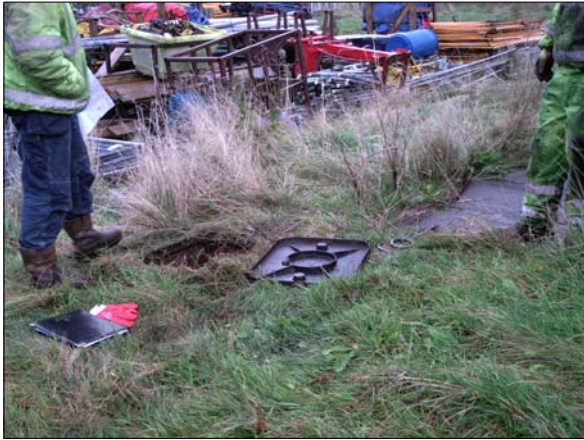
Title: GP45

Description: EDS12 - LOCATION

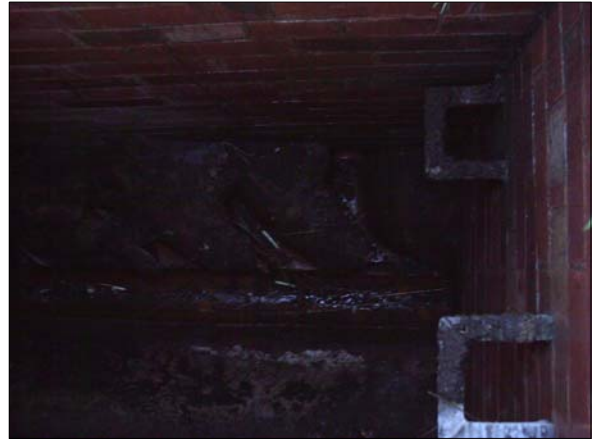
Title: GP46

Description: EDS12

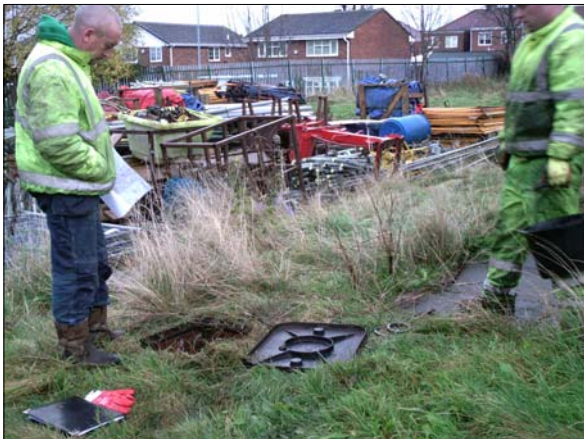
Title: GP47

Description: EDS12 - LOCATION

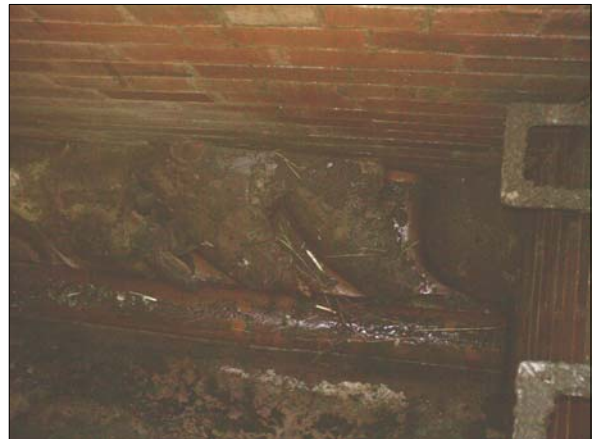
Title: GP48

Description: EDS12

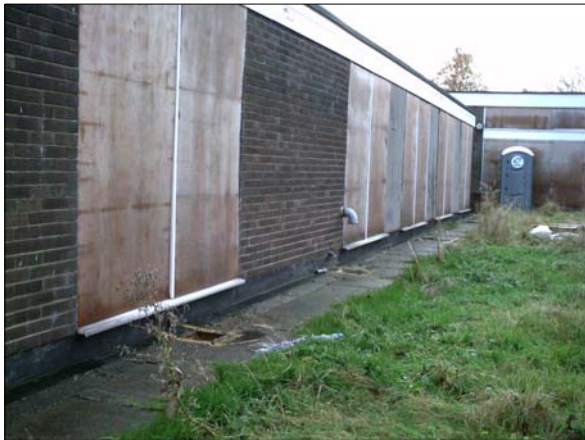
Title: GP49

Description: GULLIES - LOCATION TO FRONT OF BUILDING 1

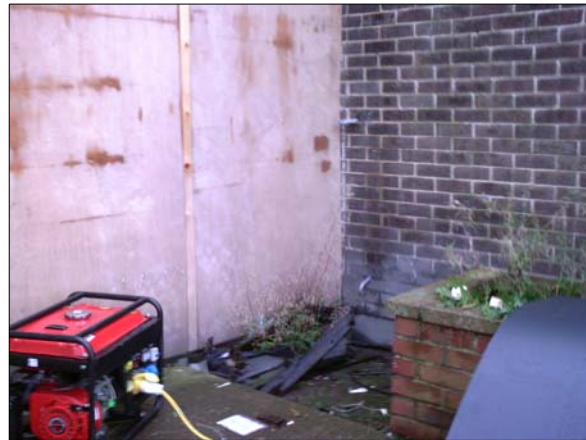
Title: GP50

Description: RWP & RWG - LOCATION ENTRANCE OF BUILDING 1

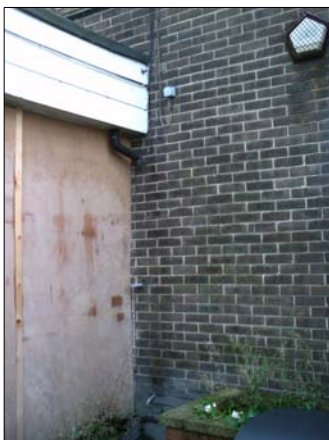
Title: GP51

Description: RWP & RWG - LOCATION ENTRANCE OF BUILDING 1

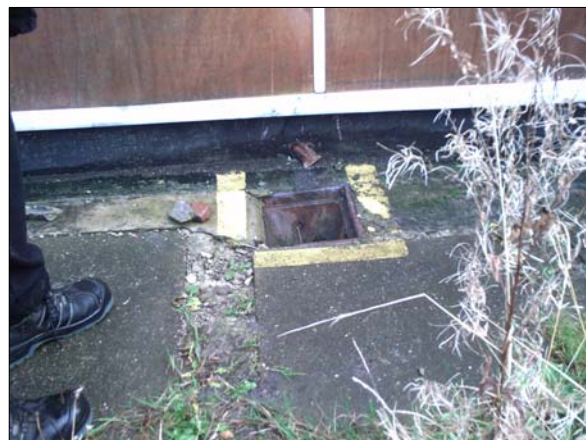
Title: GP52

Description: GULLY - TO FRONT OF BUILDING 1

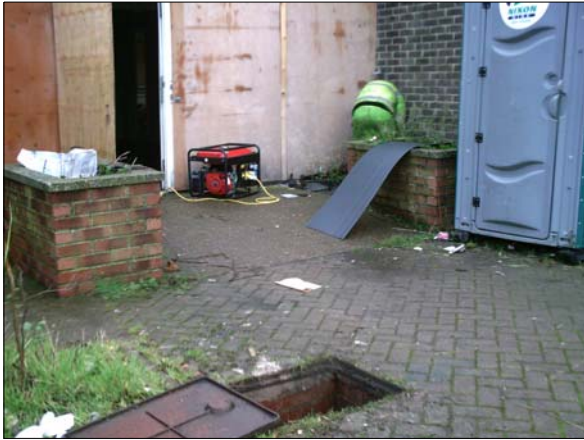
Title: GP53

Description: EDS15 - LOCATION

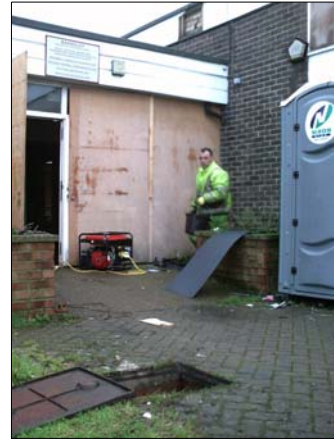
Title: GP54

Description: EDS15 (DYE TESTING) - LOCATION

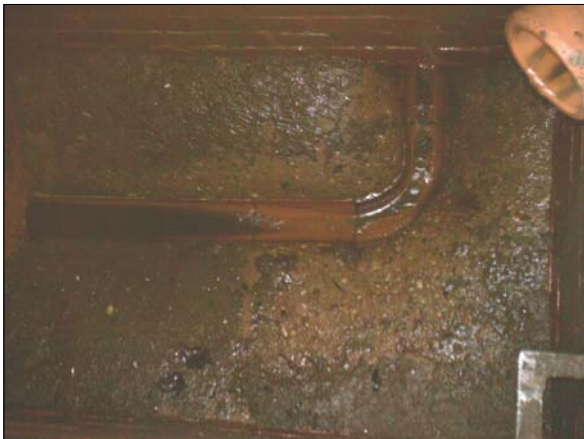
Title: GP55

Description: EDS15

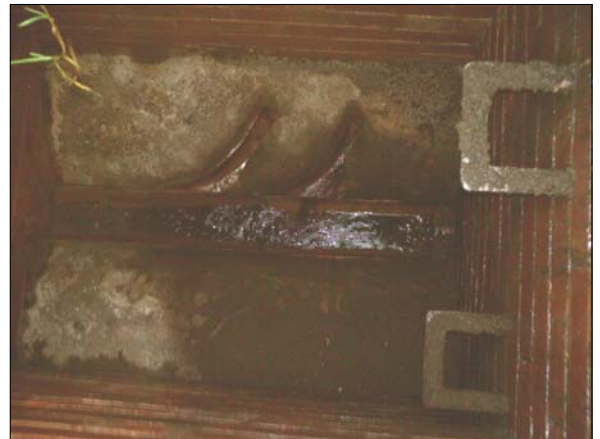
Title: GP56

Description: EDS14

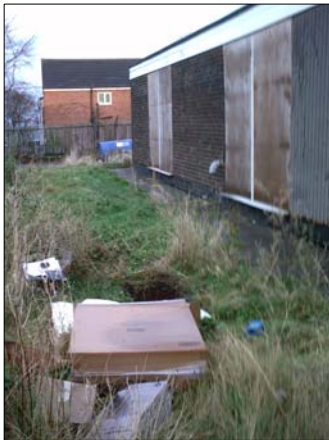
Title: GP57

Description: EDS14 - LOCATION

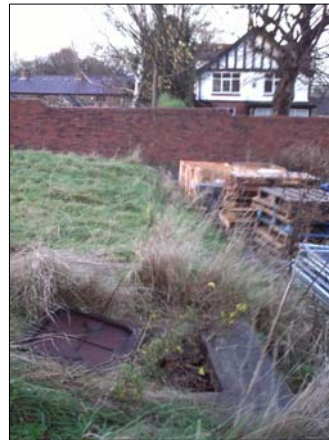
Title: GP58

Description: EDS11 - LOCATION

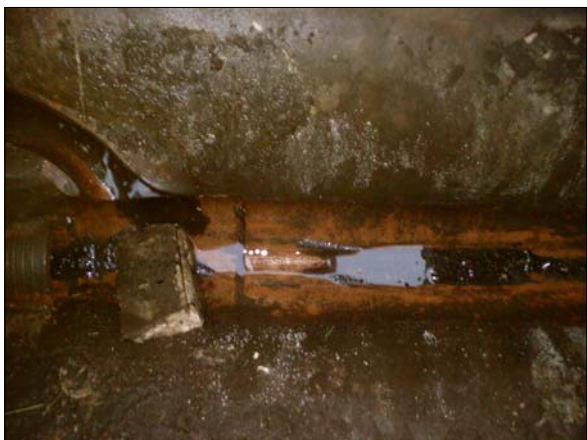
Title: GP59

Description: EDS11

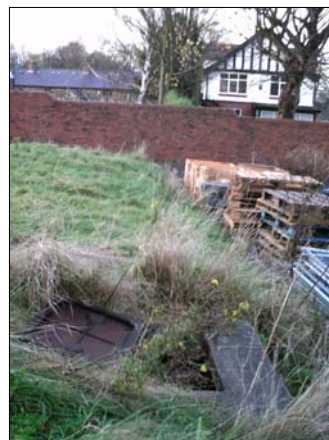
Title: GP60

Description: EDS11 - LOCATION

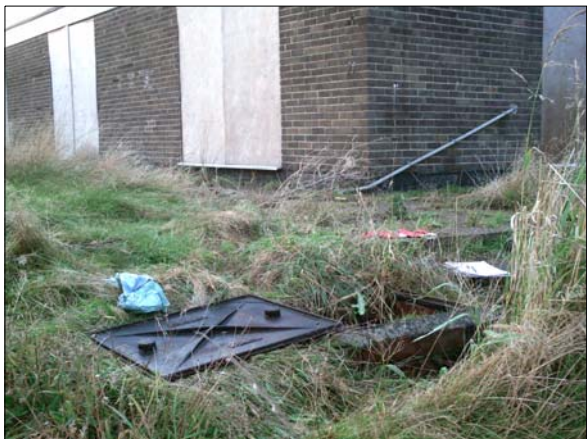
Title: GP61

Description: EDS10 - LOCATION

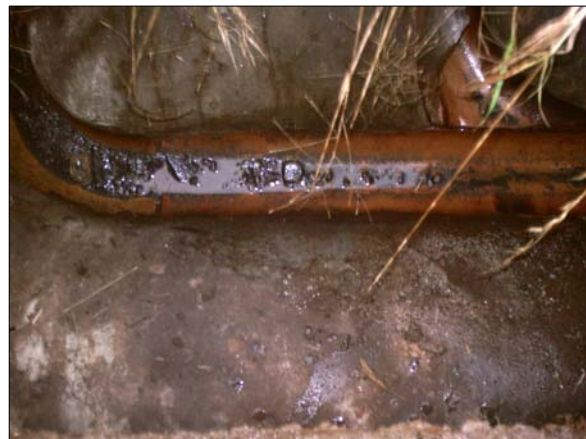
Title: GP62

Description: EDS10

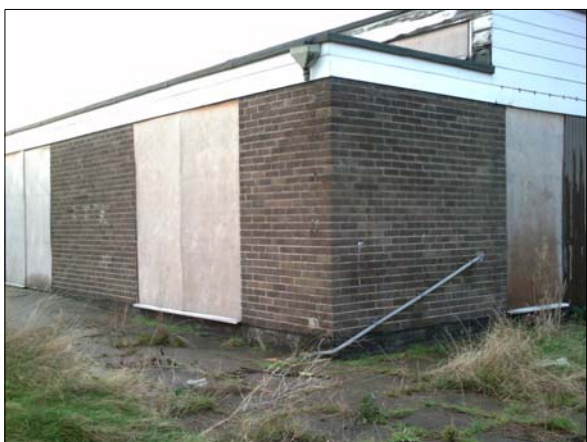
Title: GP63

Description: RWP INTO EDS10 - REAR OF BUILDING 1

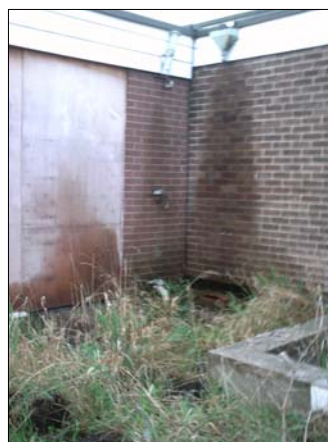
Title: GP64

Description: EDS13 - LOCATION

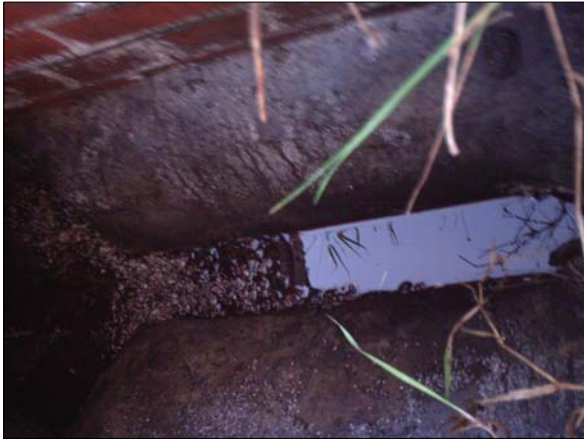
Title: GP65  
Date: 21/11/12  
Description: EDS13

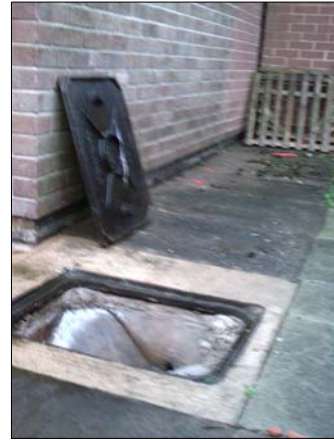
Title: GP66  
Date: 21/11/12  
Description: EDS19 - LOCATION

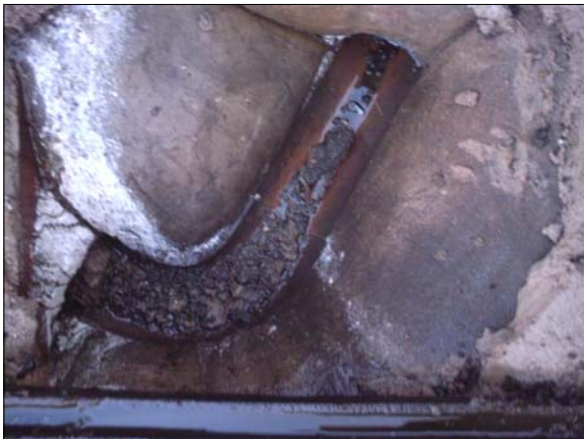
Title: GP67  
Date: 21/11/12  
Description: EDS19
