VCS Report

Project: Hoyland, Barnsley

Job No: PTS21335-01

This report describes the Visual Condition Survey of the Hoyland, Barnsley scheme. This can be identified on the site plan within Appendix A. The survey was undertaken in June 2021 in the daytime using a HD resolution video survey.

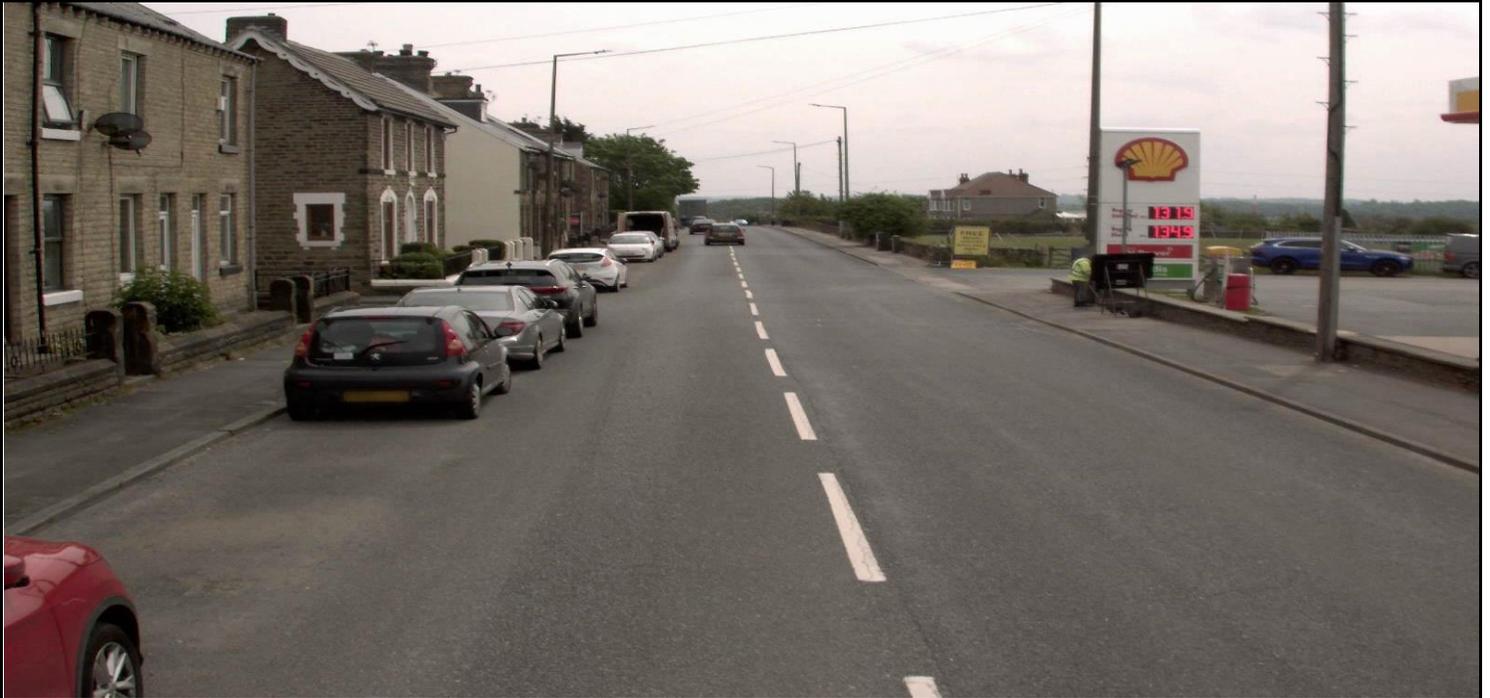
Chainage : 71m

Feature / Defect : Major Surface Defectiveness

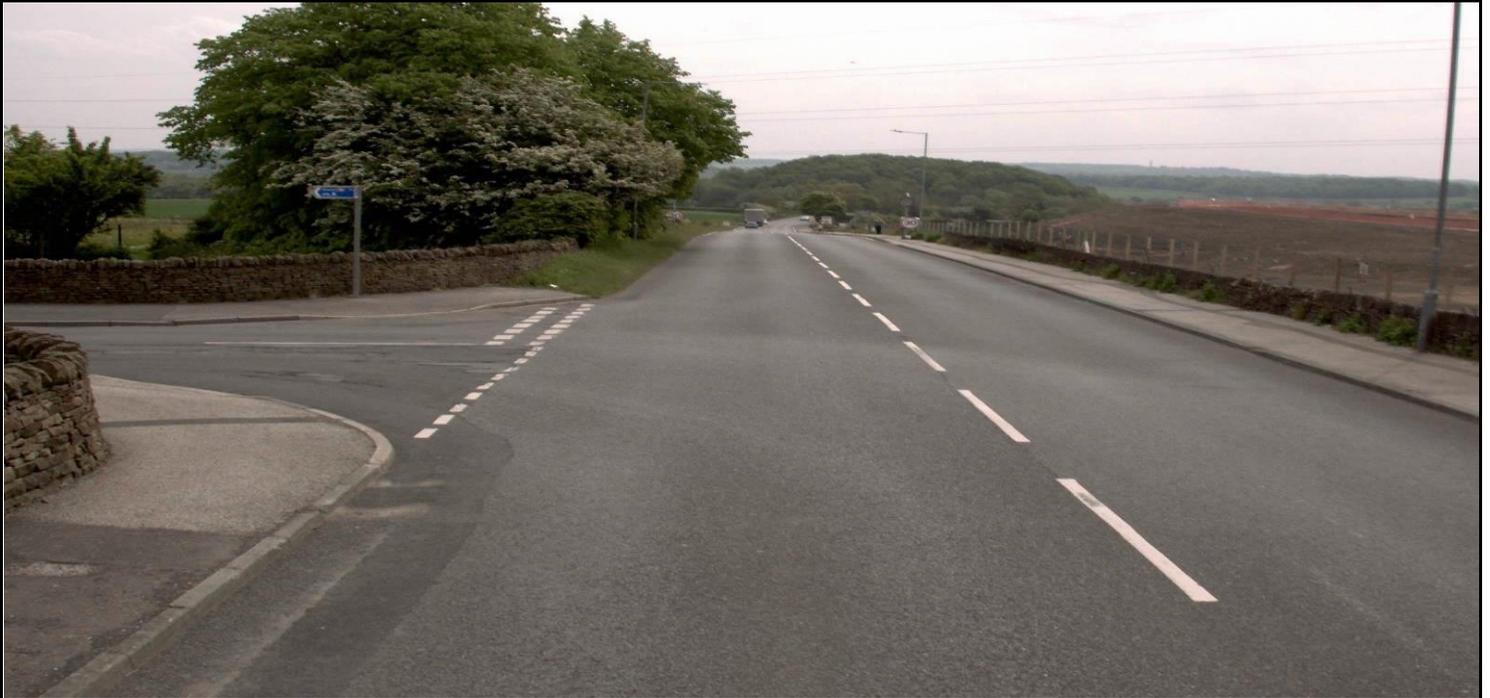
Chainage : 429m

Feature / Defect : Major Surface Defectiveness

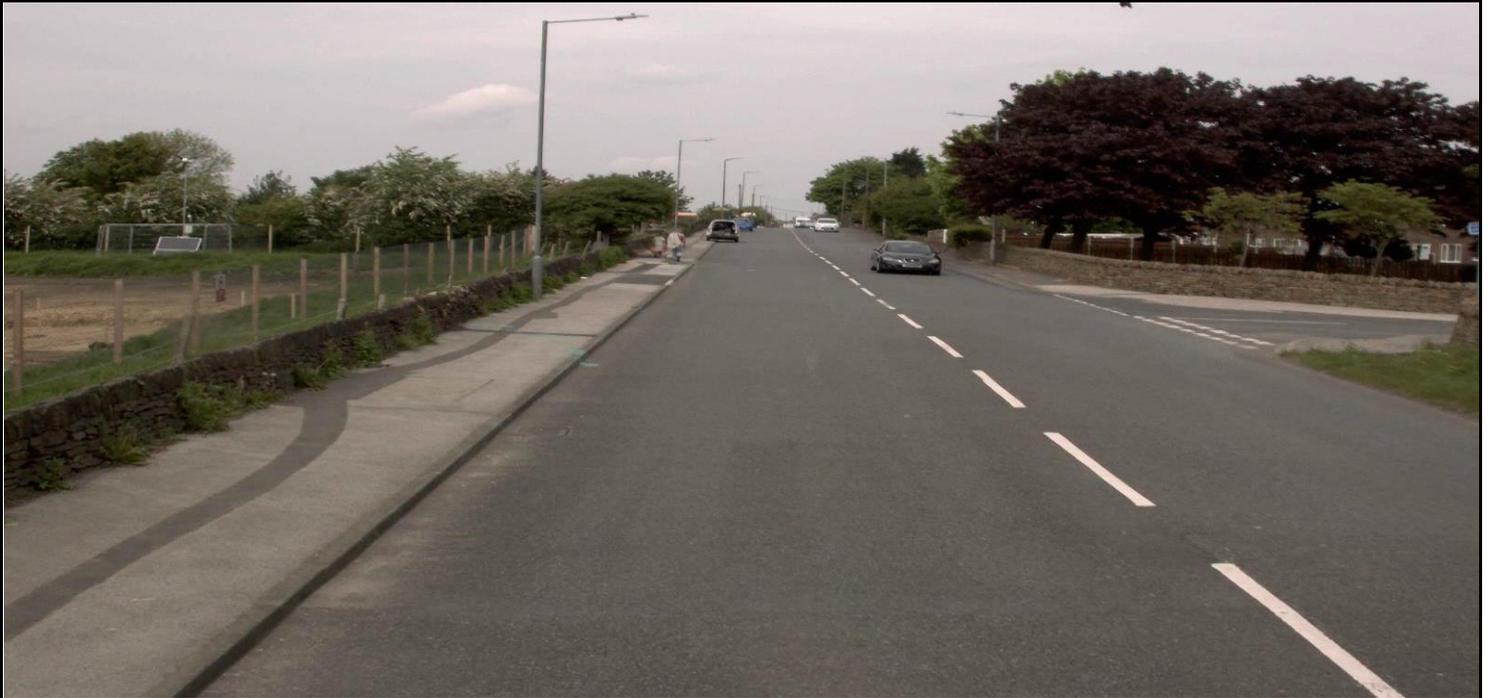
Chainage : 471m

Feature / Defect : Major Surface Defectiveness

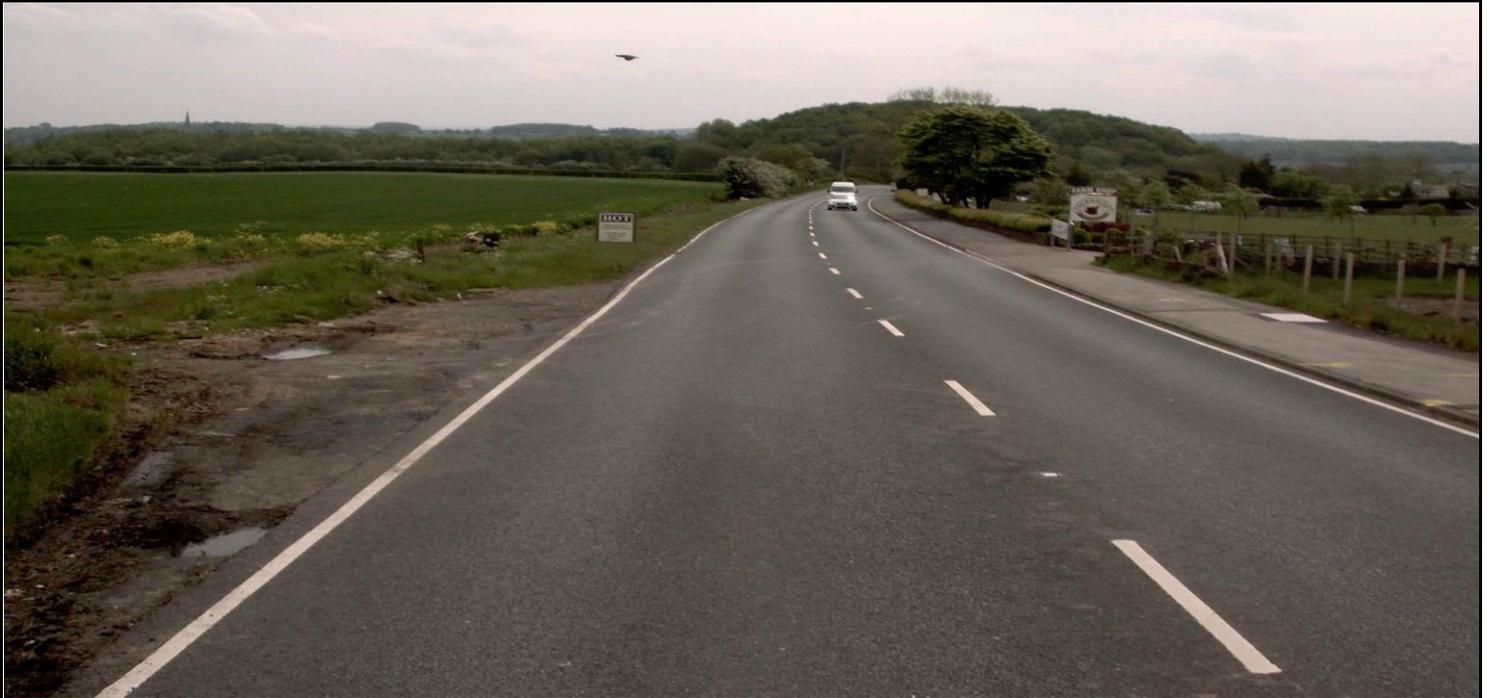
Chainage : 655m

Feature / Defect : Minor Surface Defectiveness

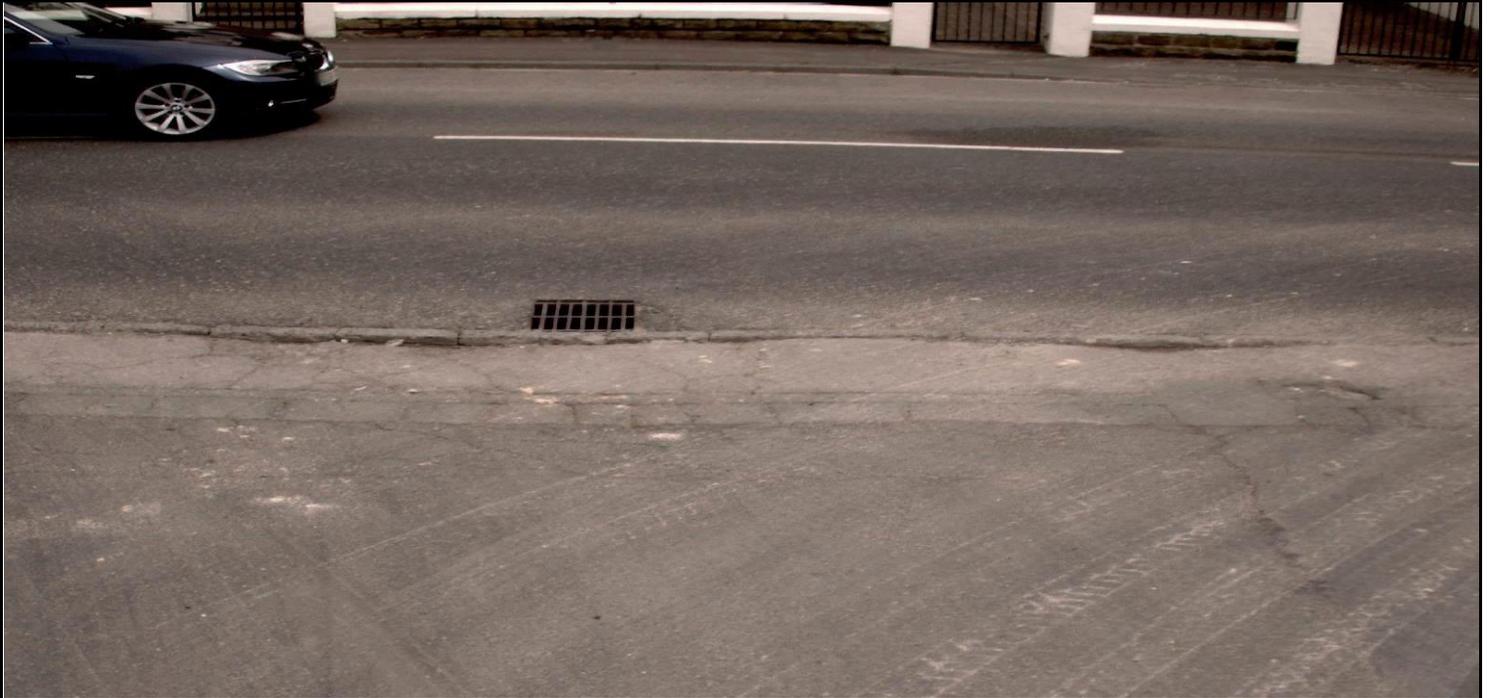
Chainage : 0m

Feature / Defect : Major Cracking

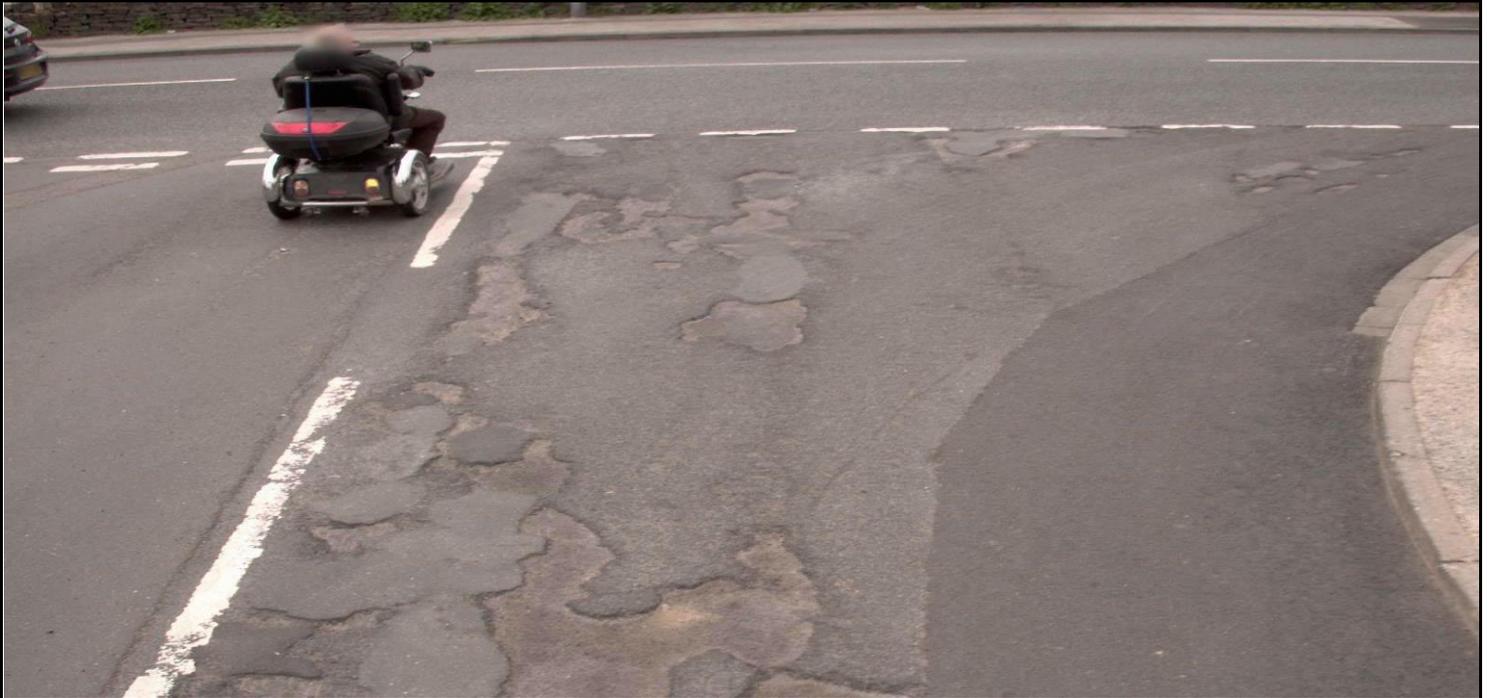
Chainage : 0m

Feature / Defect : Major Surface Defectiveness

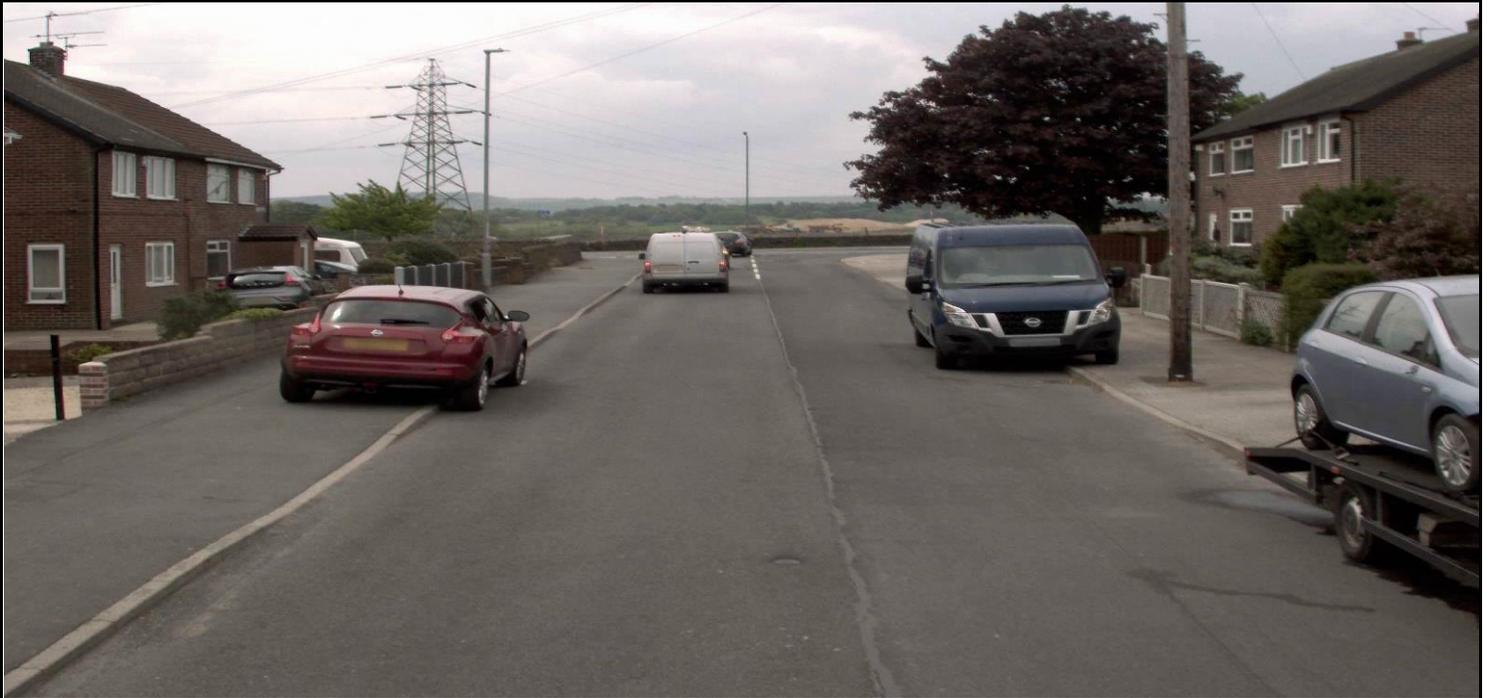
Chainage : 74m

Feature / Defect : Major Surface Defectiveness

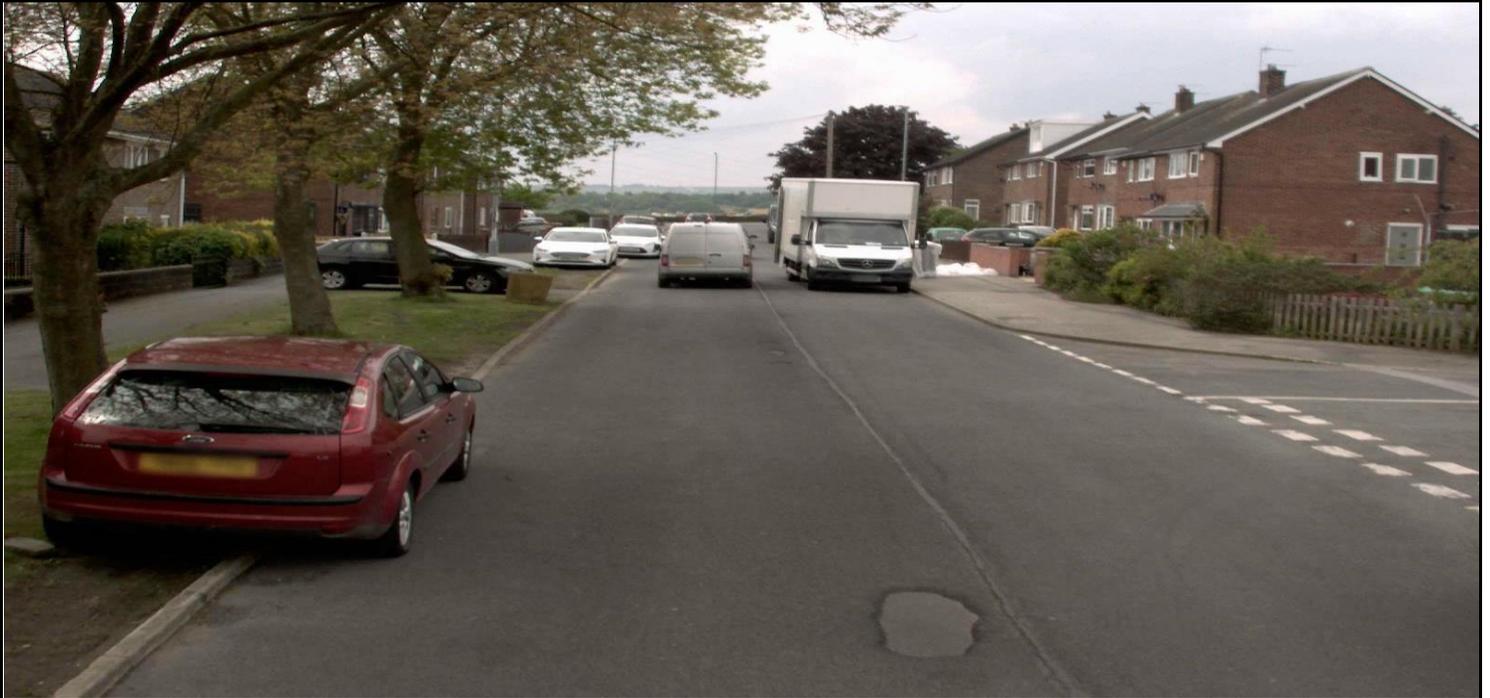
Chainage : 136m

Feature / Defect : Major Surface Defectiveness

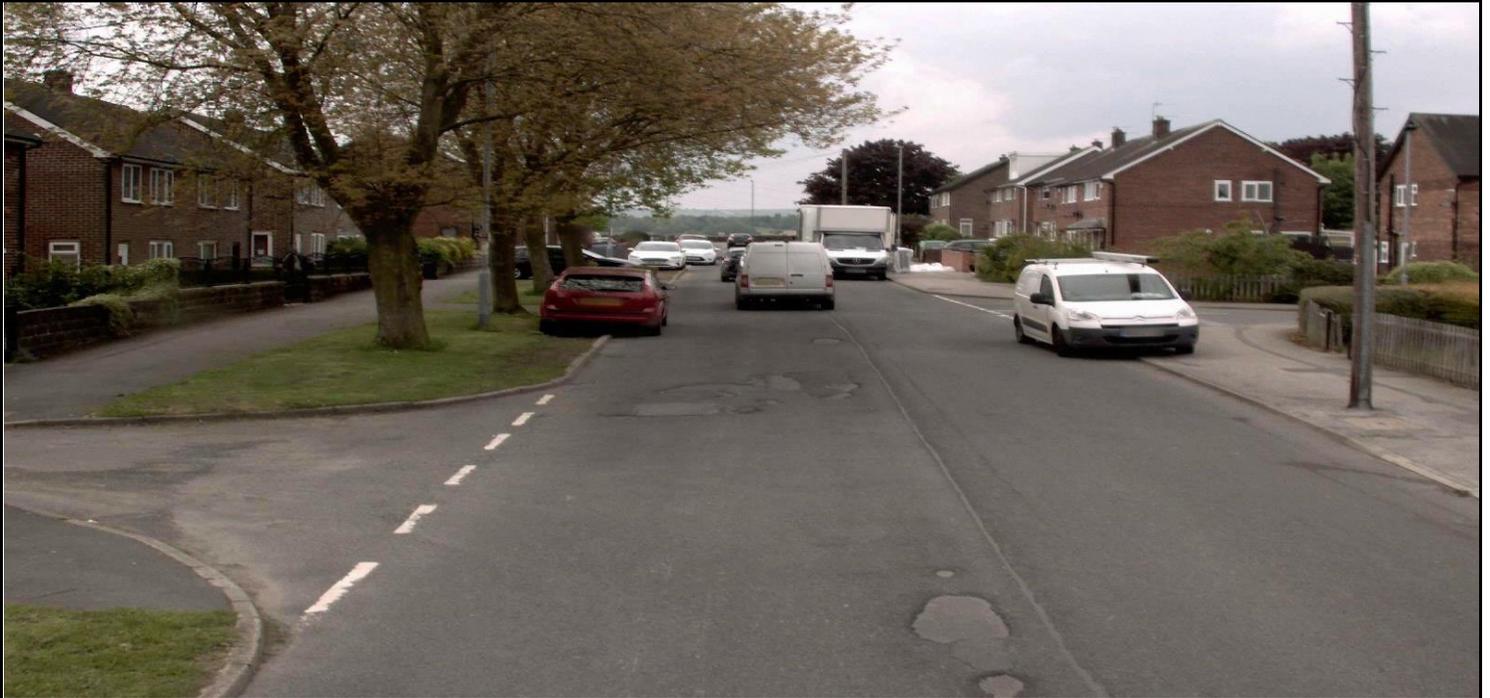
Photo Ref : 25	Section : Parkside Road
Chainage : 154m	Feature / Defect : Major Surface Defectiveness

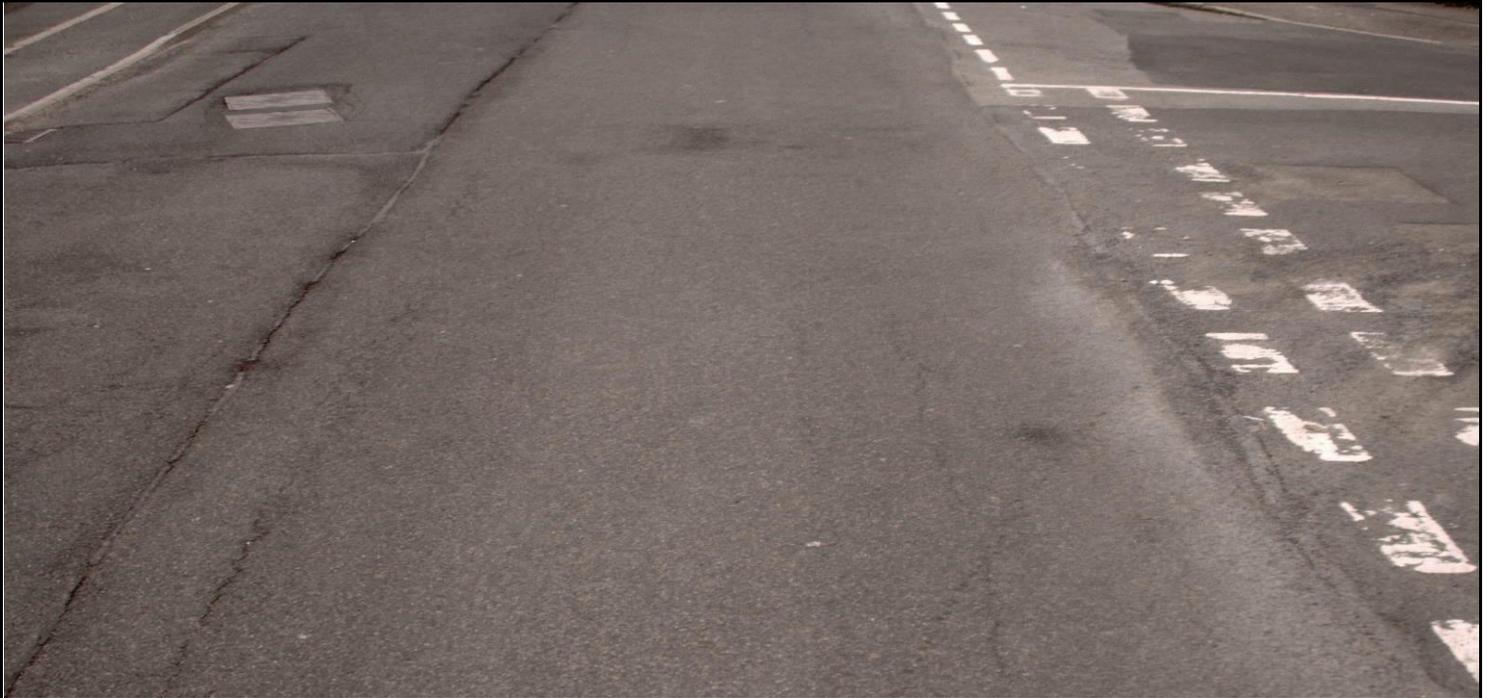
Chainage : 190m

Feature / Defect : Minor Cracking

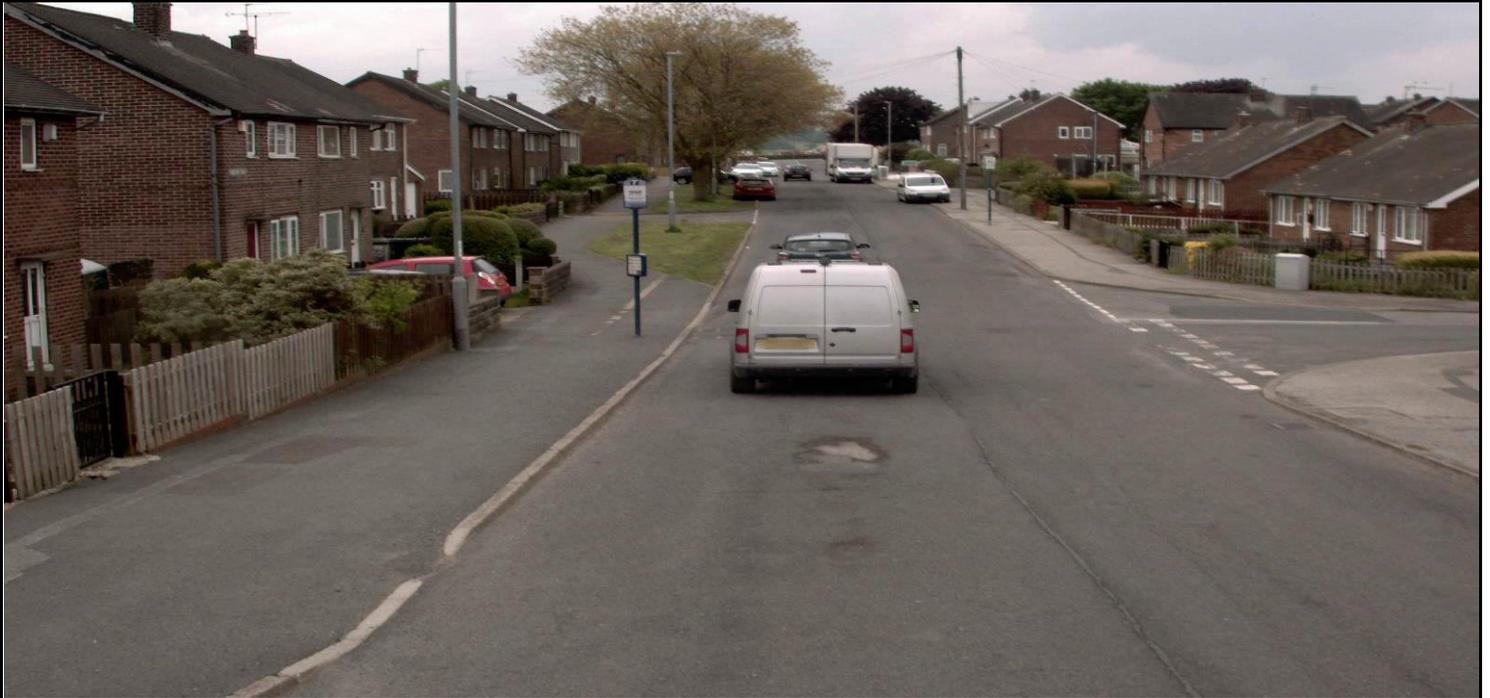
Chainage : 208m

Feature / Defect : Major Surface Defectiveness

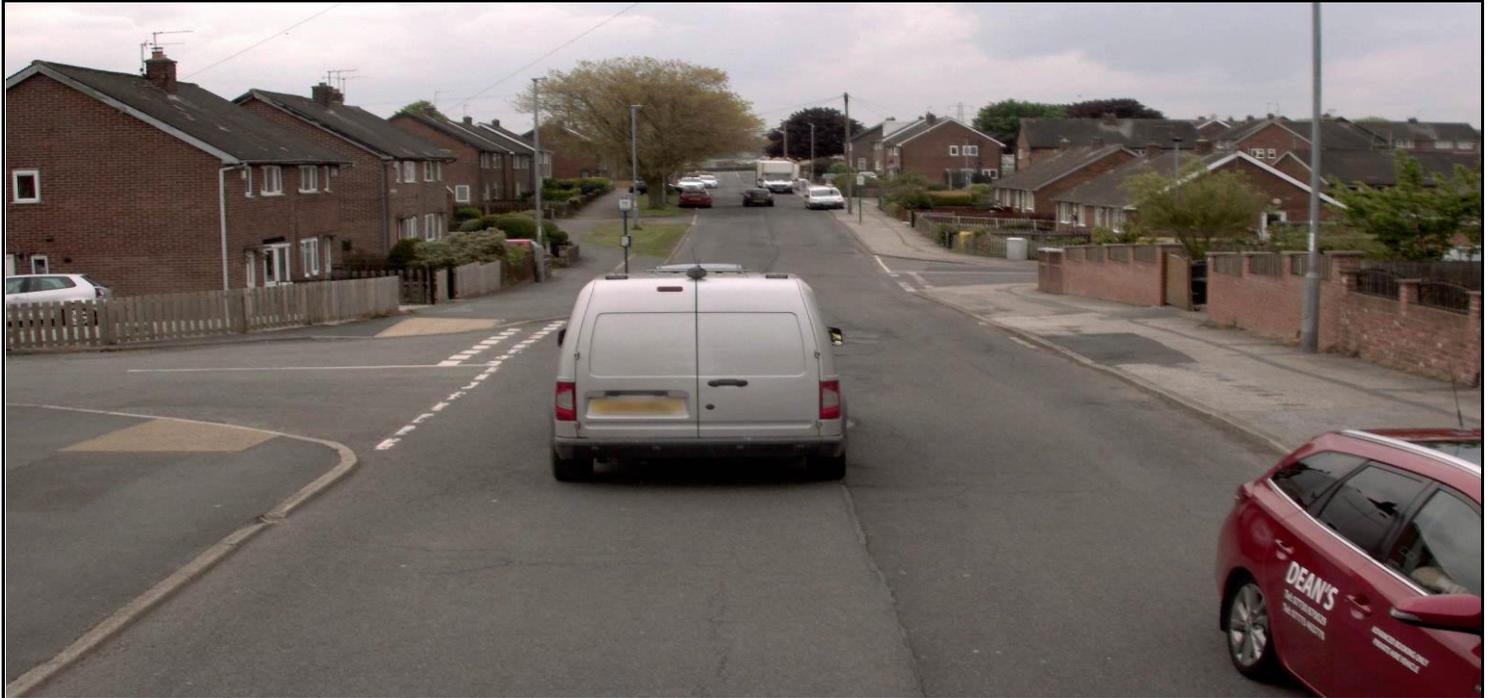
Photo Ref : 31	Section : Parkside Road
Chainage : 213m	Feature / Defect : Minor Cracking

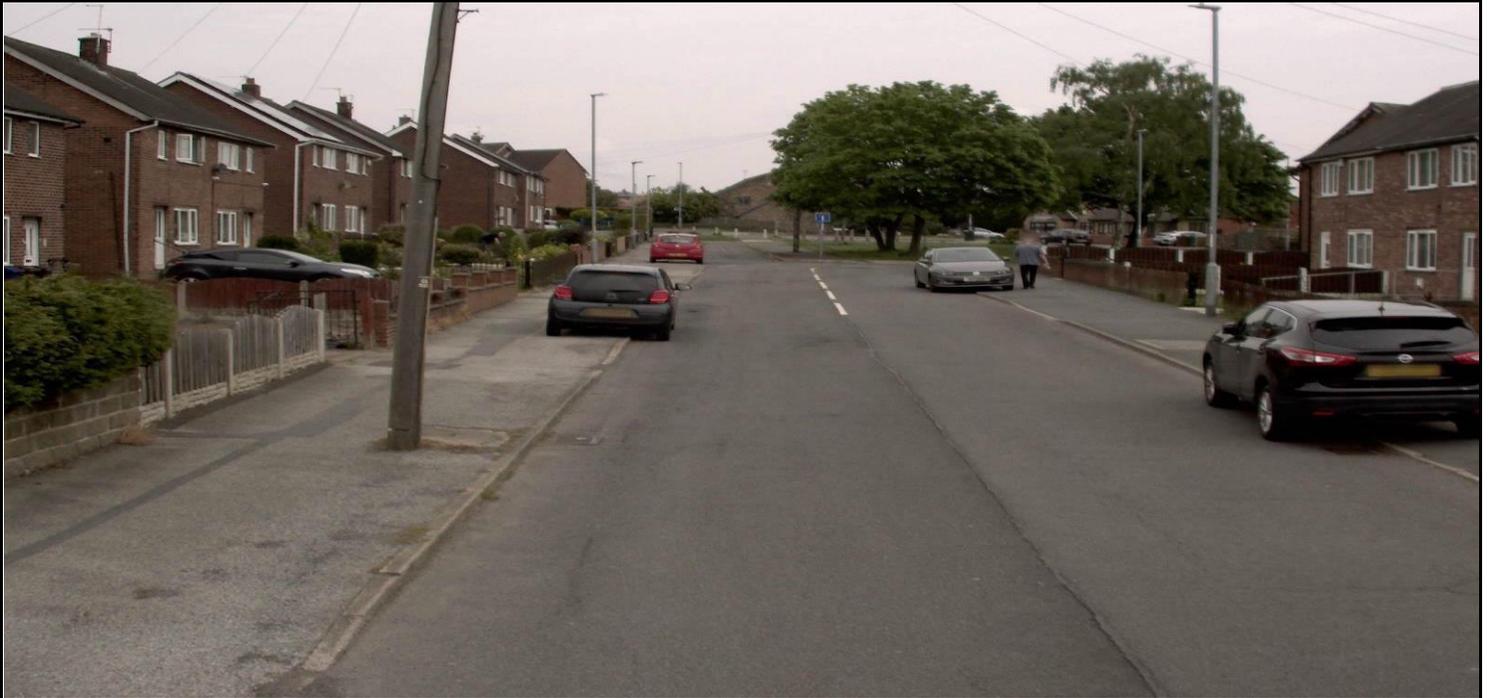
Chainage : 232m

Feature / Defect : Major Cracking

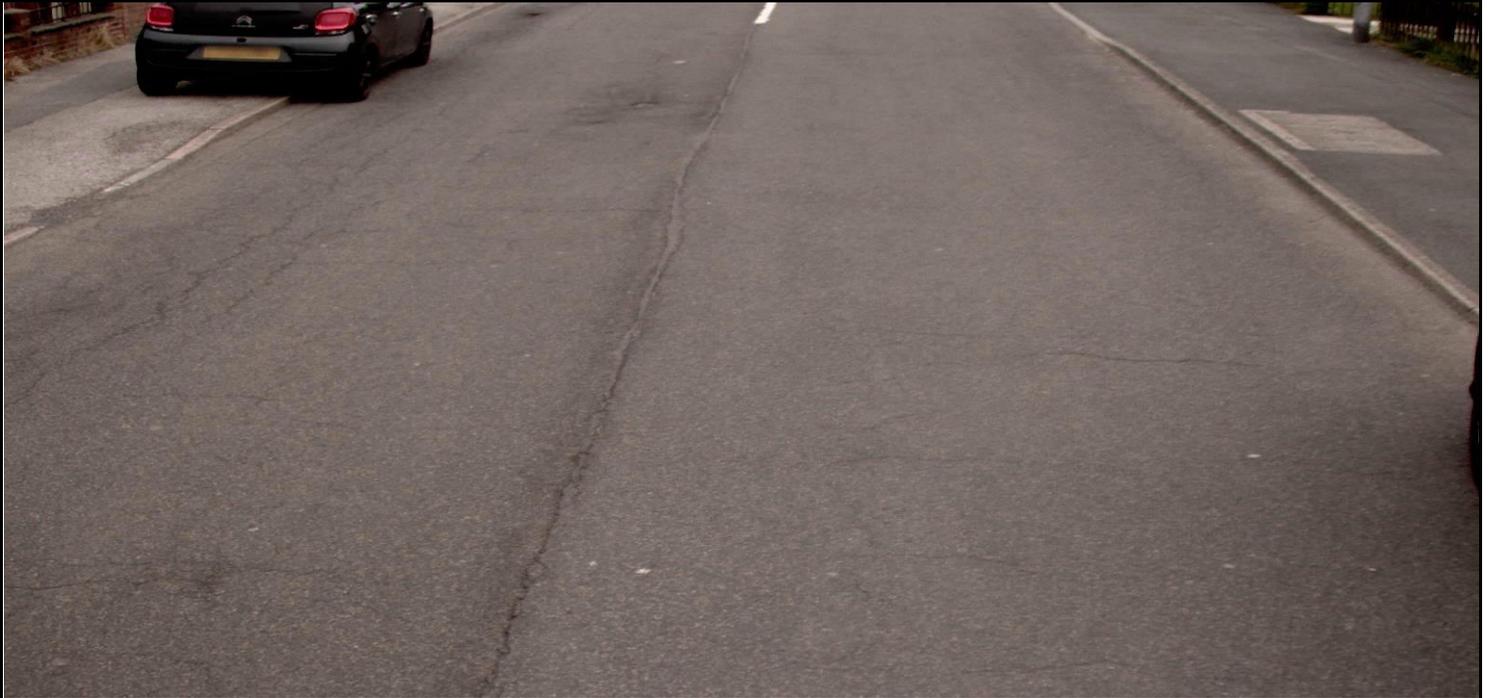
Chainage : 244m

Feature / Defect : Minor Transverse Cracking

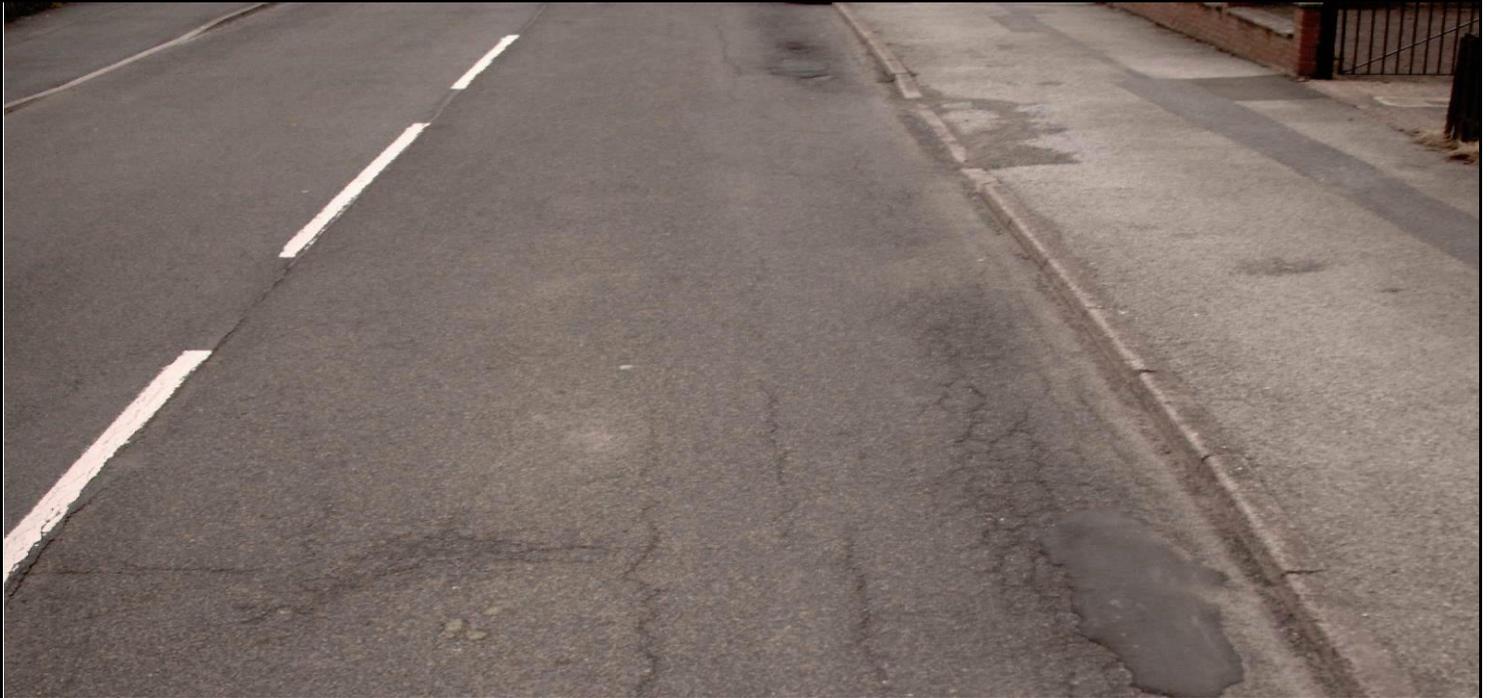
Chainage : 268m

Feature / Defect : Minor Craziing,Minor Cracking

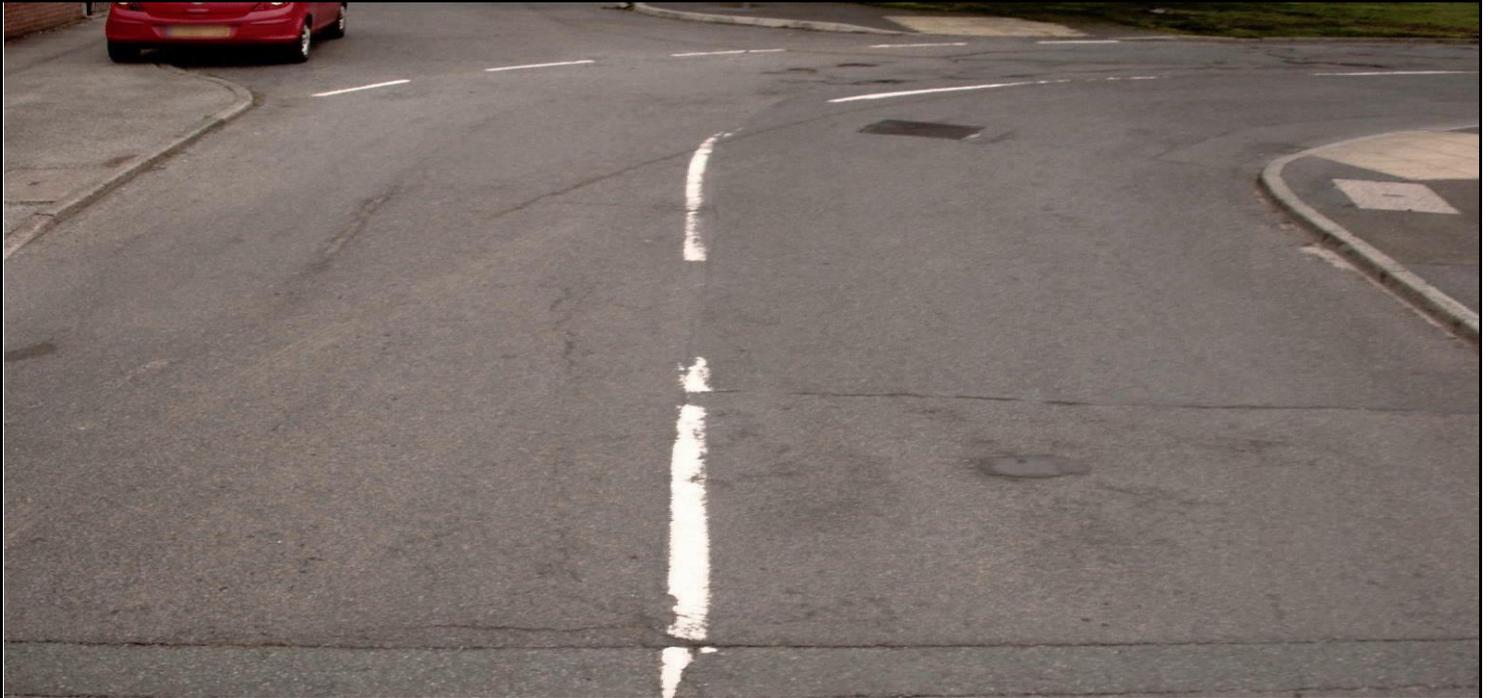
Chainage : 278m

Feature / Defect : Minor Transverse Cracking

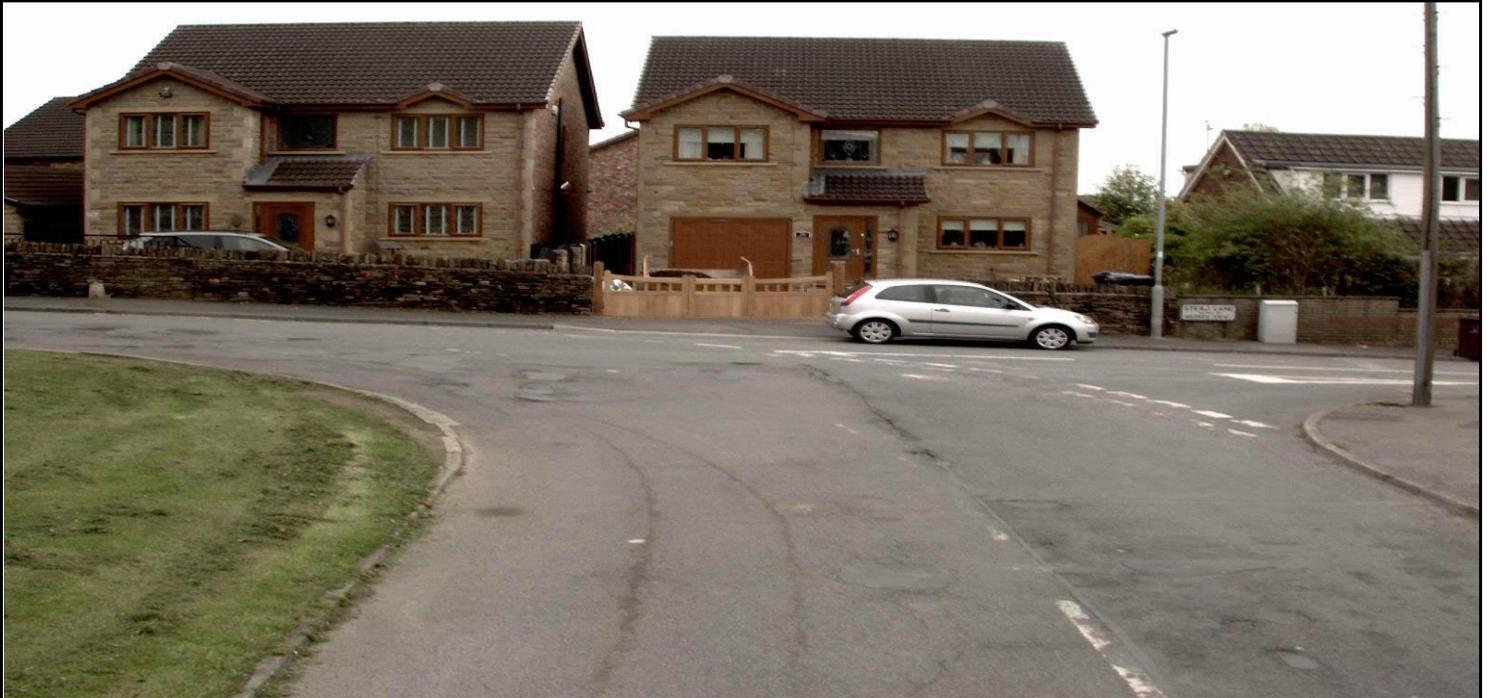
Chainage : 306m

Feature / Defect : Minor Cracking

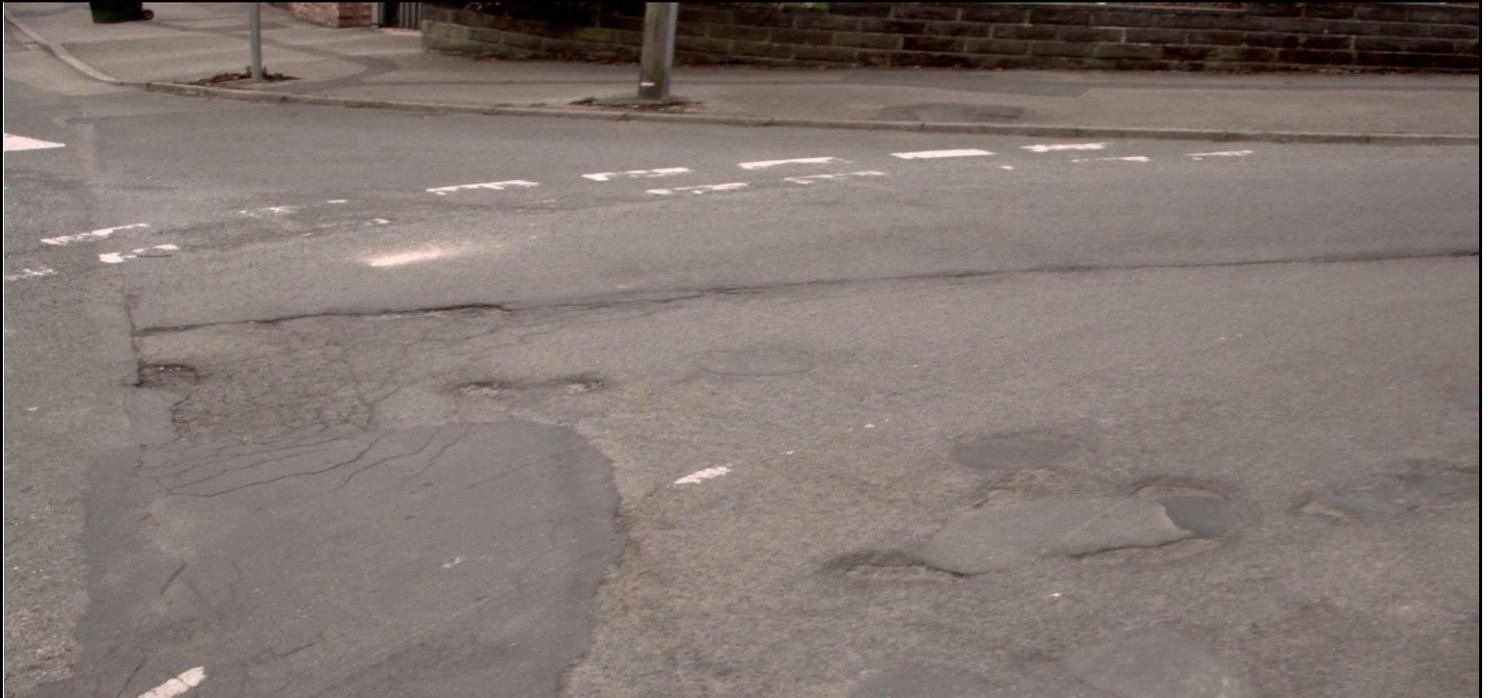
Chainage : 319m

Feature / Defect : Major Cracking

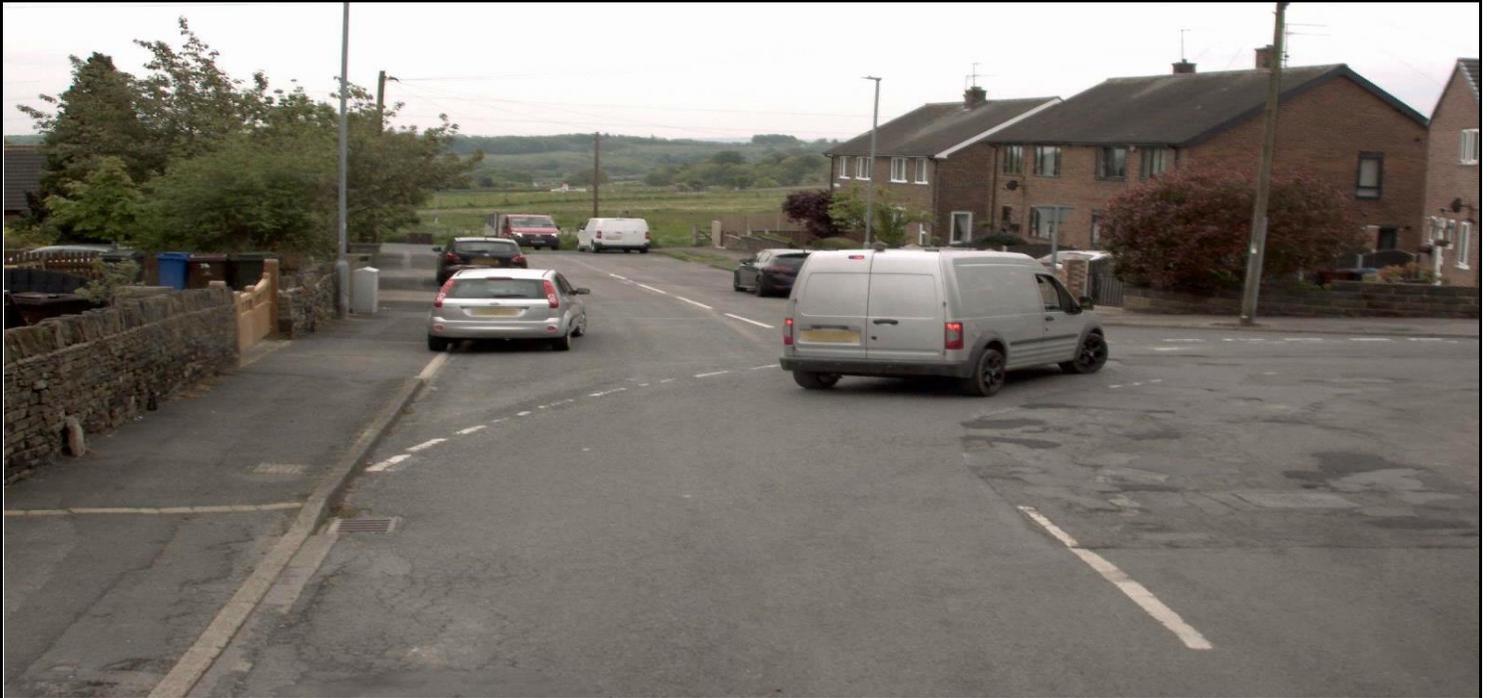
Chainage : 333m

Feature / Defect : Major Cracking

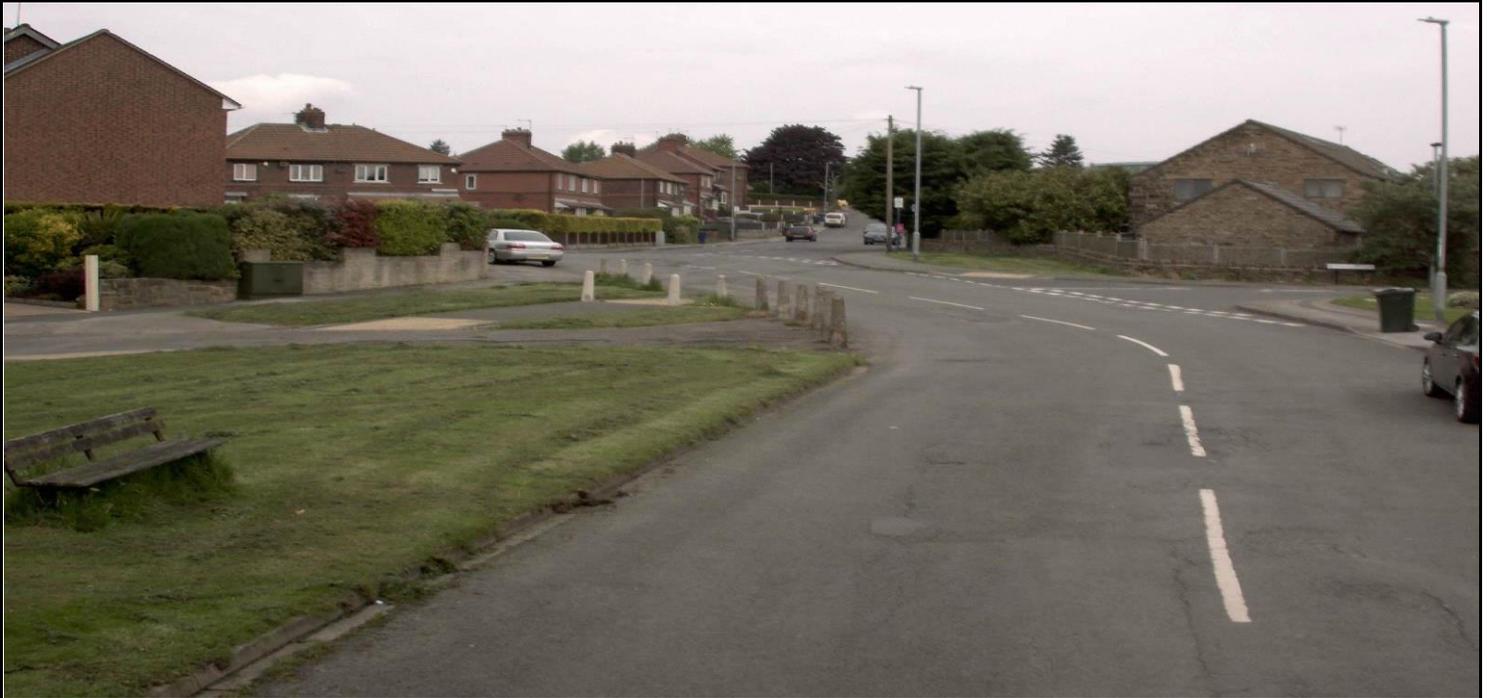
Chainage : 345m

Feature / Defect : Major Cracking

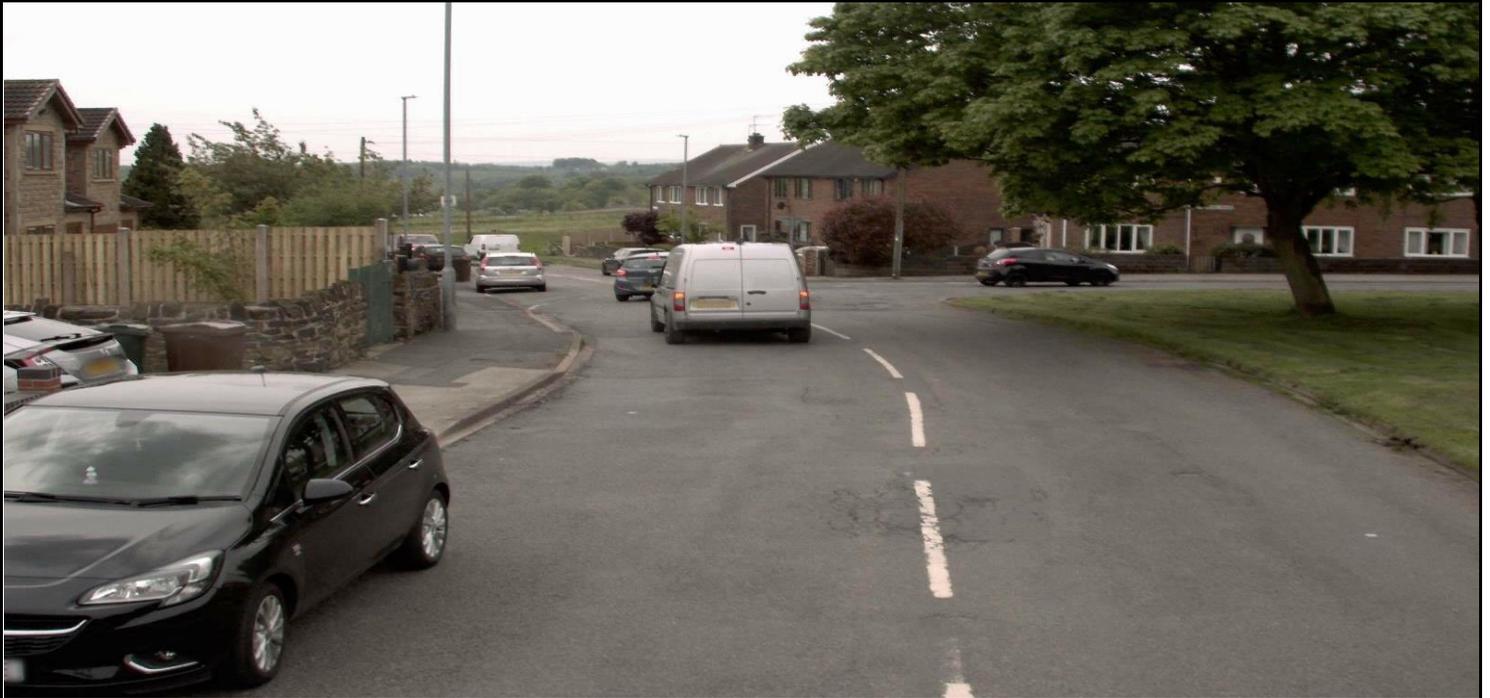
Chainage : 349m

Feature / Defect : Major Cracking

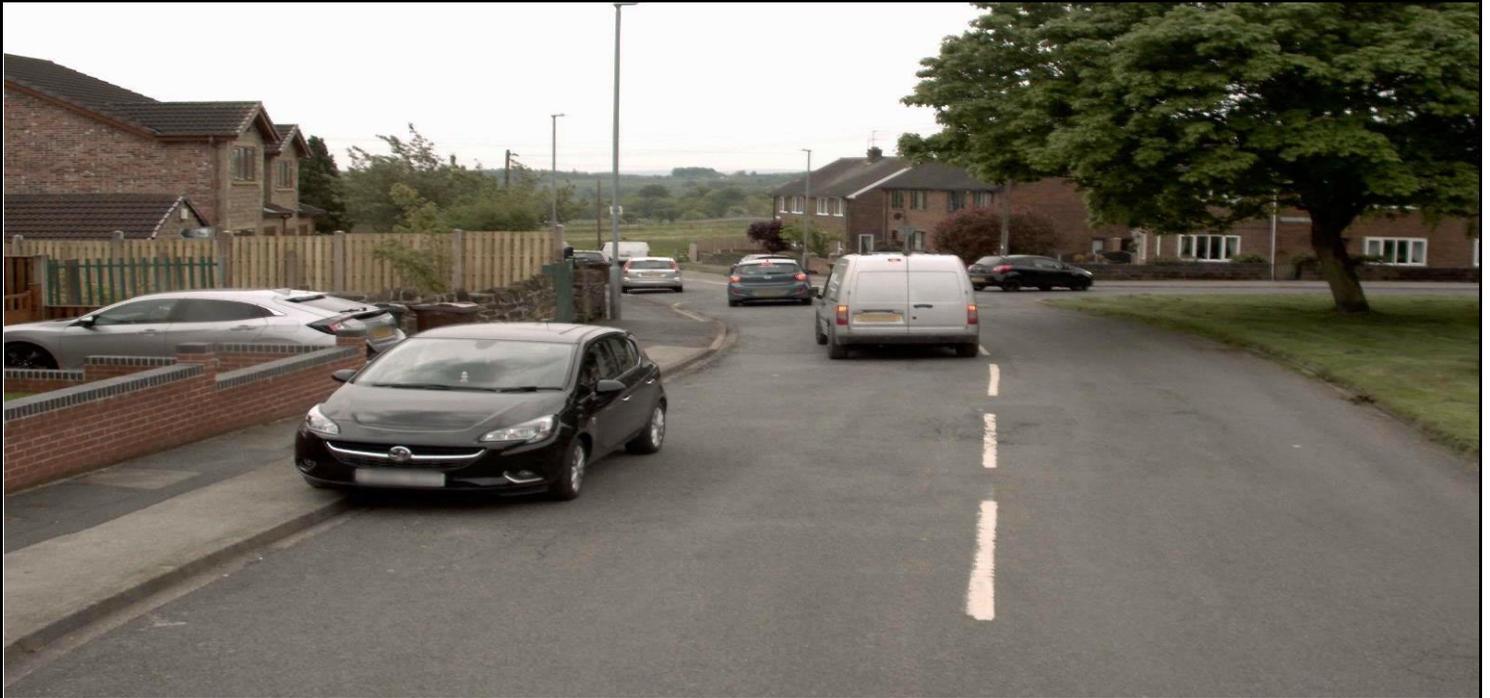
Chainage : 362m

Feature / Defect : Minor Cracking
