VCS Report

Project: Hoyland, Barnsley

Job No: PTS21335-01

This report describes the Visual Condition Survey of the Hoyland, Barnsley scheme. This can be identified on the site plan within Appendix A. The survey was undertaken in June 2021 in the daytime using a HD resolution video survey.

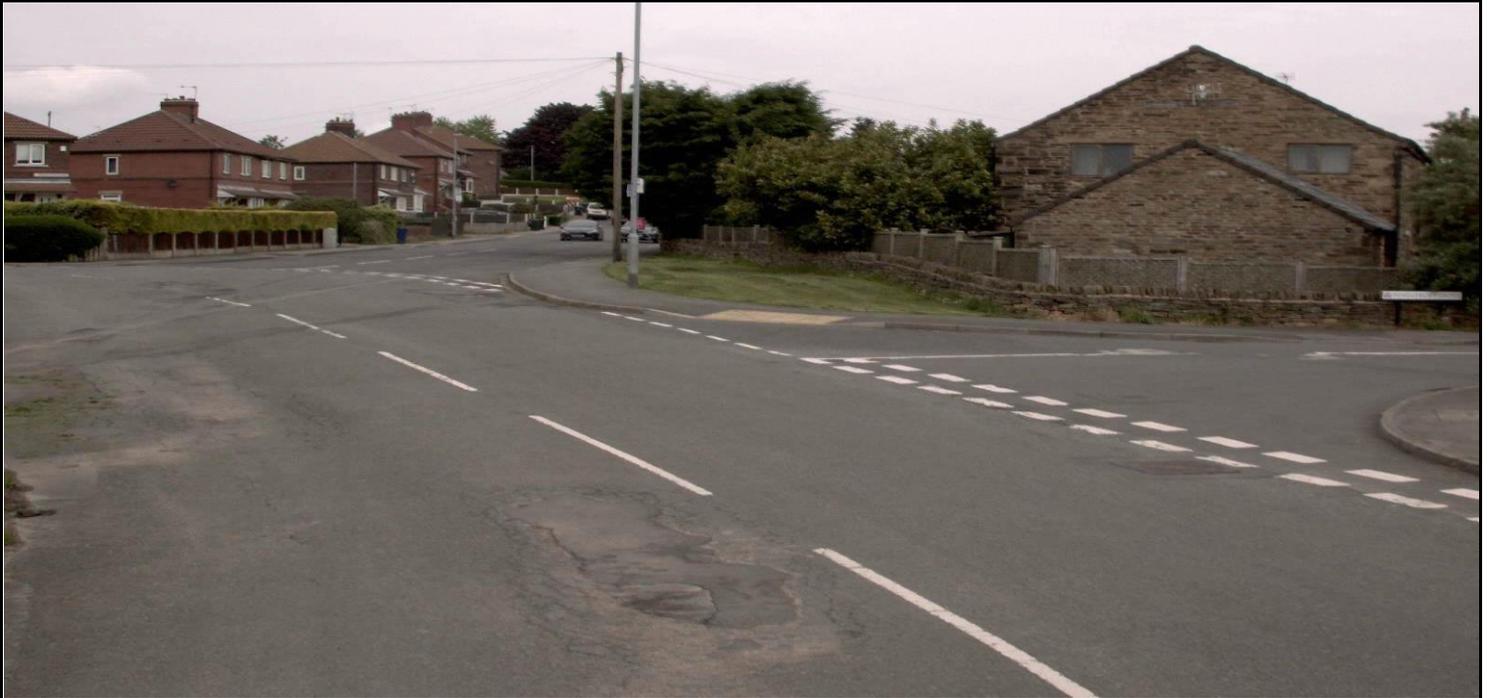
Chainage : 370m

Feature / Defect : Major Cracking

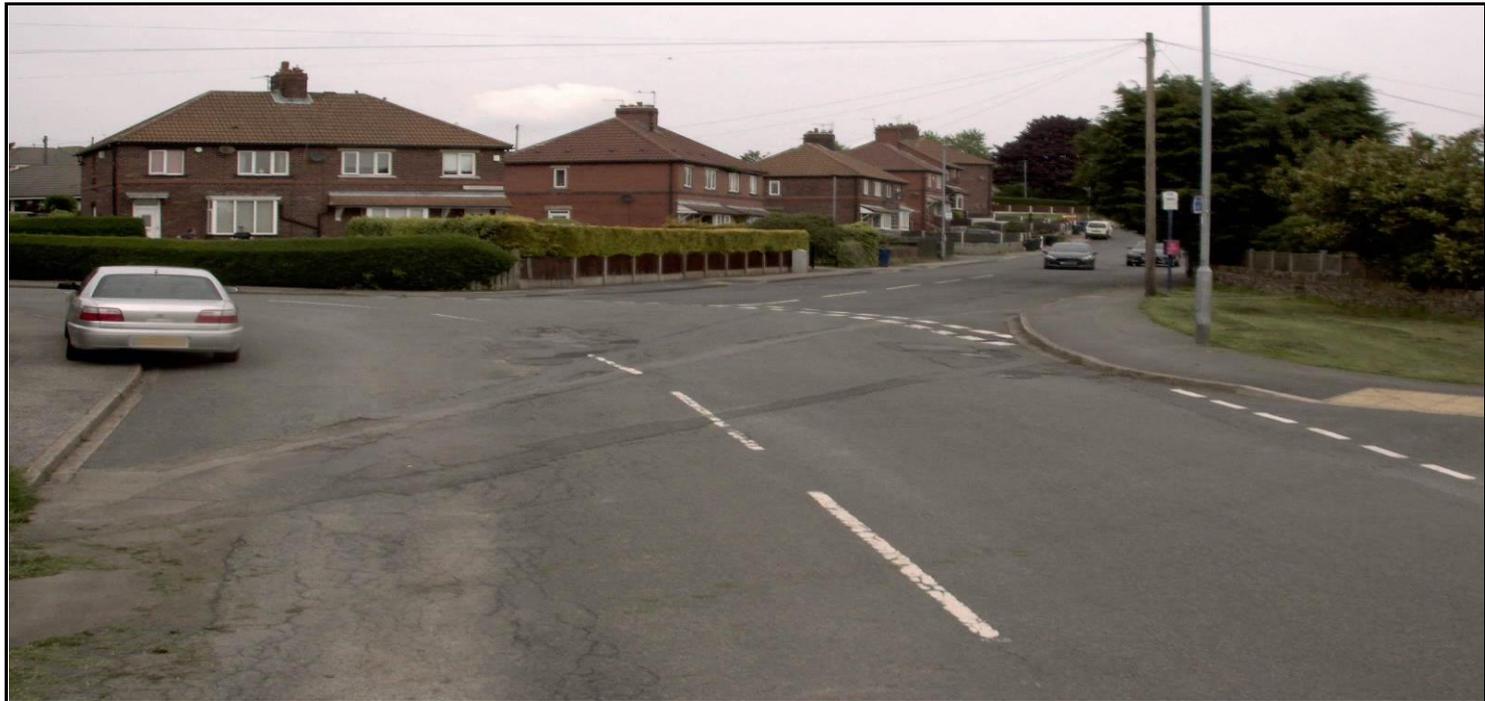
Photo Ref : 55	Section : Parkside Road
Chainage : 378m	Feature / Defect : Major Cracking

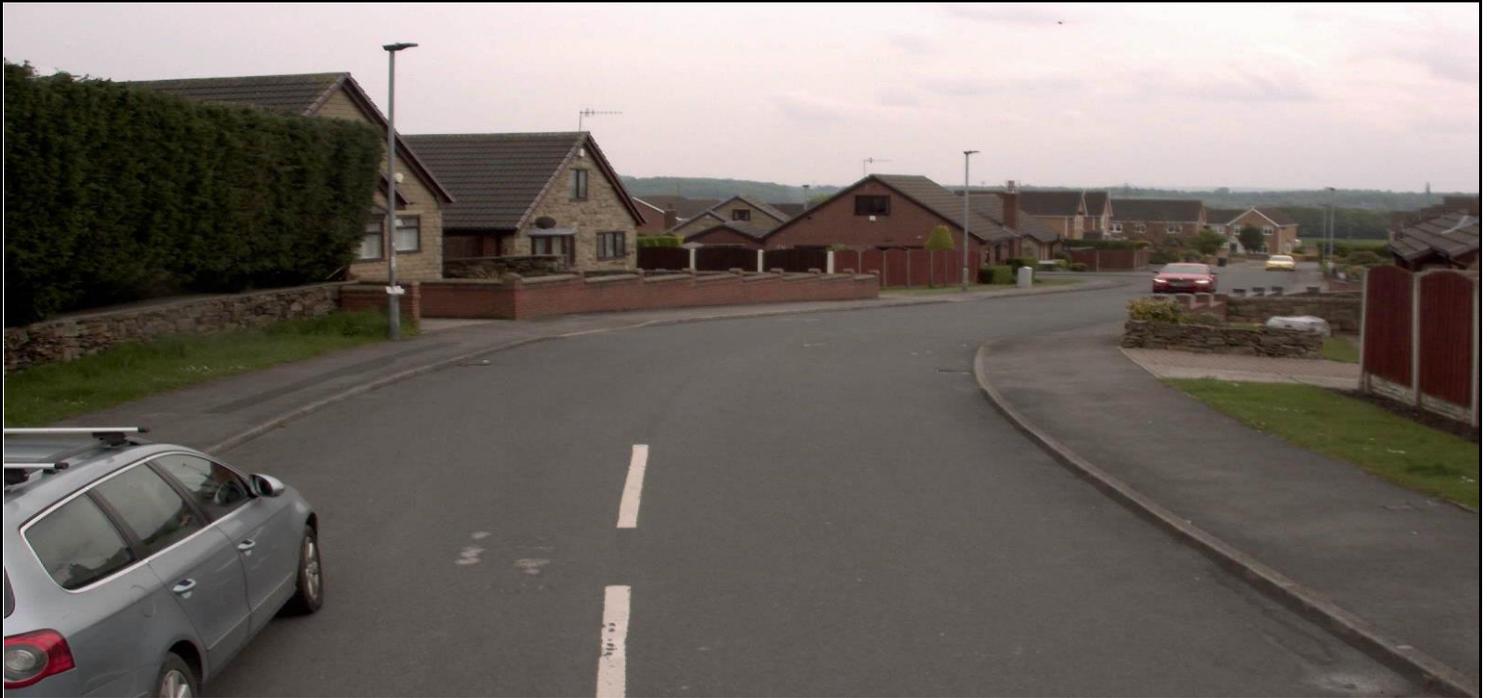
Photo Ref : 59	Section : Pendlebury Grove
Chainage : 17m	Feature / Defect : Major Surface Defectiveness

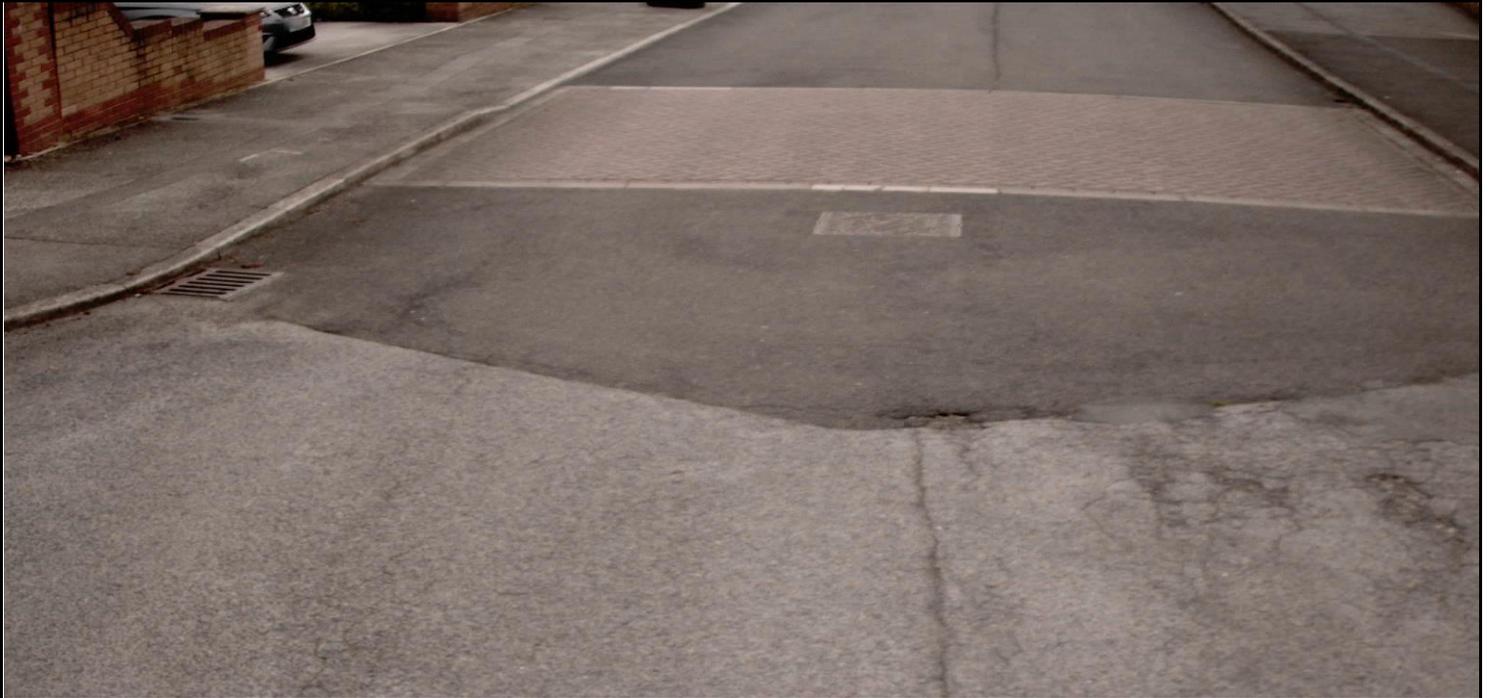
Feature / Defect : Major Cracking, Major Surface Defectiveness

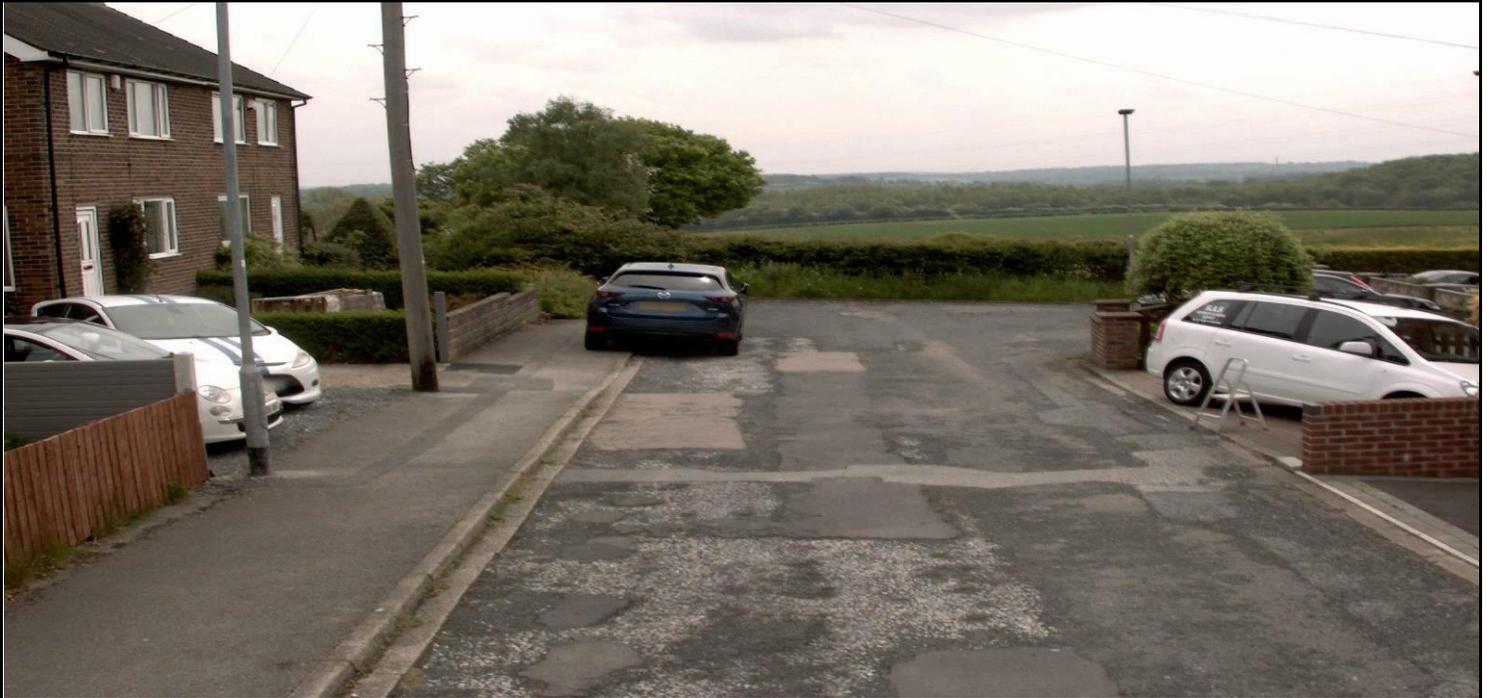
Feature / Defect : Major Surface Defectiveness

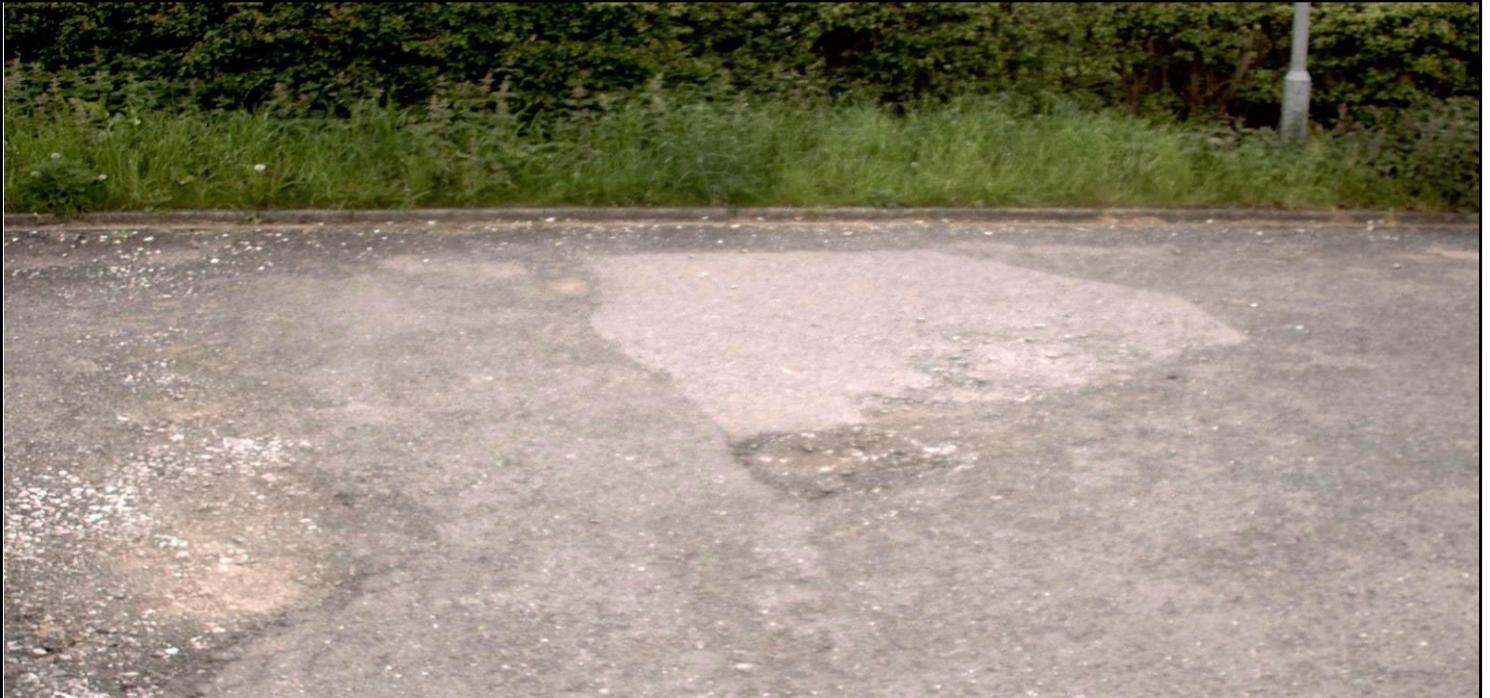
Feature / Defect : Major Surface Defectiveness

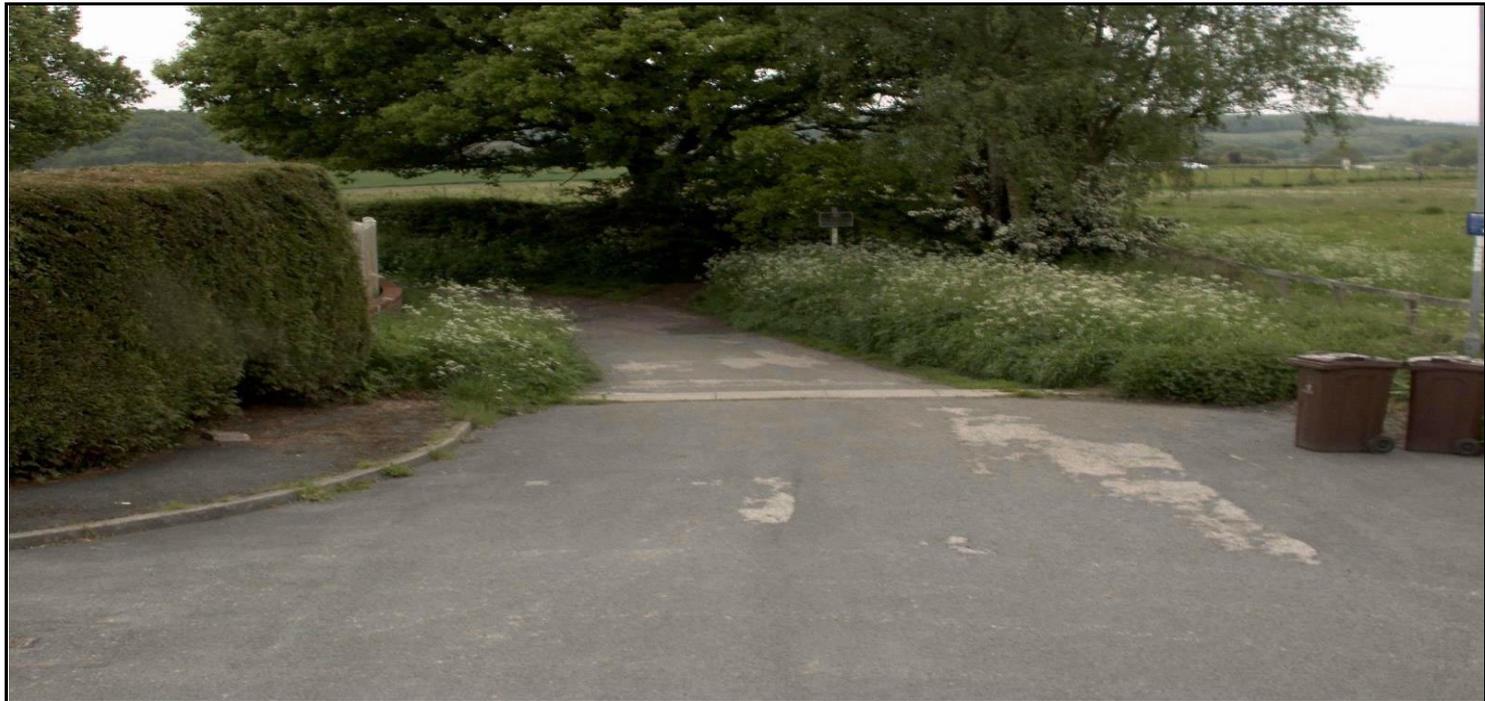
Photo Ref : 71	Section : Stead Lane
Chainage : 5m	Feature / Defect : Major Surface Defectiveness

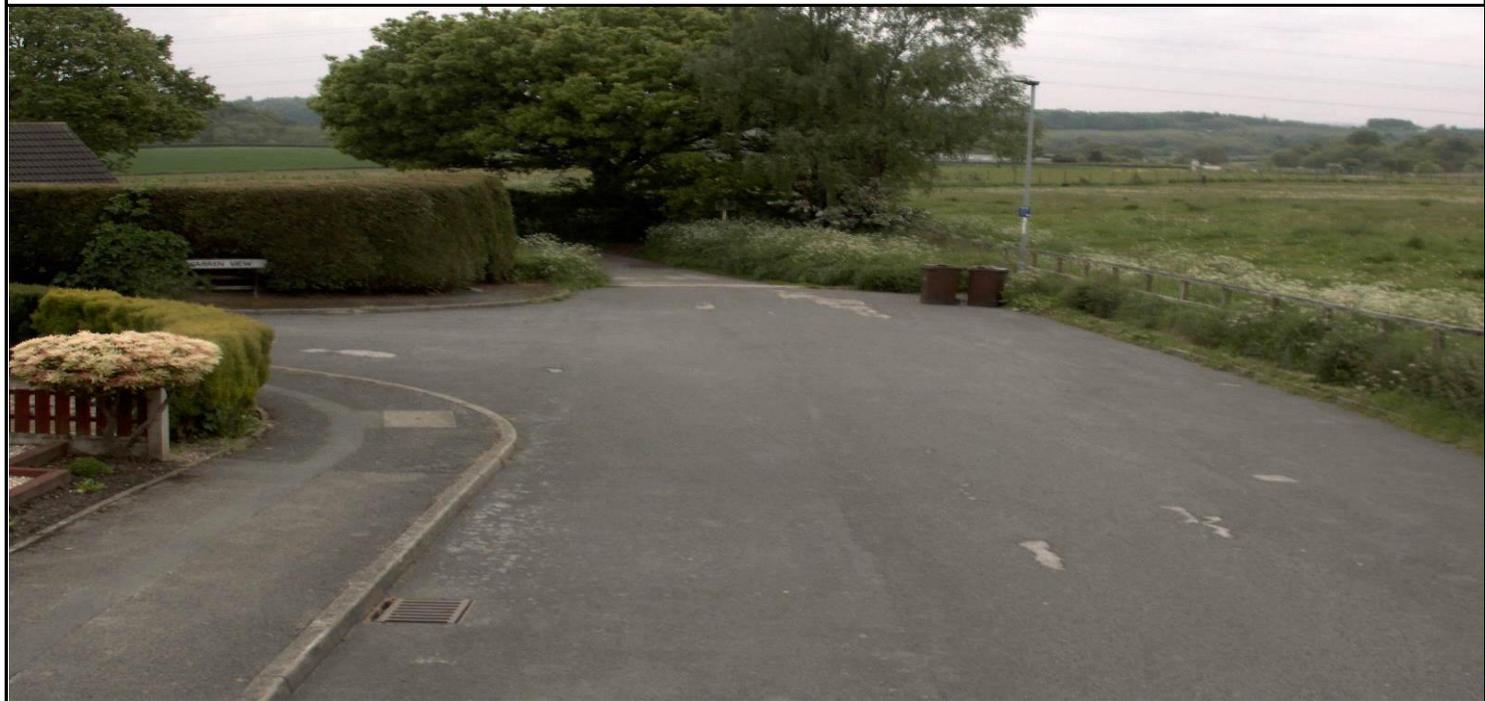
Photo Ref : 72	Section : Stead Lane
Chainage : 30m	Feature / Defect : Major Surface Defectiveness

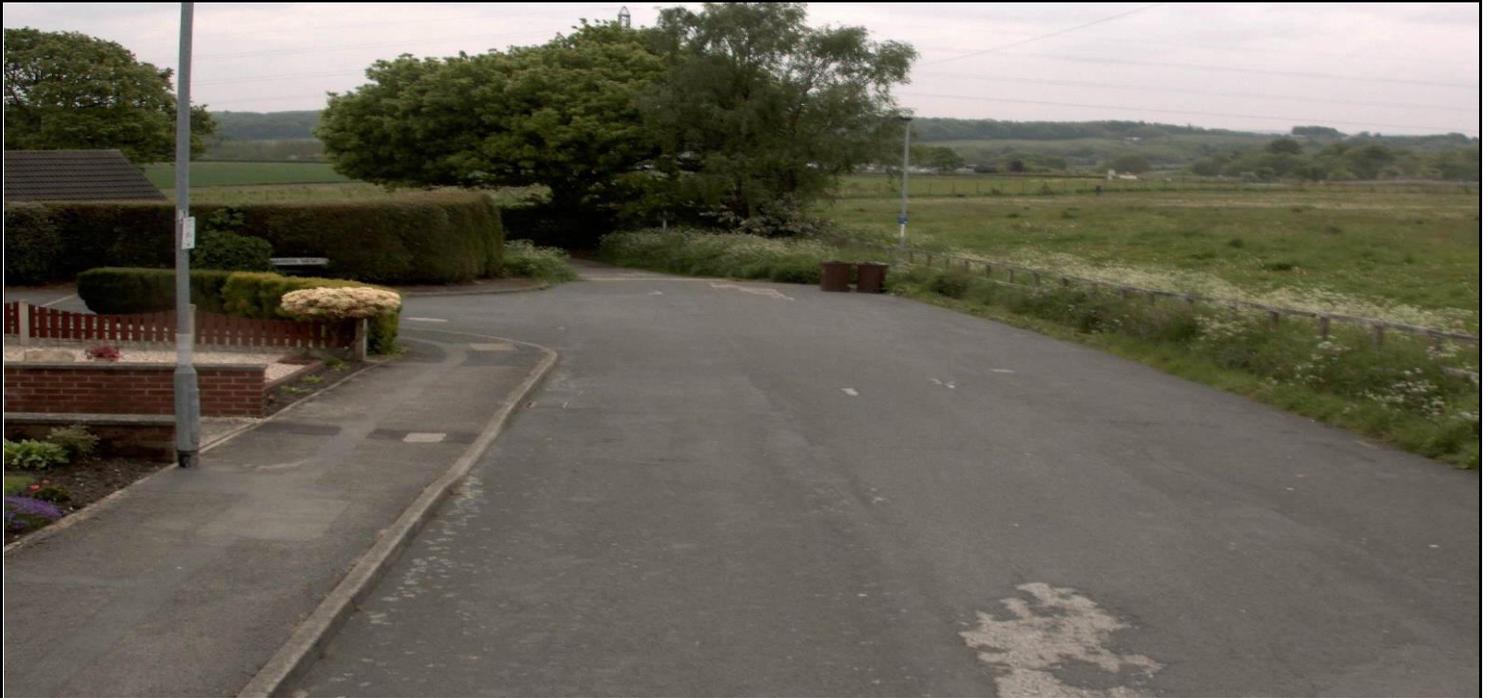
Photo Ref : 73	Section : Stead Lane
Chainage : 40m	Feature / Defect : Major Surface Defectiveness

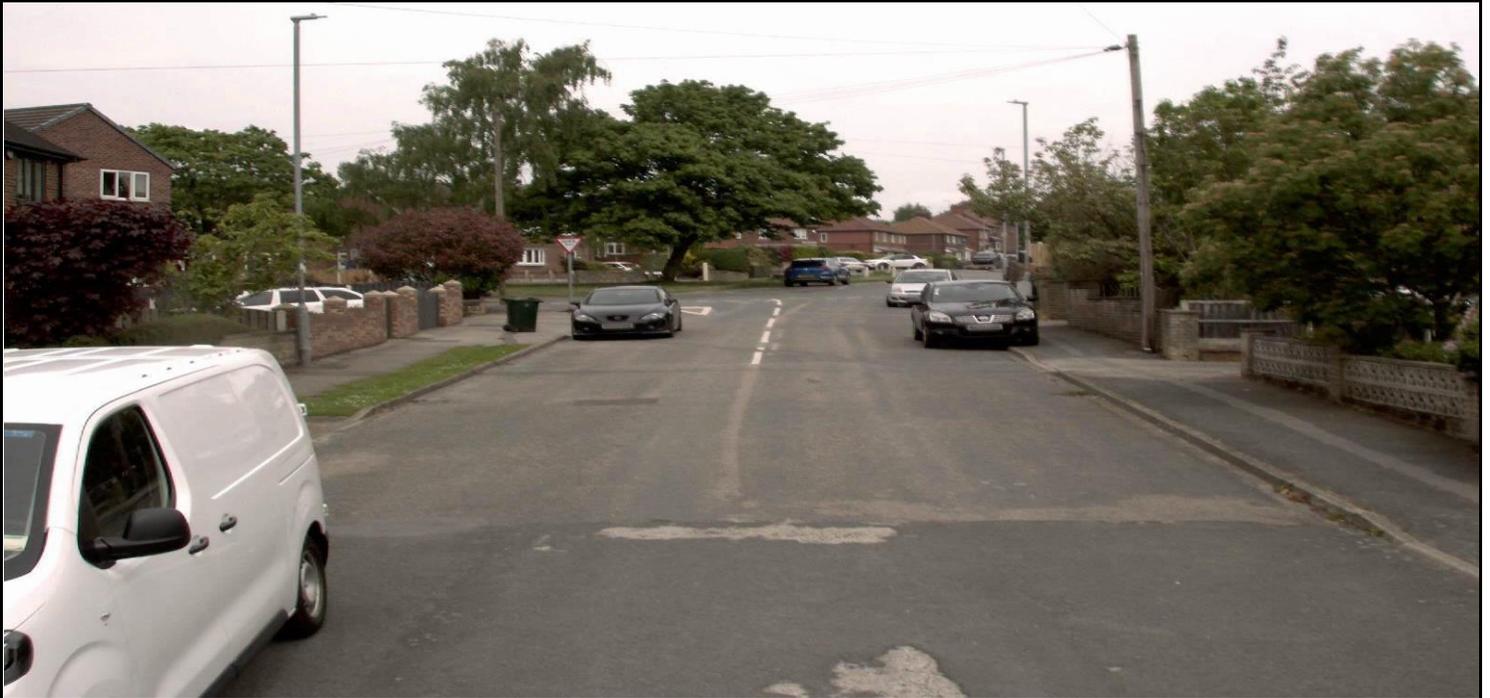
Feature / Defect : Major Surface Defectiveness

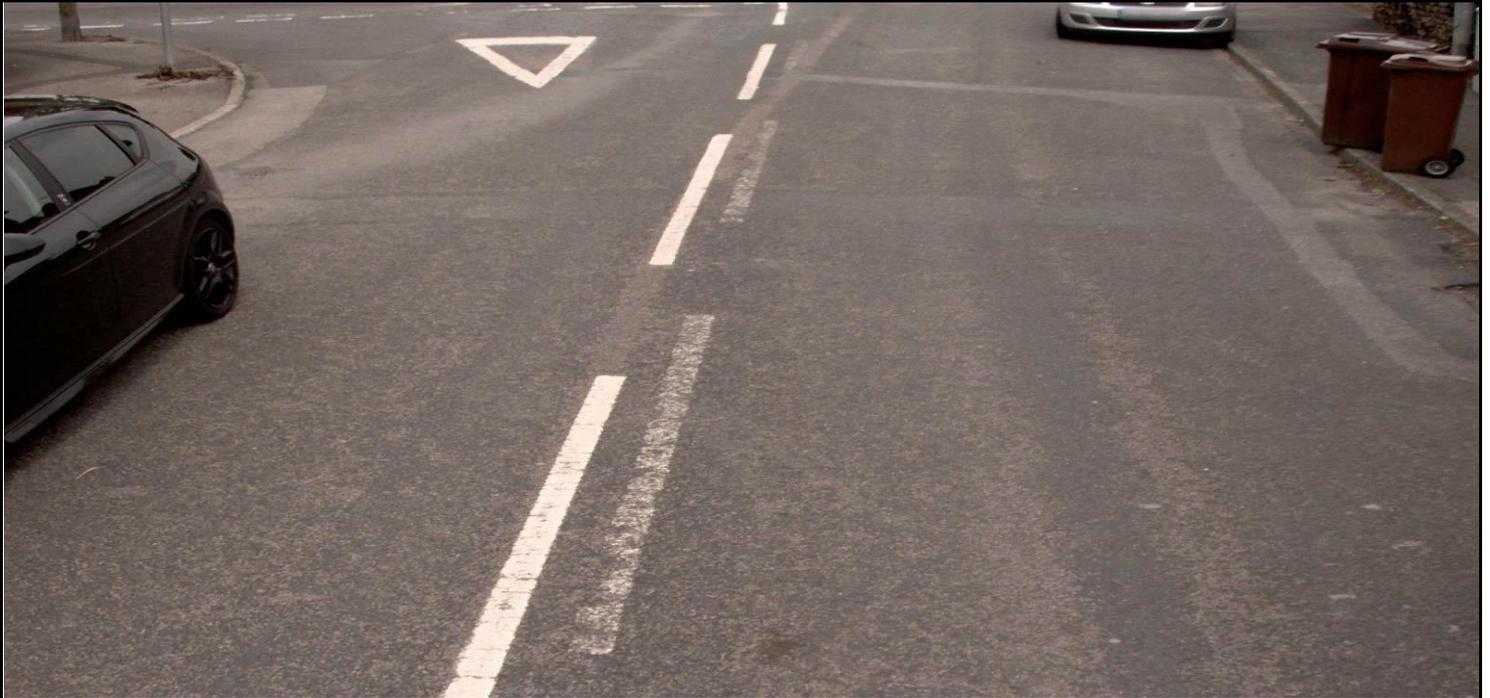
Feature / Defect : Minor Surface Defectiveness

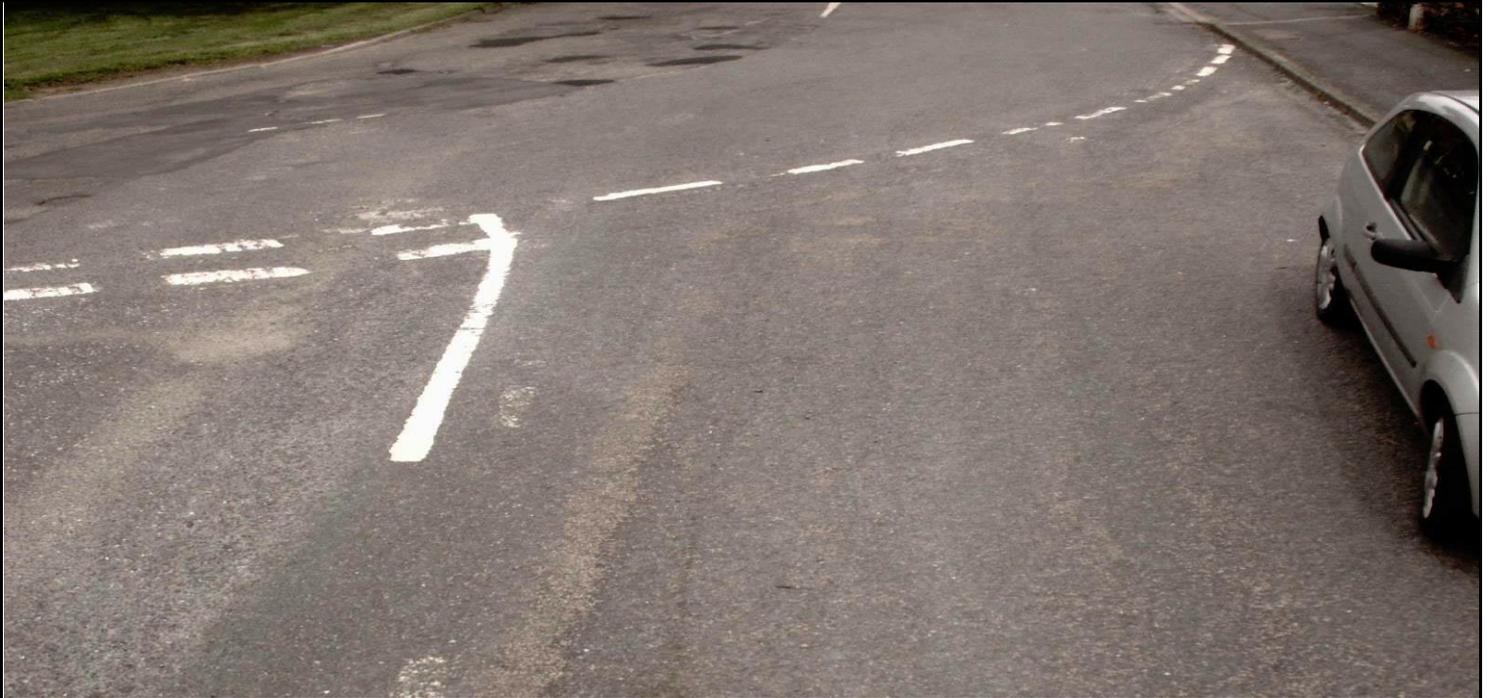
Feature / Defect : Minor Surface Defectiveness

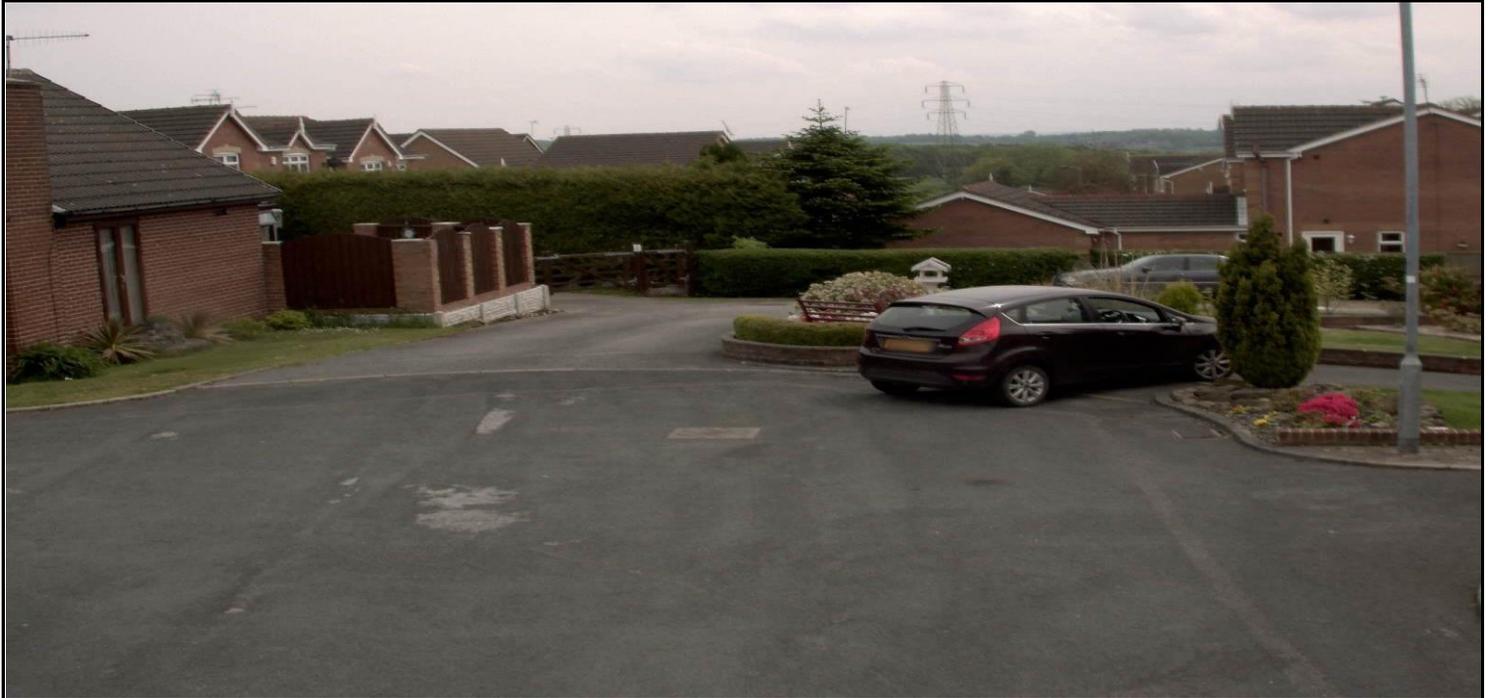
Photo Ref : 87	Section : Warren View
Chainage : 40m	Feature / Defect : Minor Surface Defectiveness, Major Surface Defectiveness

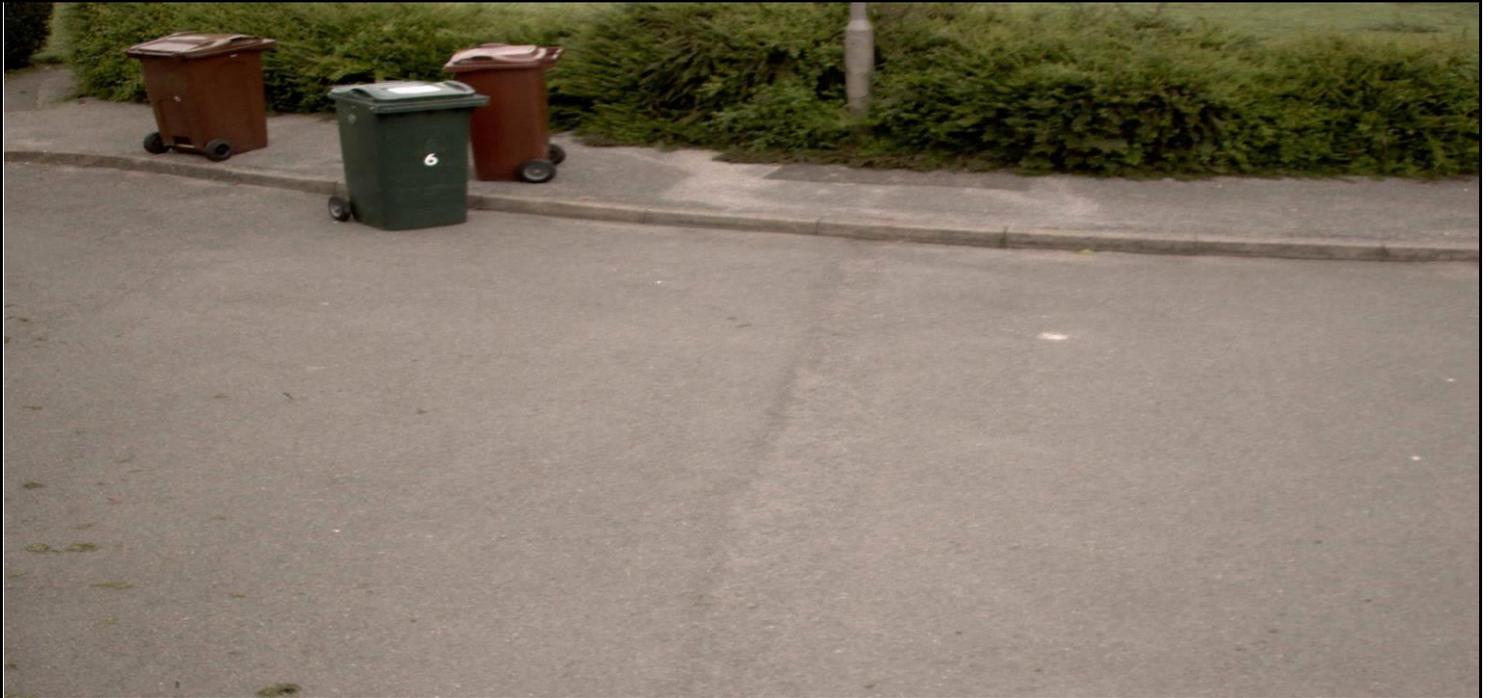
Feature / Defect : Minor Surface Defectiveness

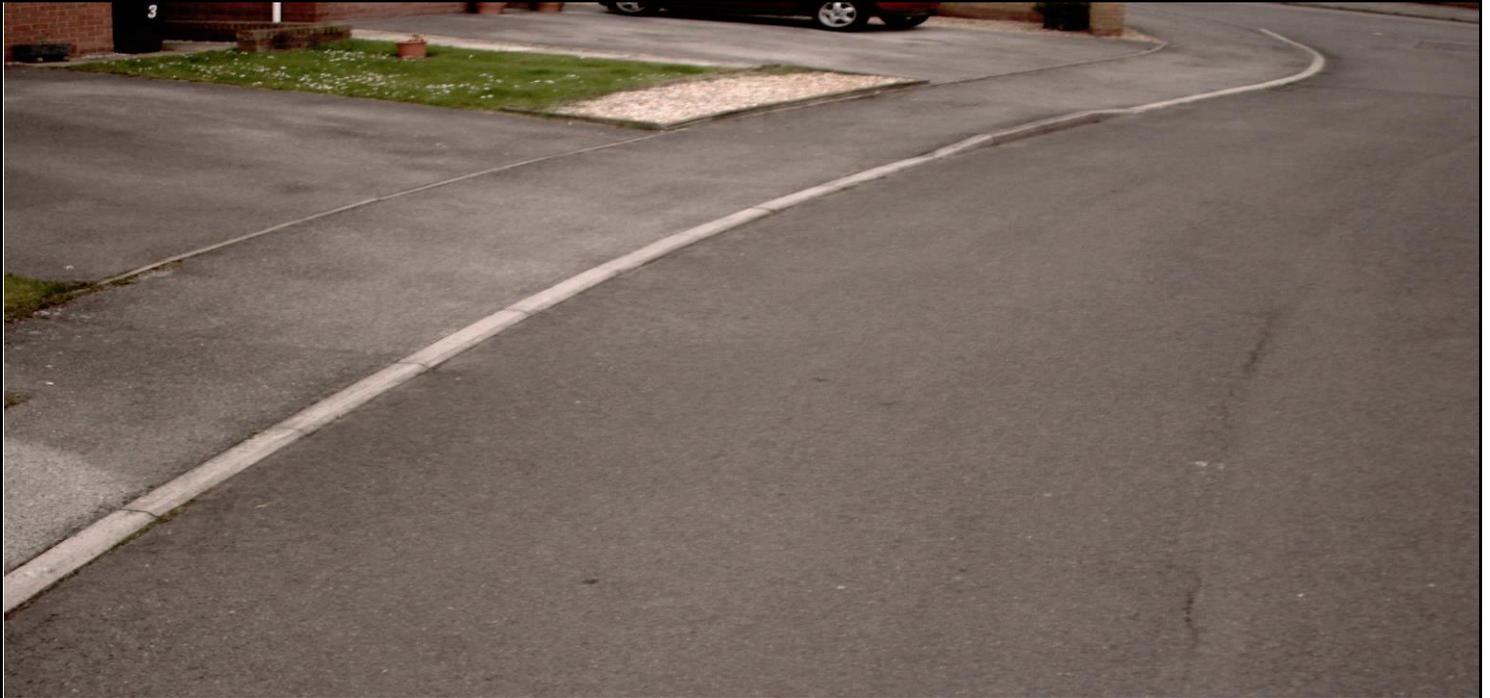
Feature / Defect : Minor Cracking

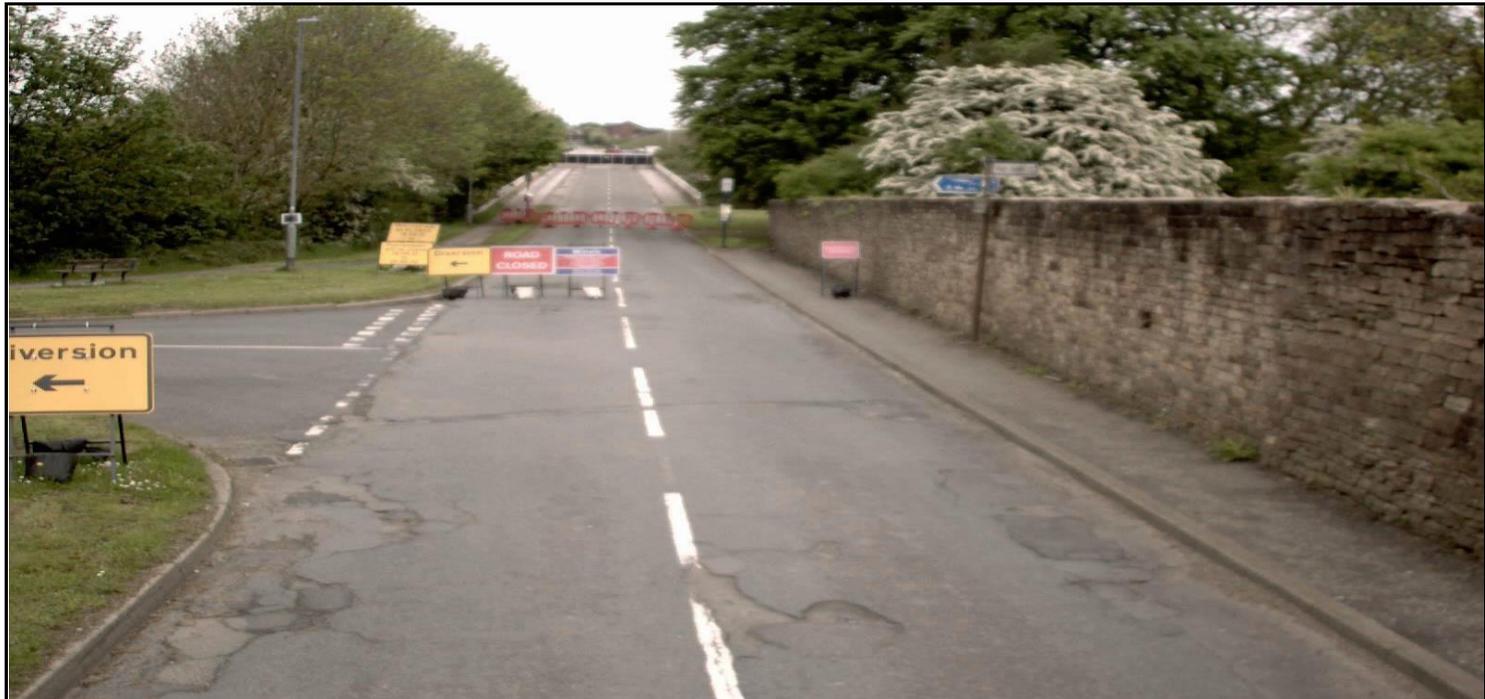
Photo Ref : 101	Section : Tankersley Lane
Chainage : 0m	Feature / Defect : Major Surface Defectiveness

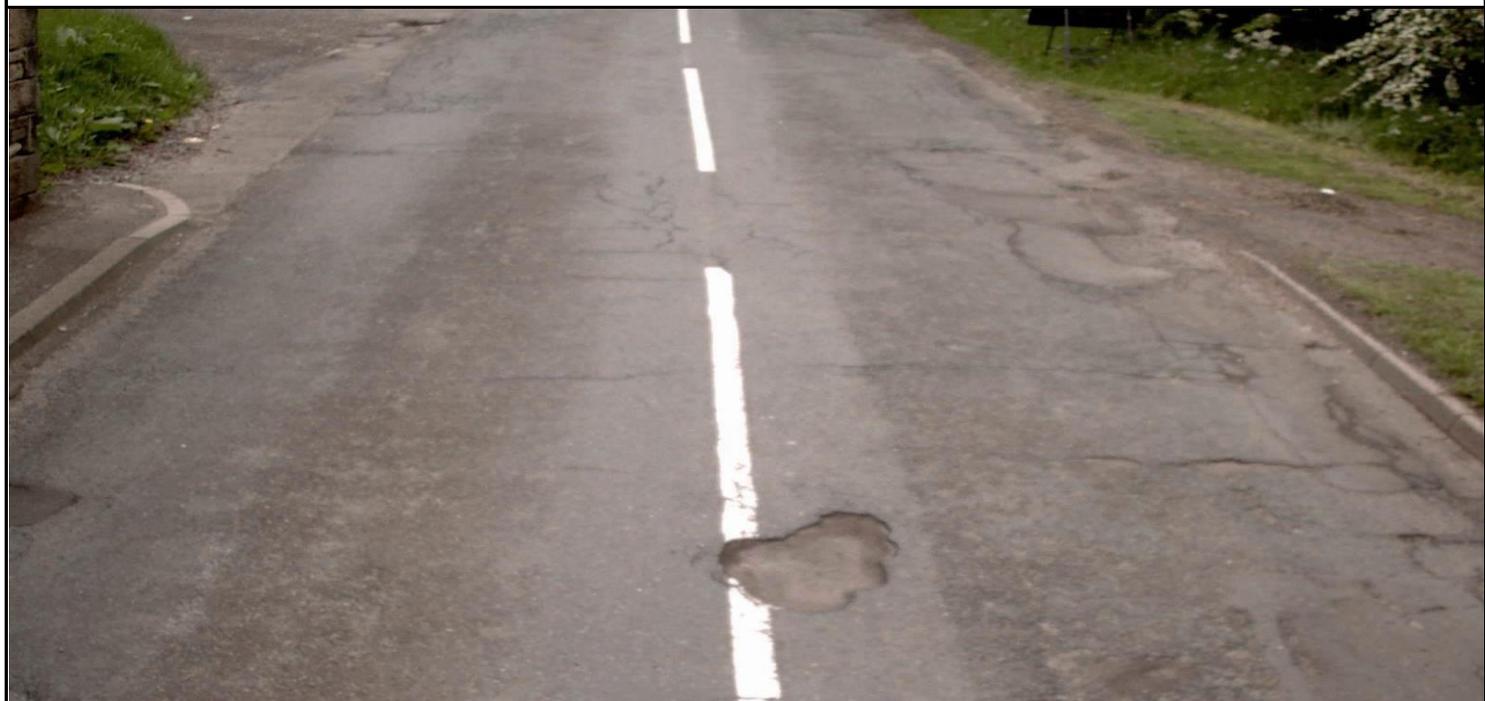
Photo Ref : 102	Section : Tankersley Lane
Chainage : 7m	Feature / Defect : Major Surface Defectiveness

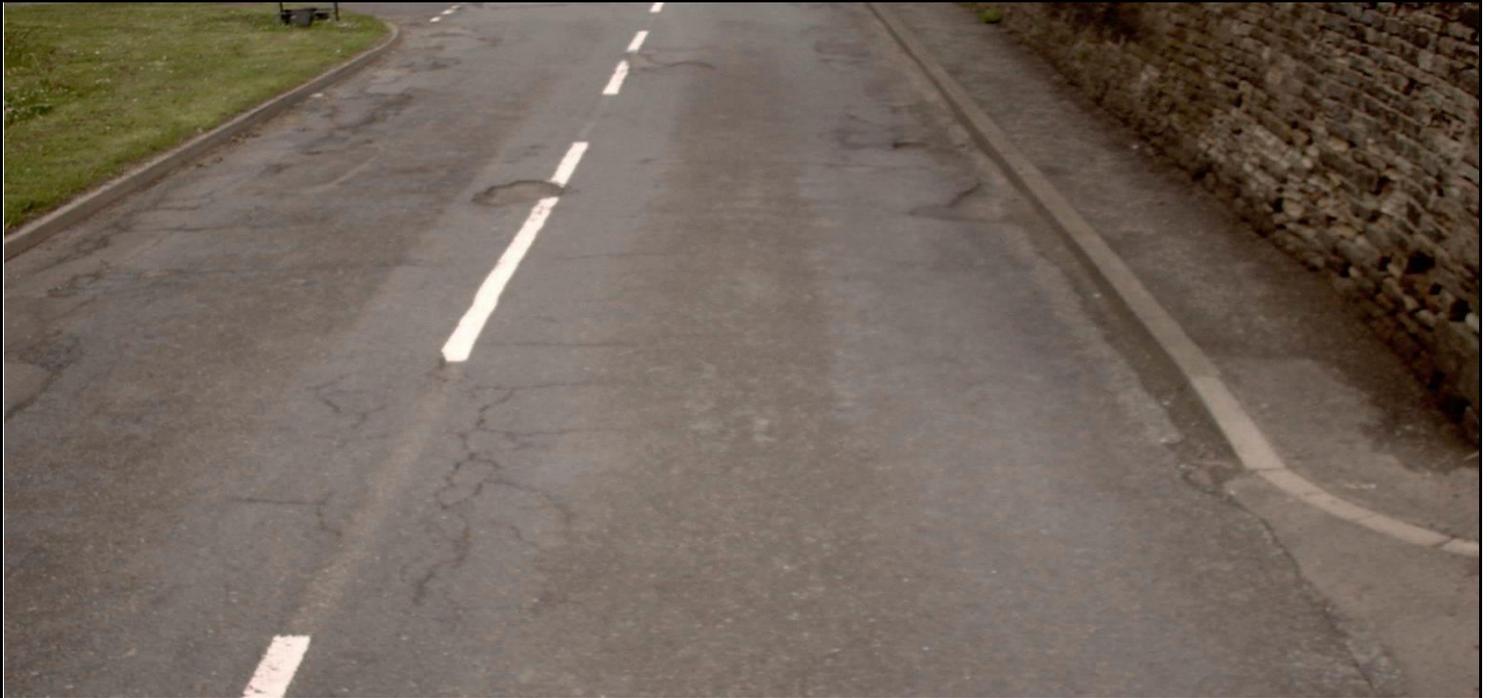
Photo Ref : 103	Section : Tankersley Lane
Chainage : 10m	Feature / Defect : Major Cracking

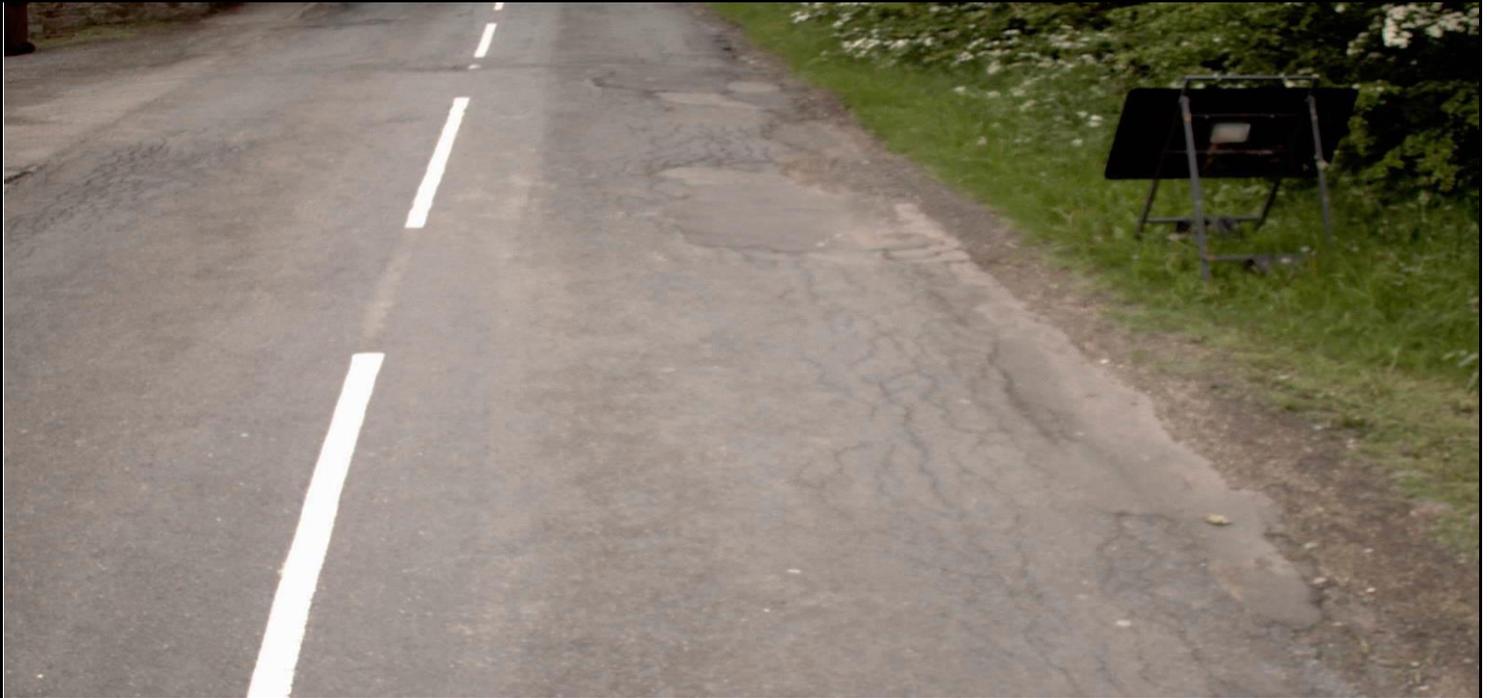
Feature / Defect : Minor Cracking

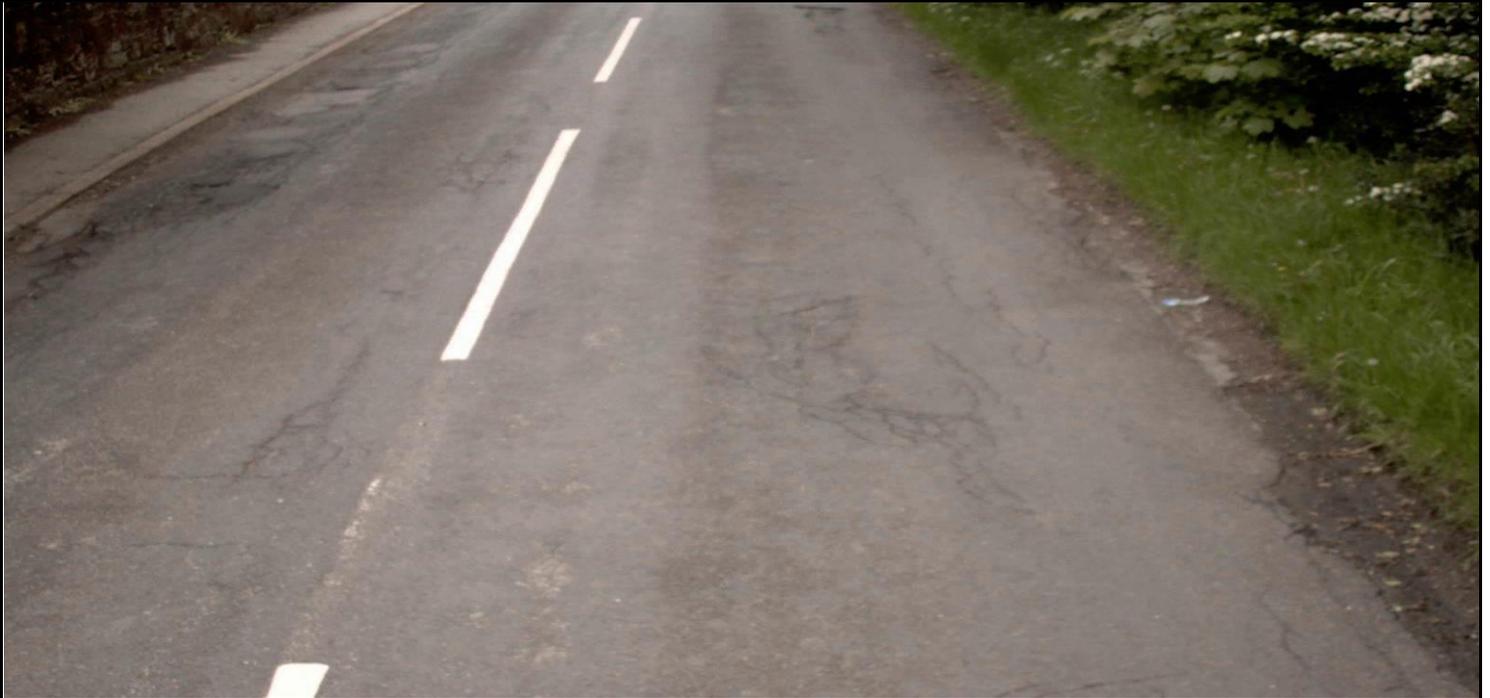
Feature / Defect : Major Cracking

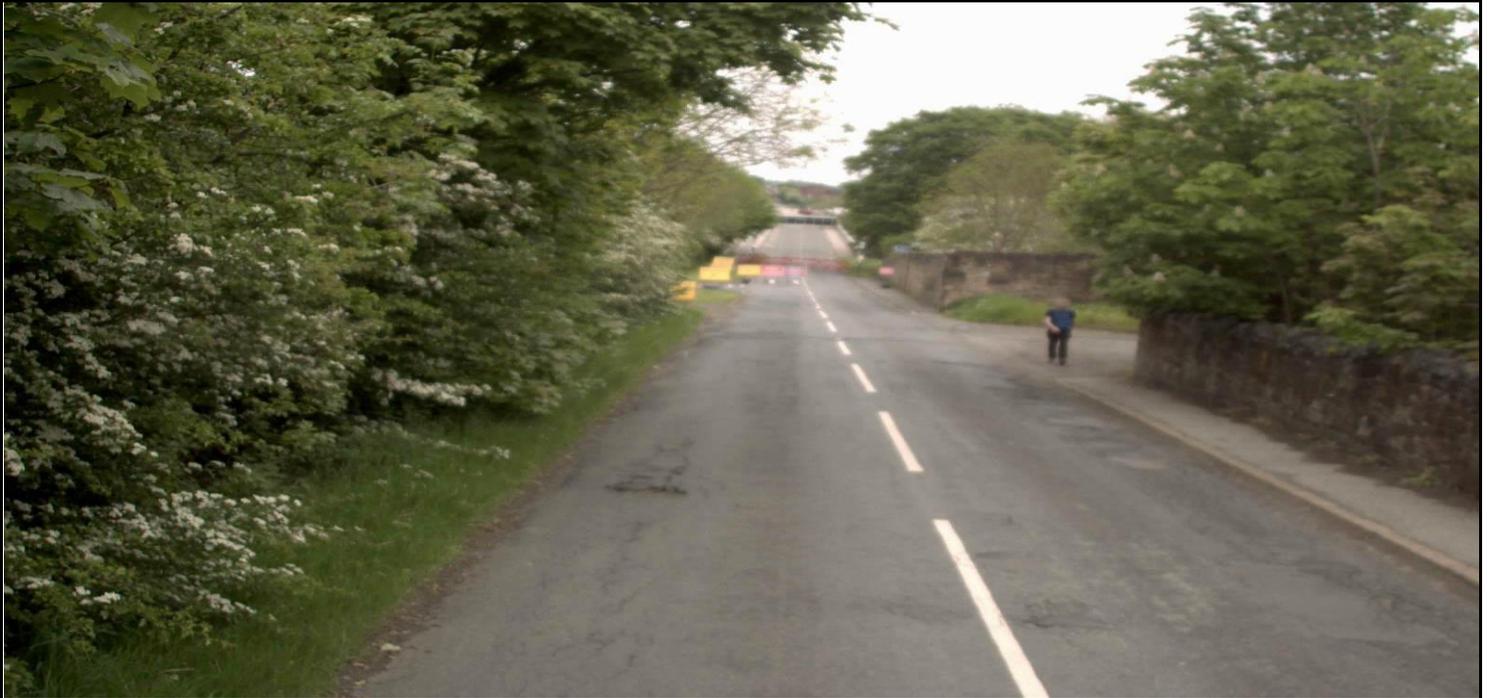
Feature / Defect : Minor Cracking

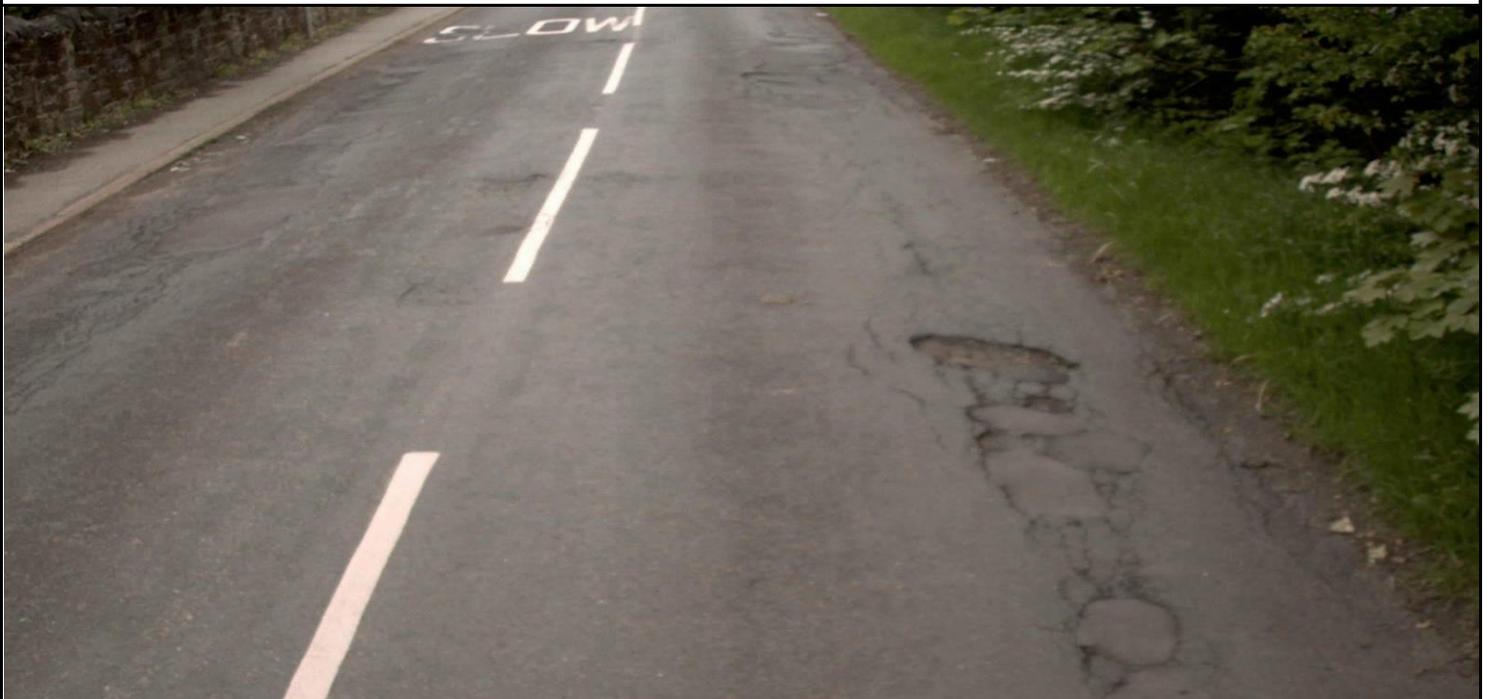
Feature / Defect : Major Surface Defectiveness
