VCS Report

Project: Hoyland, Barnsley

Job No: PTS21335-01

This report describes the Visual Condition Survey of the Hoyland, Barnsley scheme. This can be identified on the site plan within Appendix A. The survey was undertaken in June 2021 in the daytime using a HD resolution video survey.

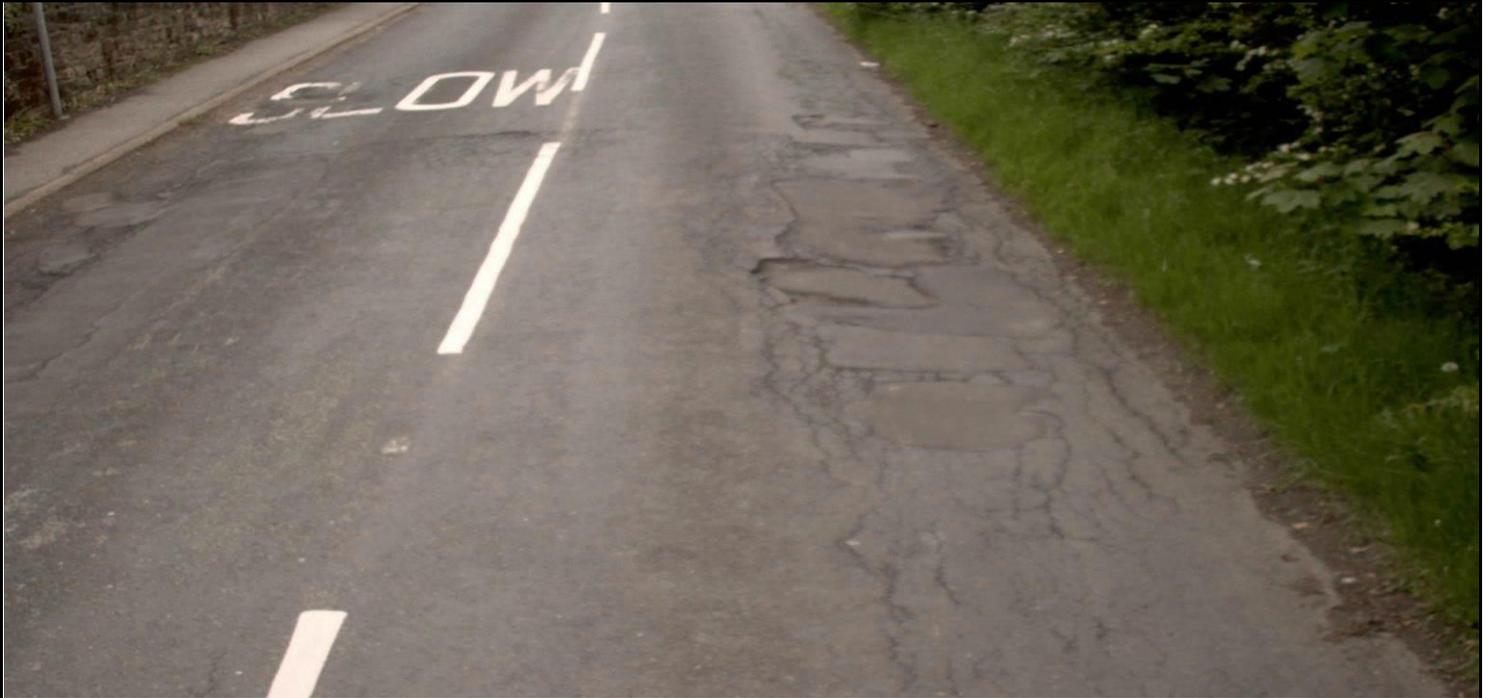
Feature / Defect : Major Cracking

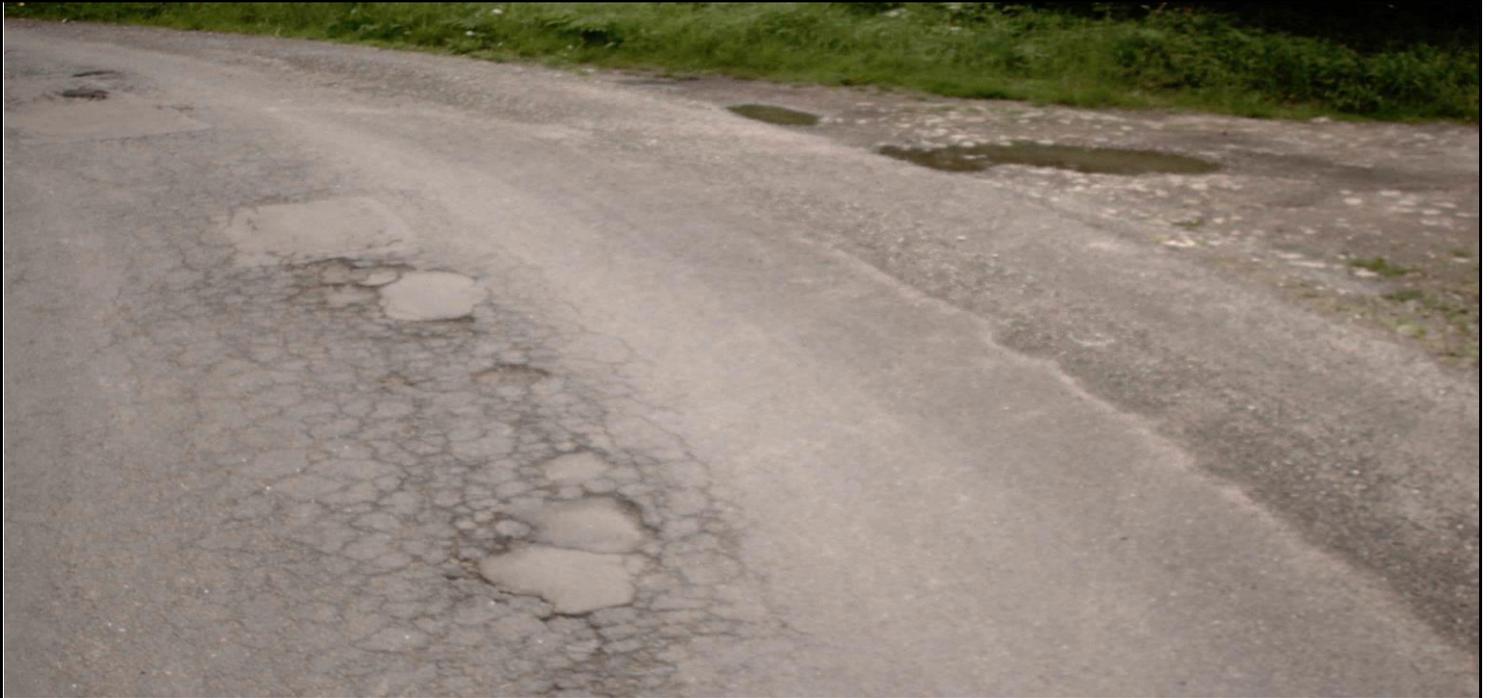
Feature / Defect : Major Cracking

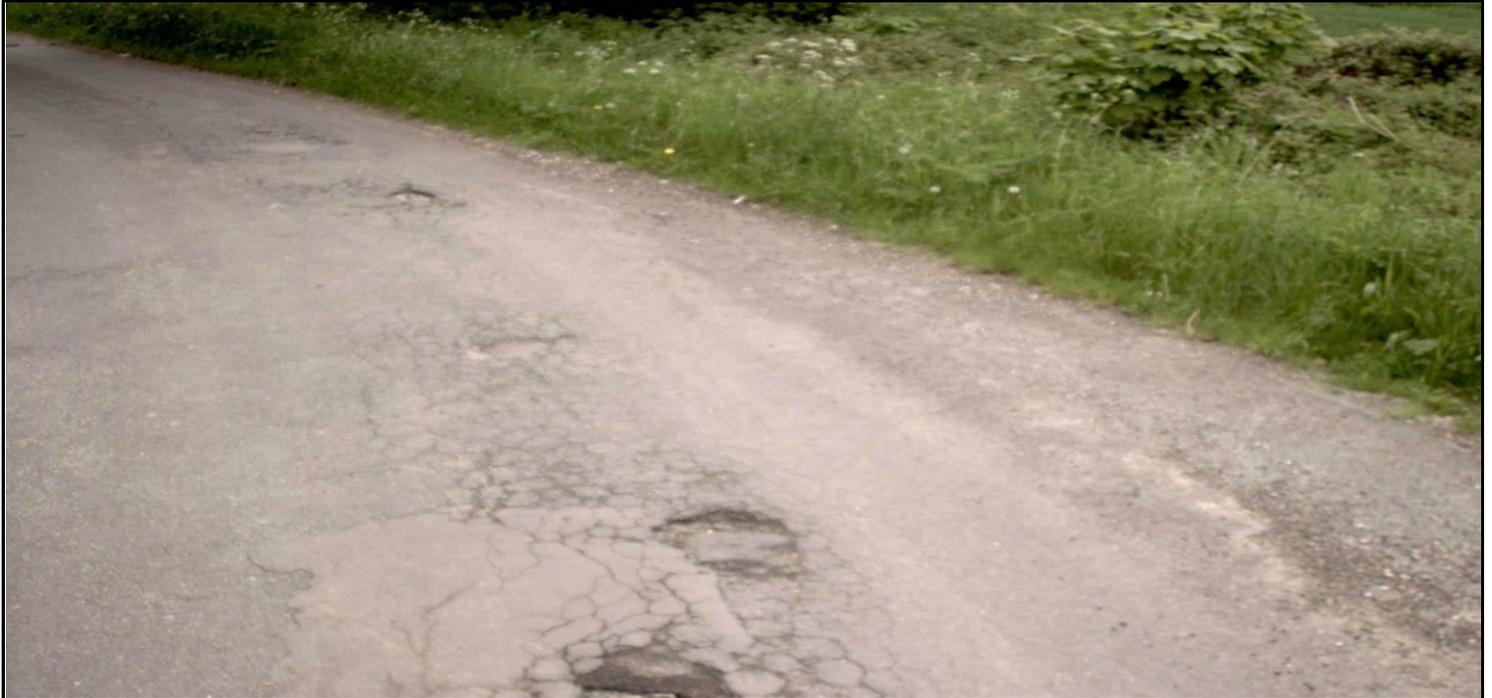
Photo Ref : 117	Section : Tankersley Lane
Chainage : 111m	Feature / Defect : Major Surface Defectiveness

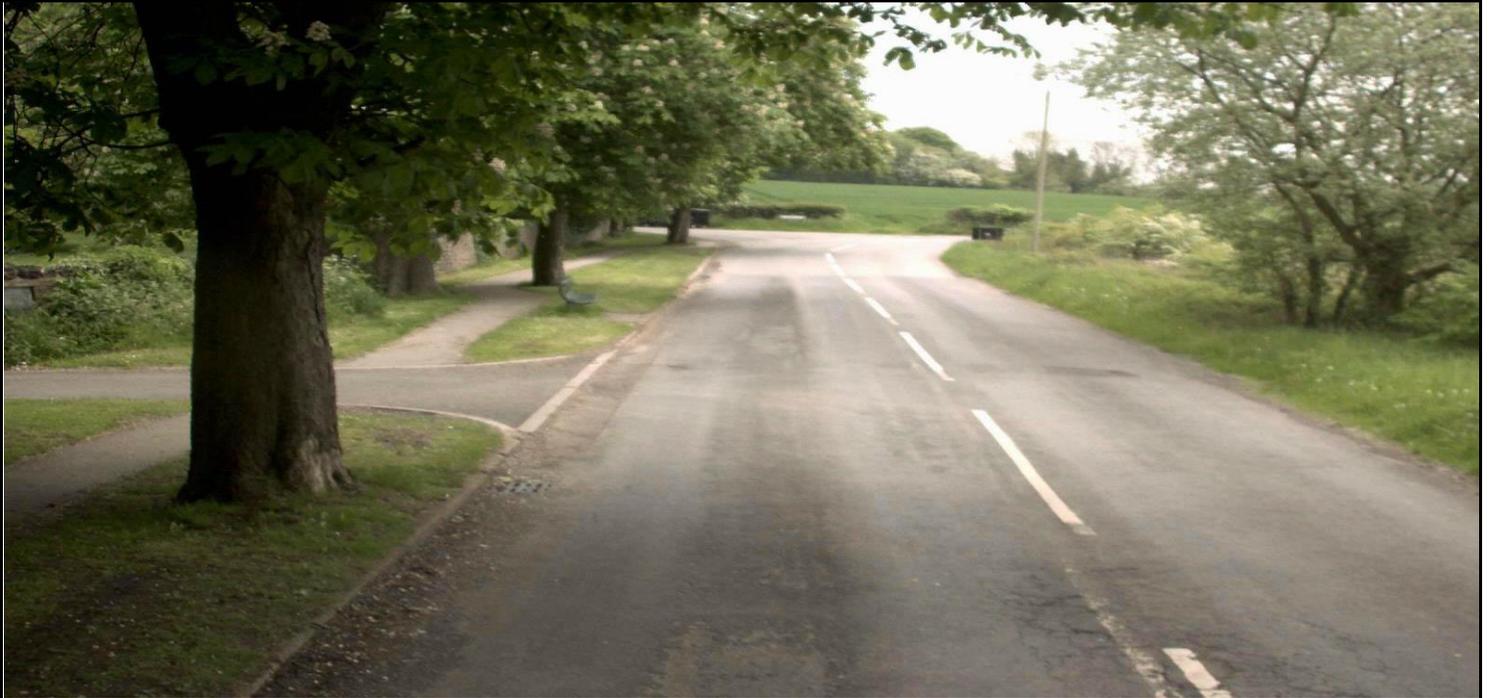
Feature / Defect : Major Cracking

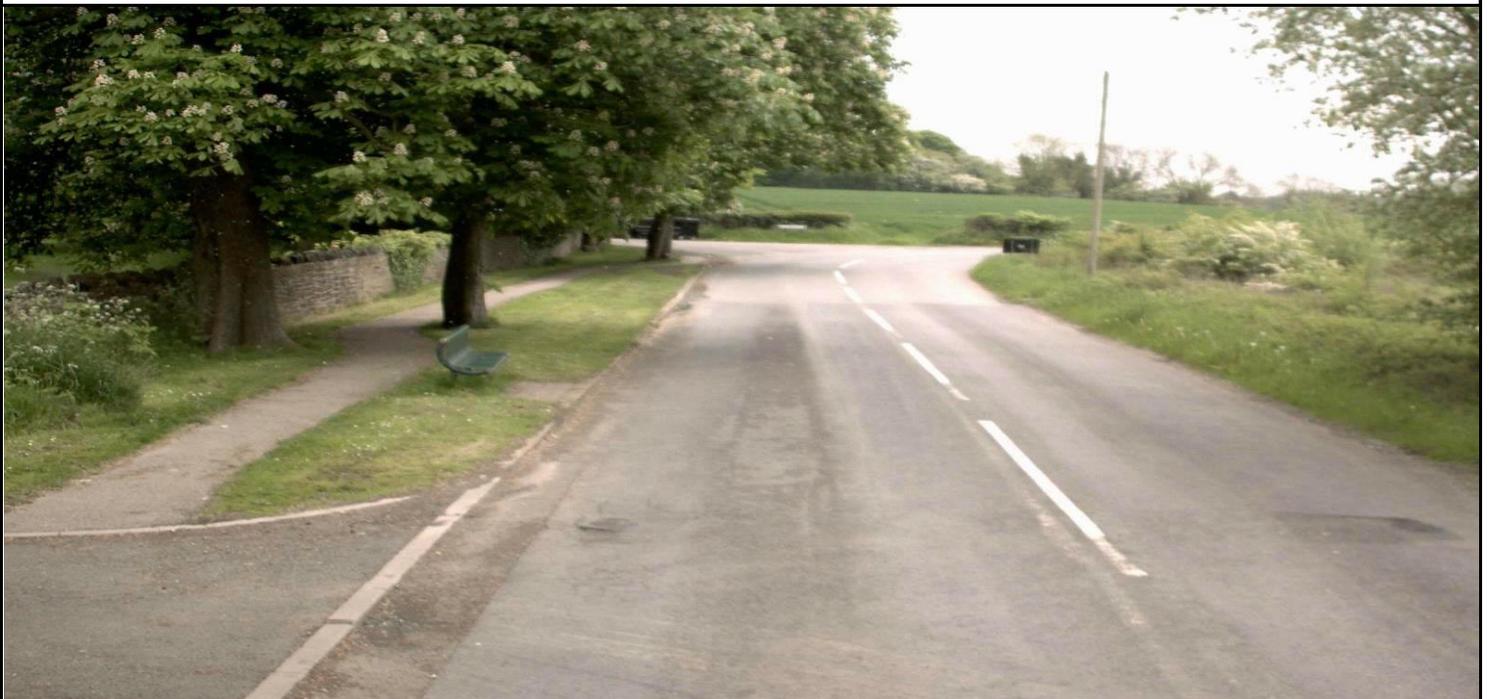
Feature / Defect : Minor Cracking

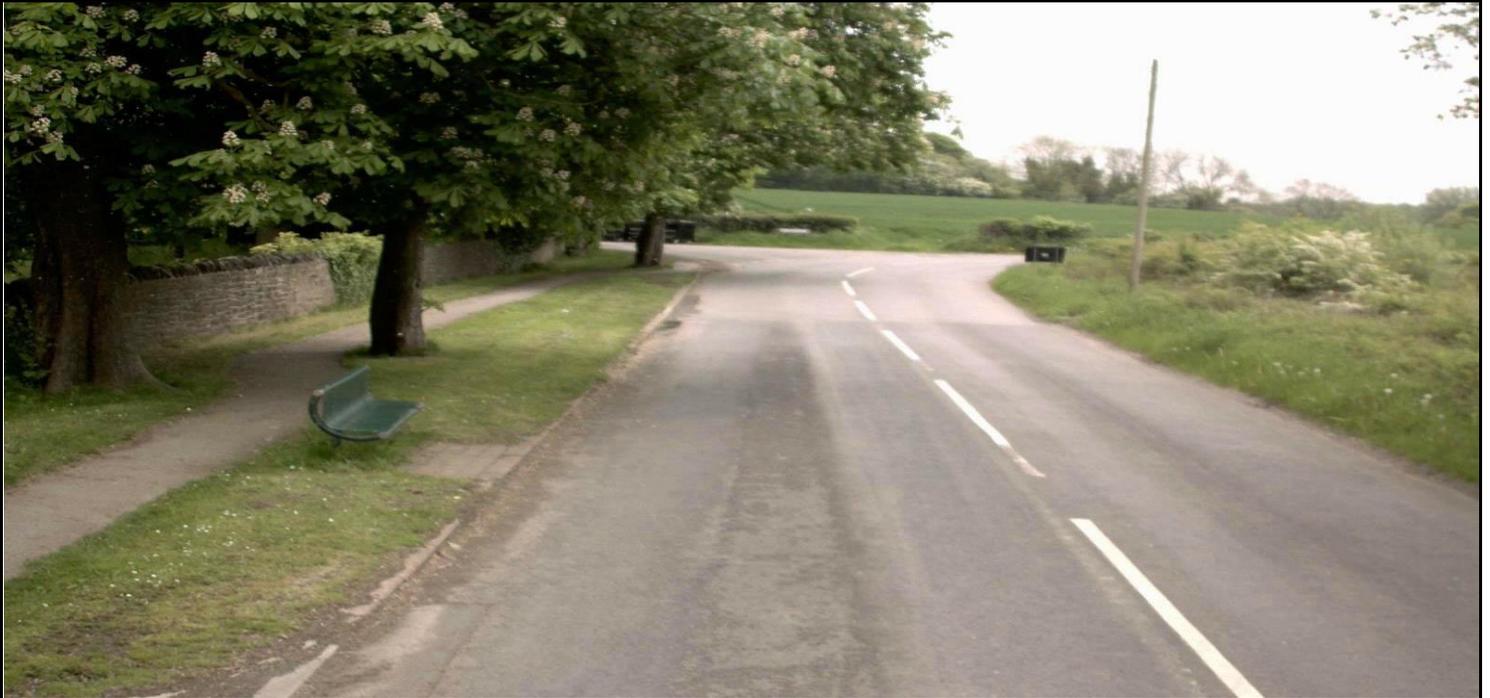
Feature / Defect : Minor Surface Defectiveness

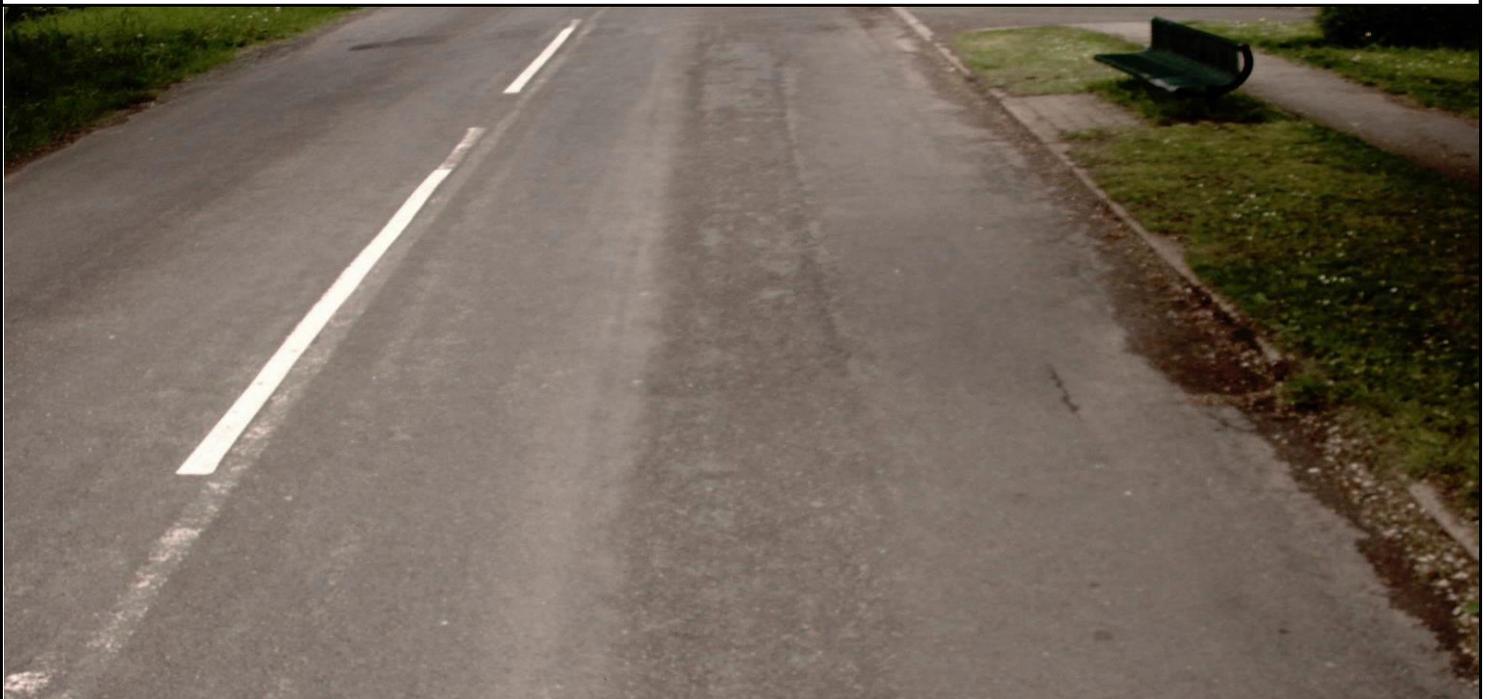
Feature / Defect : Major Cracking

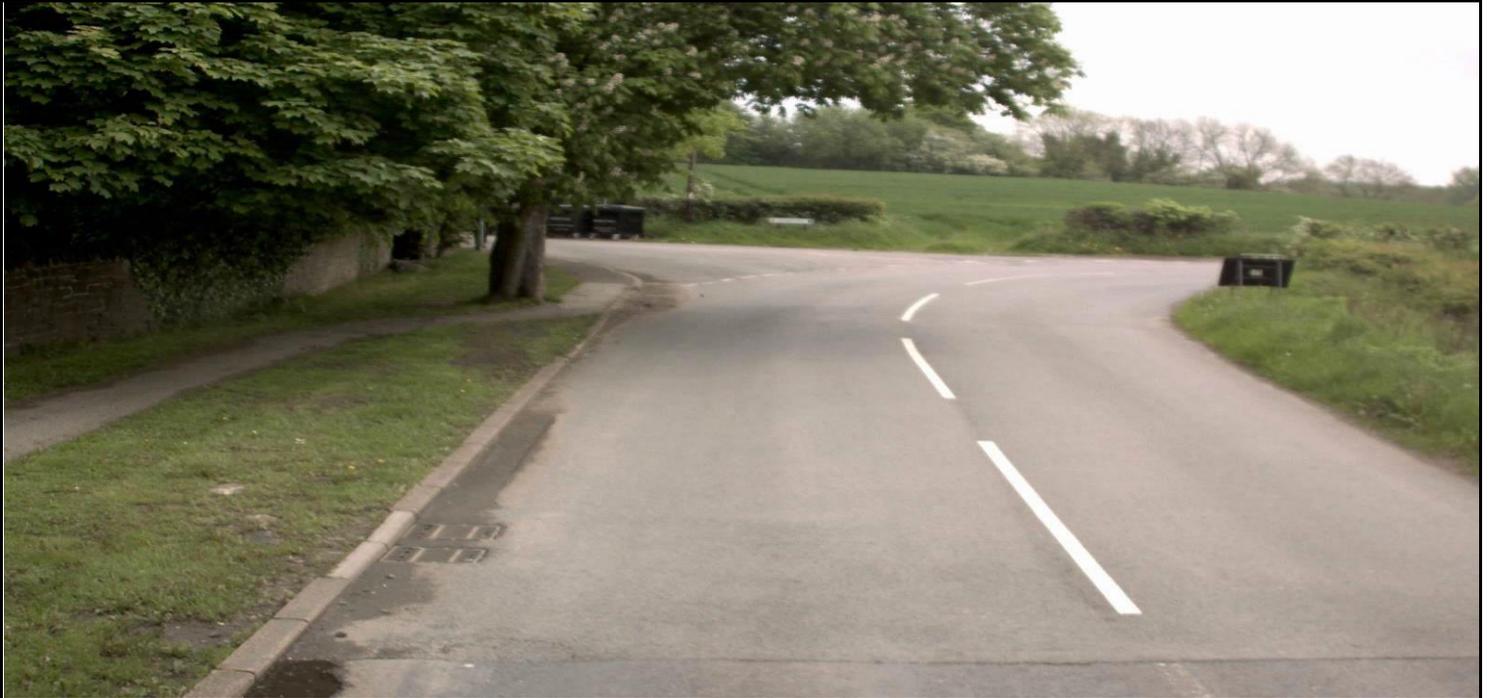
Feature / Defect : Minor Cracking

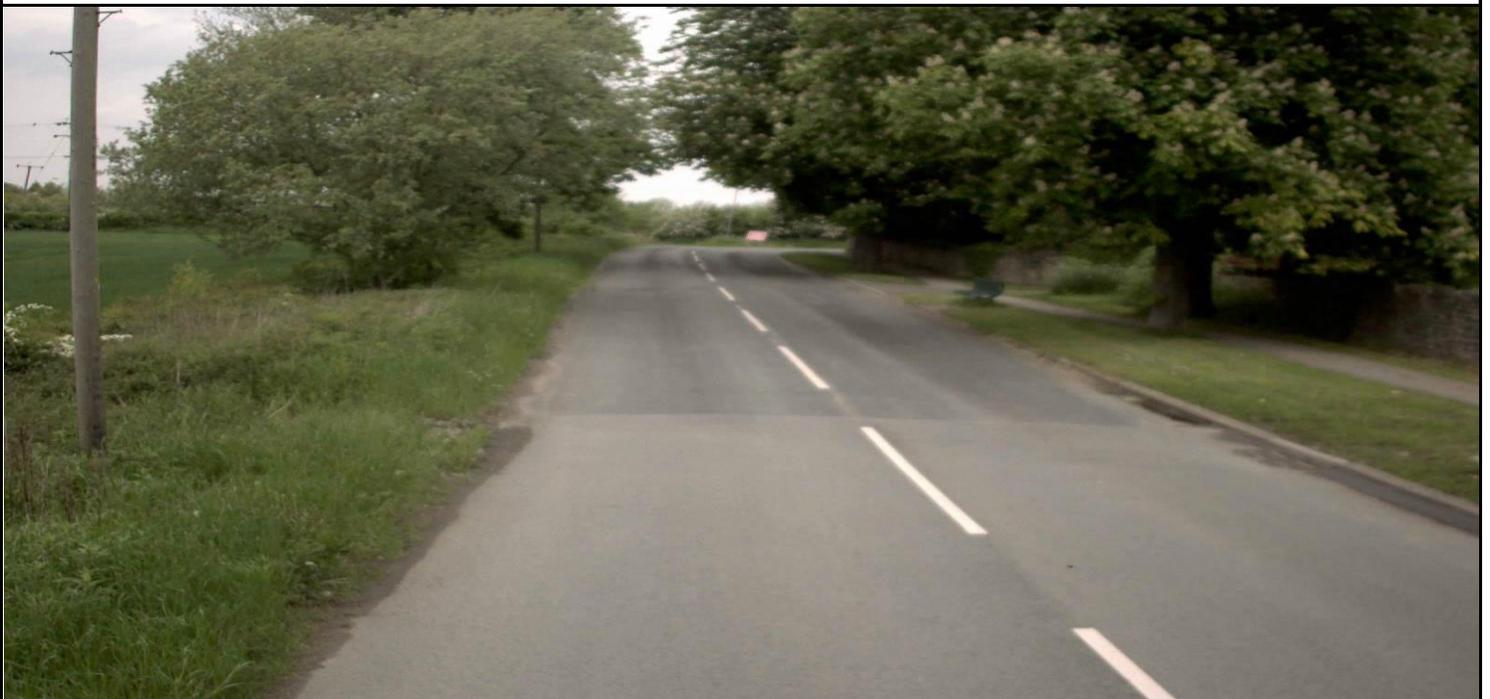
Photo Ref : 126

Feature / Defect : End of Survey

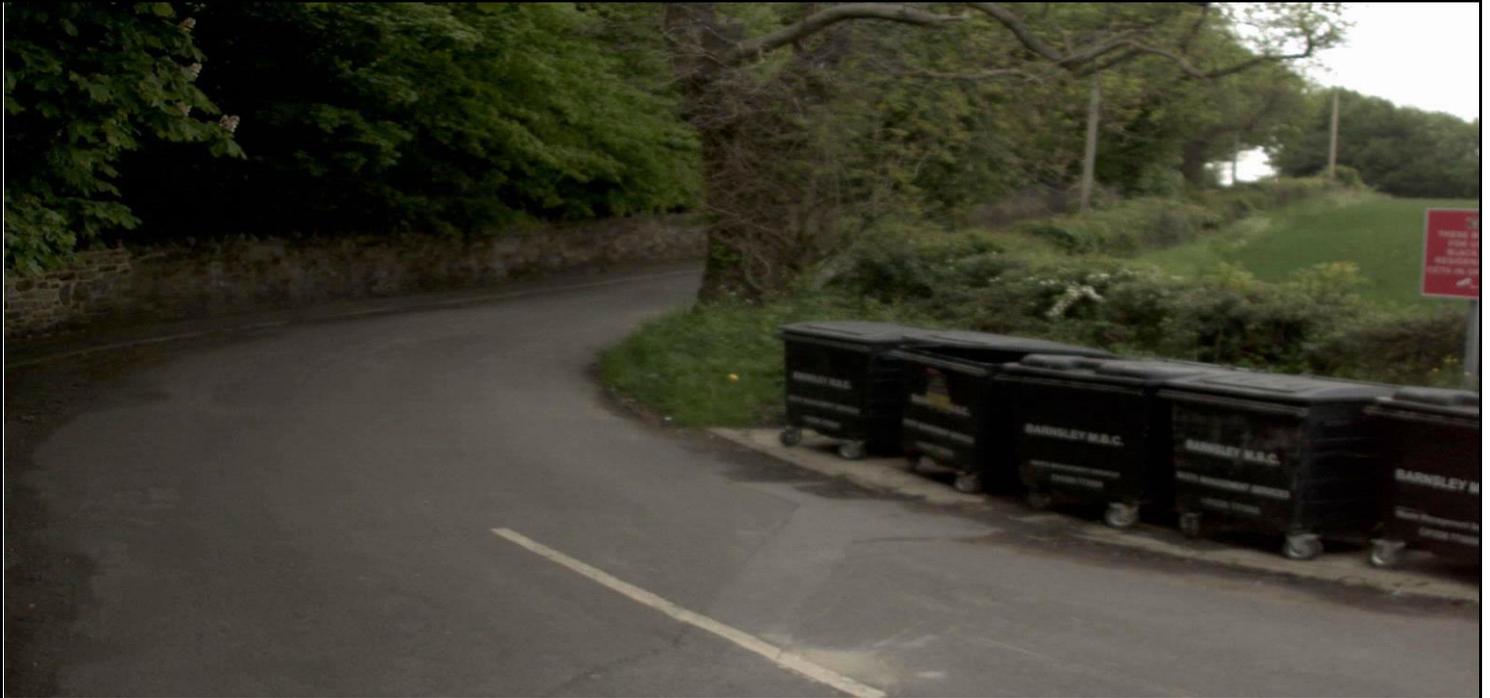
Photo Ref : 127	Section : Black Lane
Chainage : 0m	Feature / Defect : Start of Survey

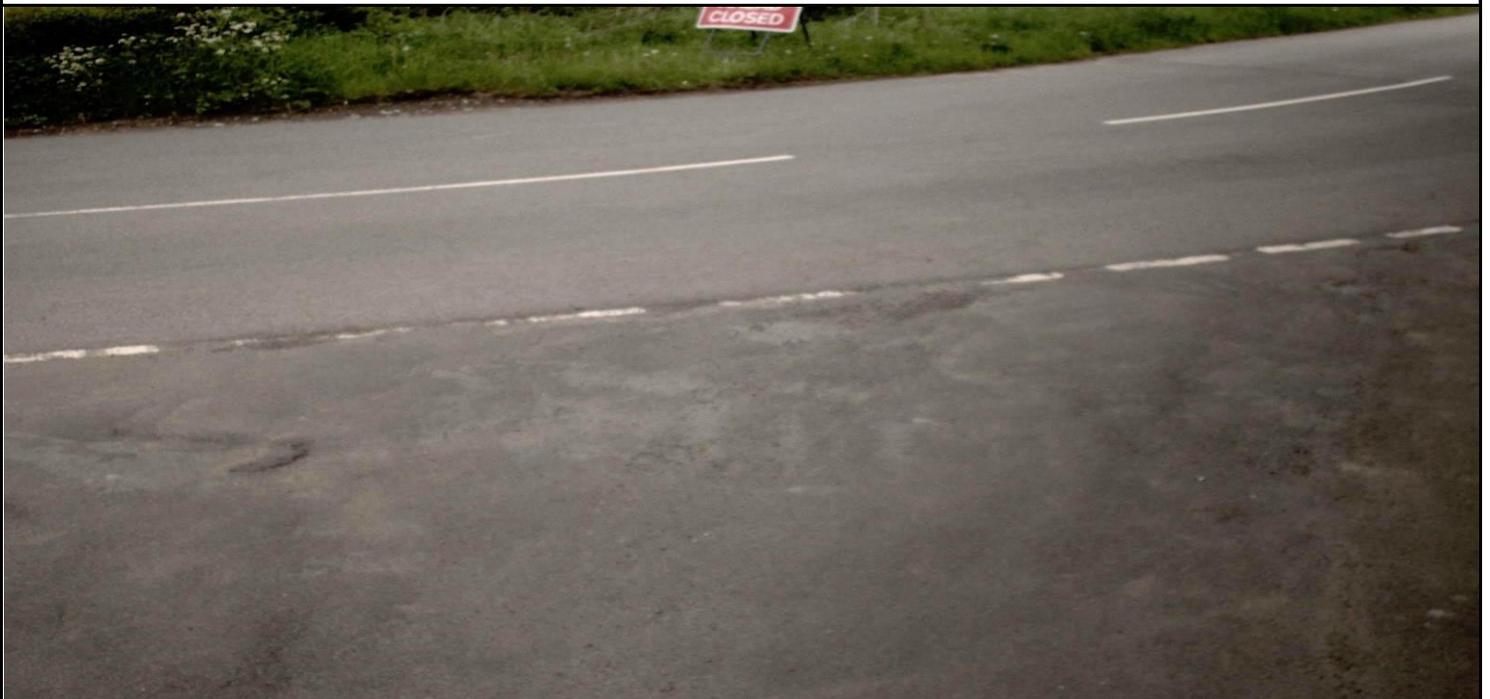
Photo Ref : 128	Section : Black Lane
Chainage : 0m	Feature / Defect : Minor Surface Defectiveness

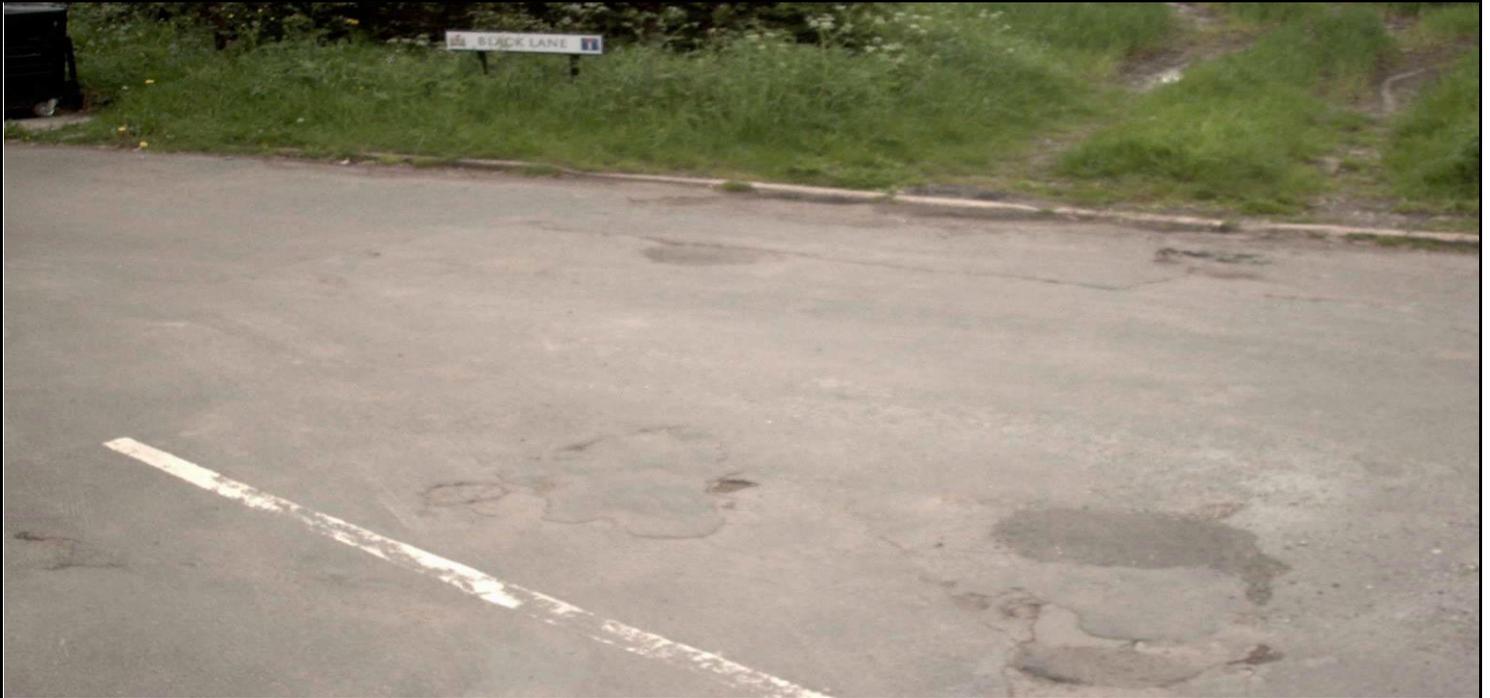
Photo Ref : 129

Feature / Defect : Major Surface Defectiveness

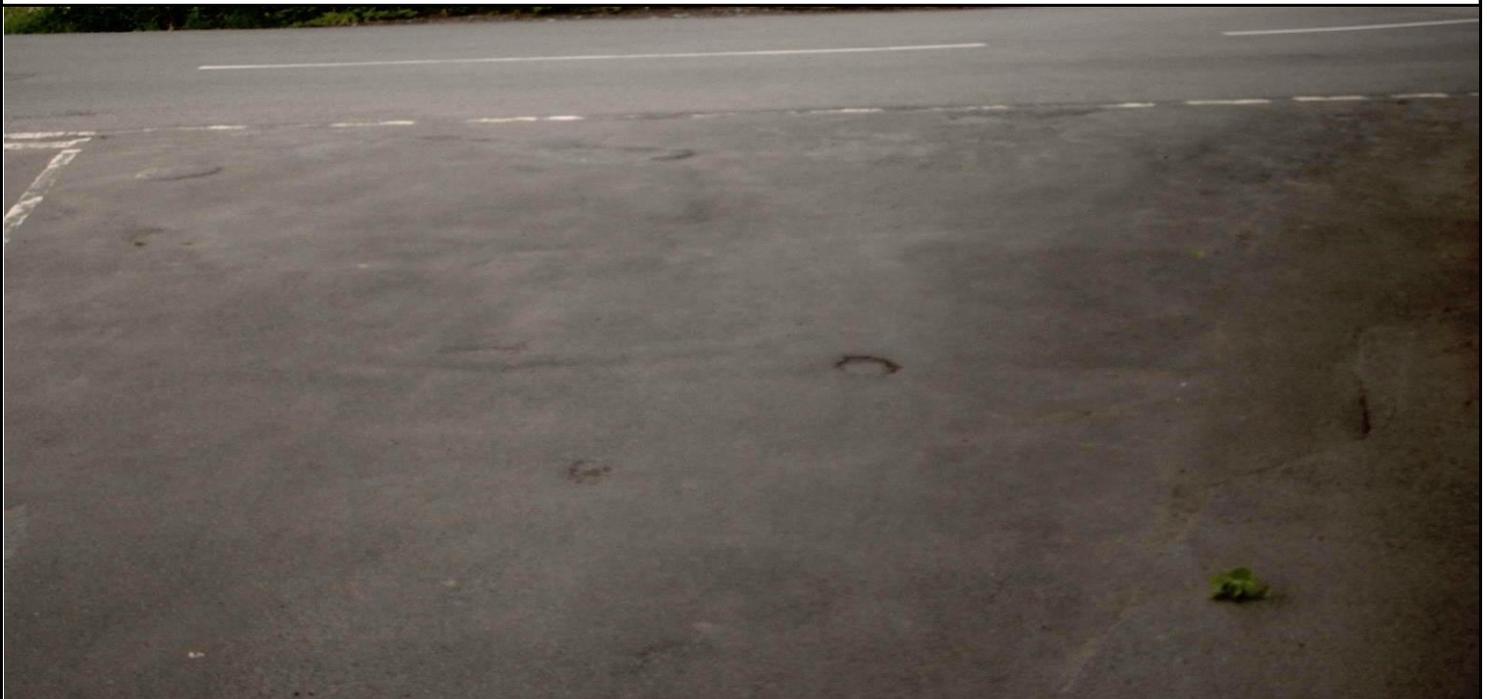
Photo Ref : 130

Feature / Defect : Major Surface Defectiveness

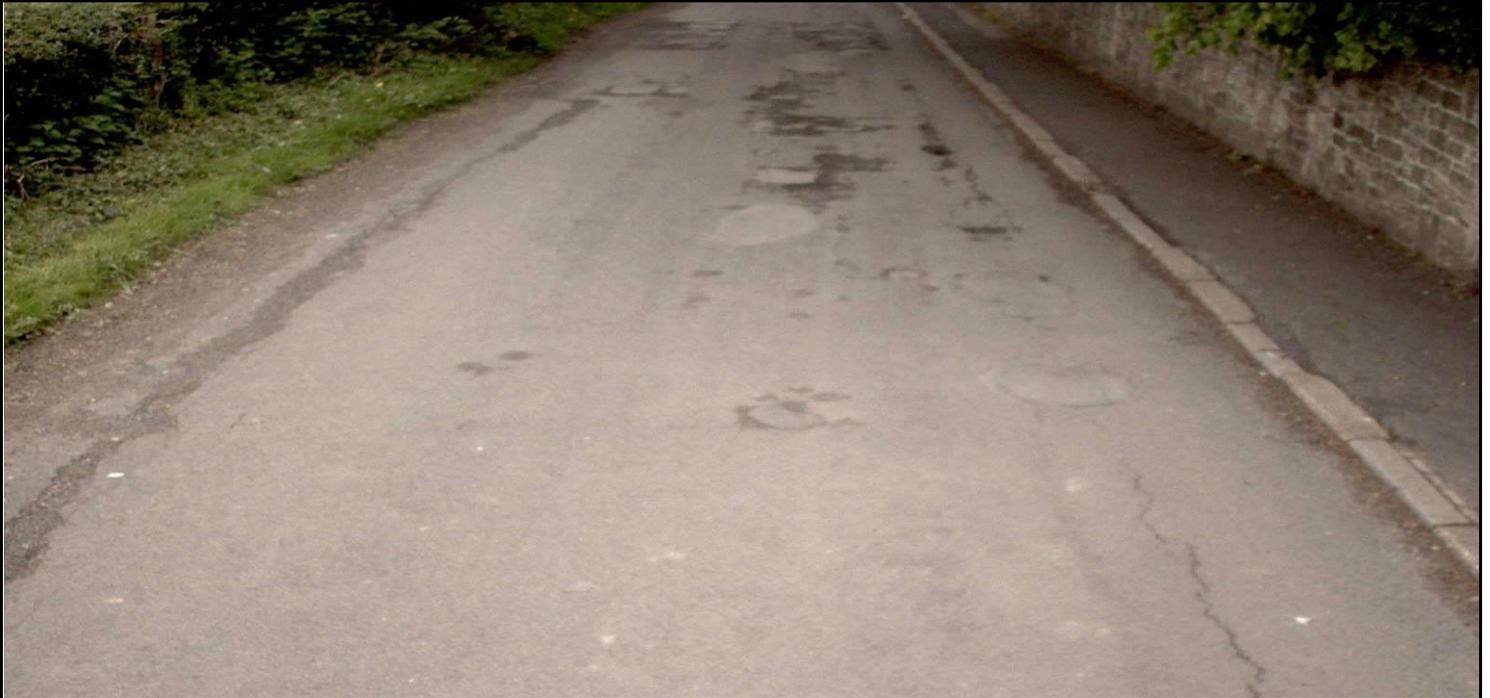
Feature / Defect : Major Surface Defectiveness

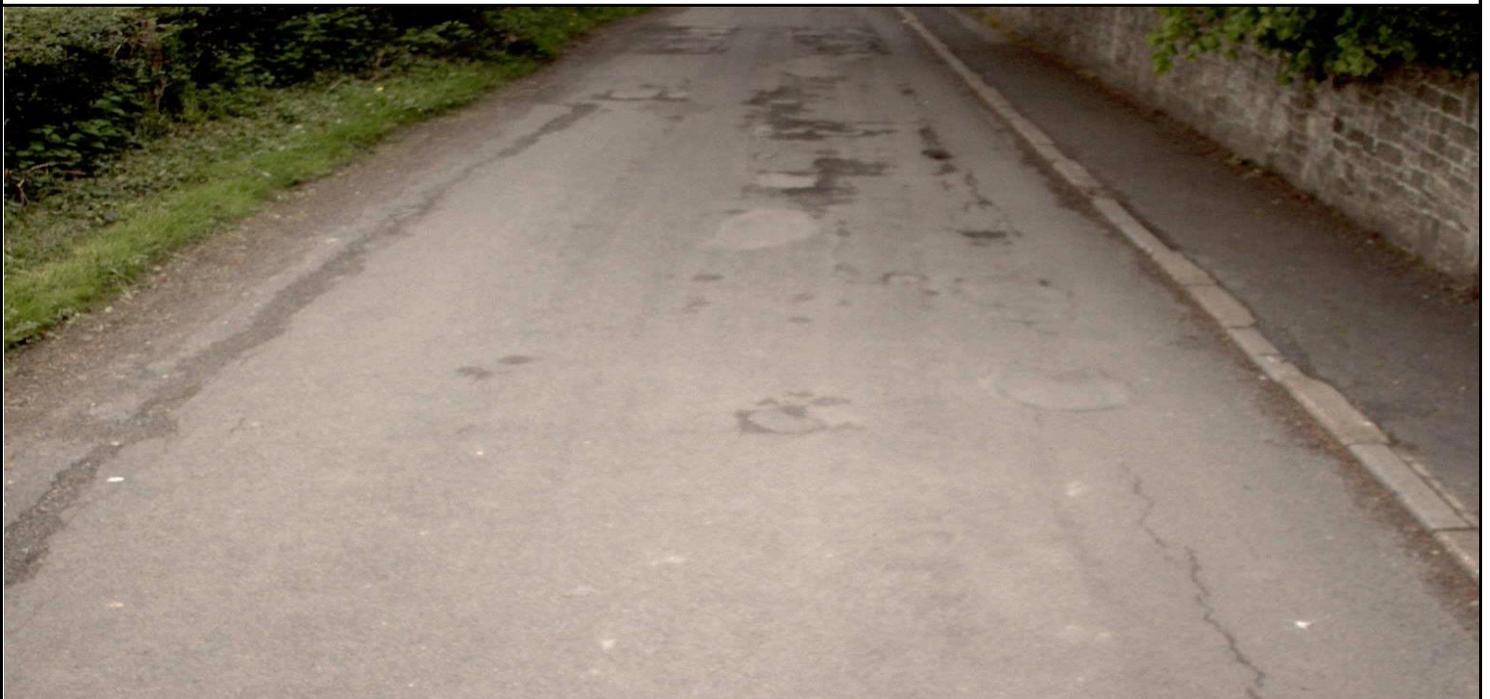
Photo Ref : 136

Feature / Defect : Major Cracking

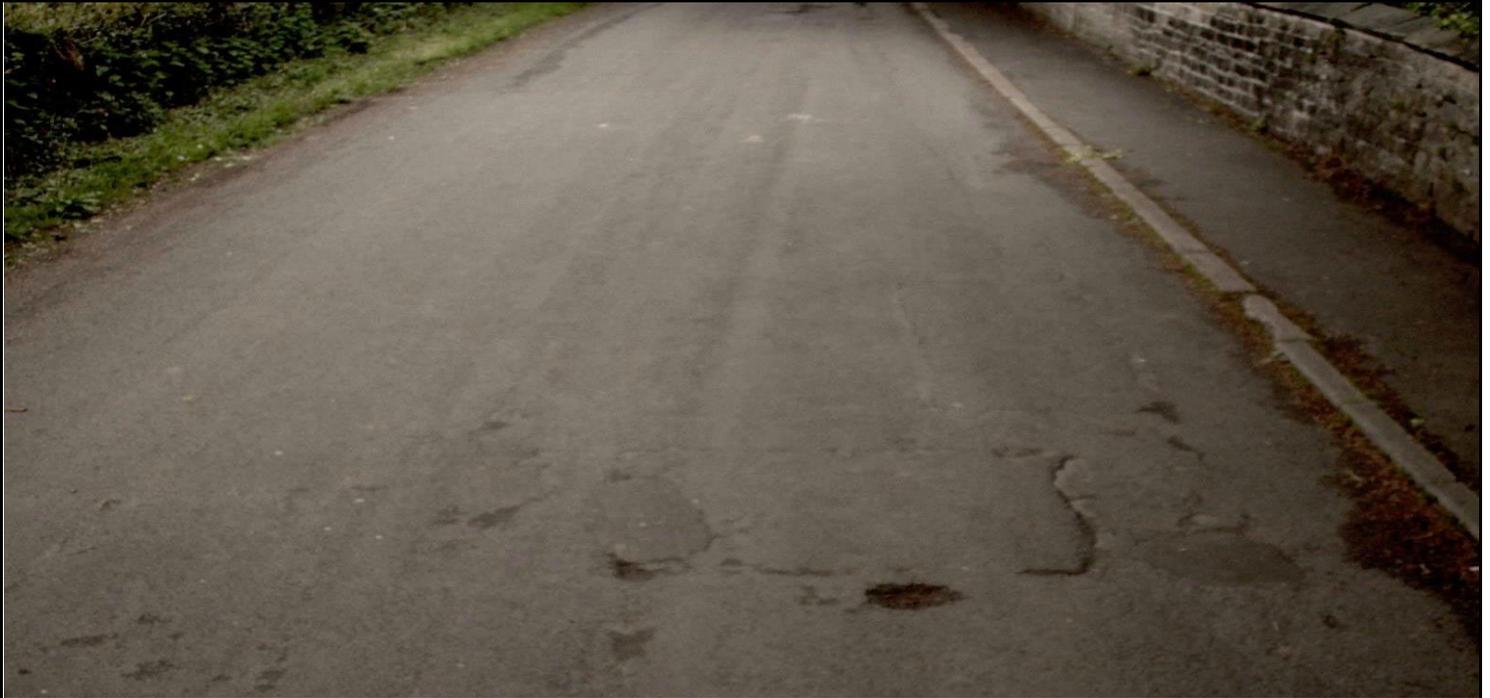
Photo Ref : 137	Section : Black Lane
Chainage : 117m	Feature / Defect : Major Cracking, Major Surface Defectiveness

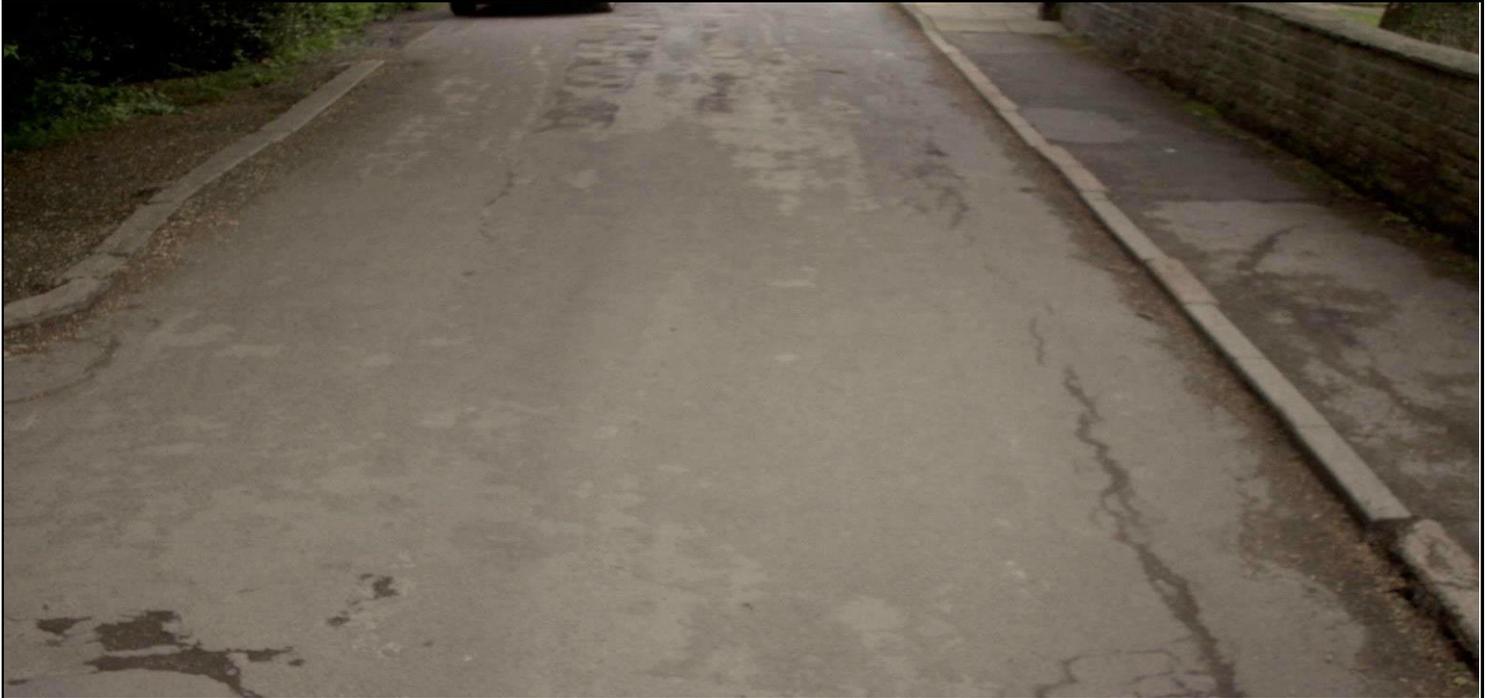
Feature / Defect : Major Cracking
