# STRUCTURAL REPORT

Bank House Farm, A628  
Silkstone, Barnsley  
S75 4FZ

NE5559

**STRUCTURAL REPORT ON** Bank House Farm, A628, Silkstone, Barnsley, S75 4FZ

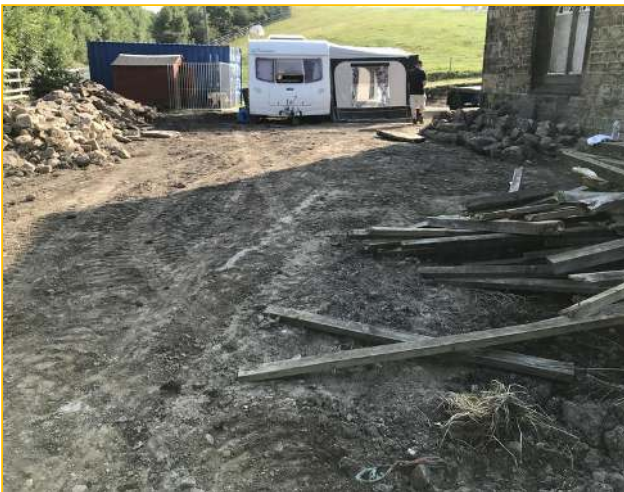
Photograph - 3 - Front of property

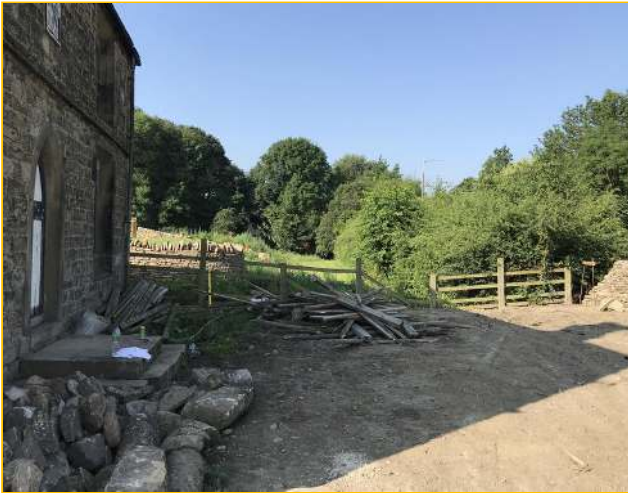
At the time of our inspection, the trees, shrubs and hedges located local to the building do not appear to be having an adverse effect on the property foundations. However, as a matter of risk mitigation, it would be prudent that all significant vegetation located upon the site is regularly maintained, such as lopping or pruning to restrict growth and overall height.

Photograph - 5 - Vegetation to front

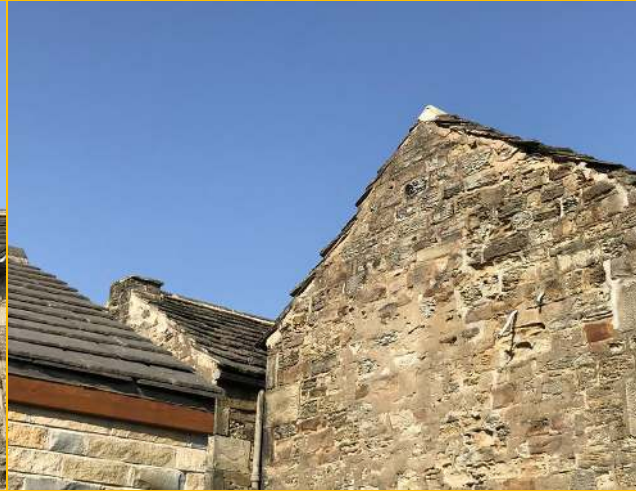
Observations from ground level did not identify any excessive distortions to the roof slopes, however observations of the inner facing pitches was restricted due to the site constraints.

Photograph - 8 - Restricted views

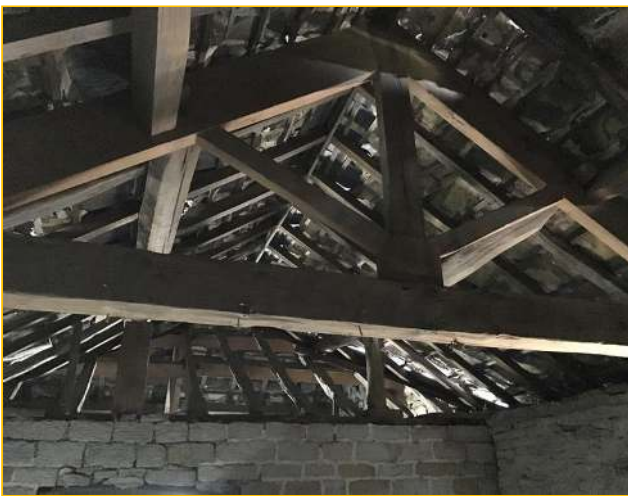
Internal observation of the main purlins and rafters indicates deflections within acceptable limits and no evidence of structural distress. The roof structure appears stable and sound.

Photograph - 50 - Left hand extension roof

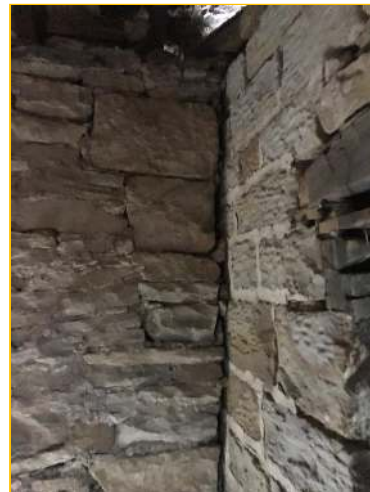
Photograph - 60 - Left hand extension
