**PLOT 4B & 5, ASHROYD BUSINESS PARK, HOYLAND**

**POST COMPLETION HIGHWAY CONDITION INSPECTION**

**11717**

**JUNE 2020**

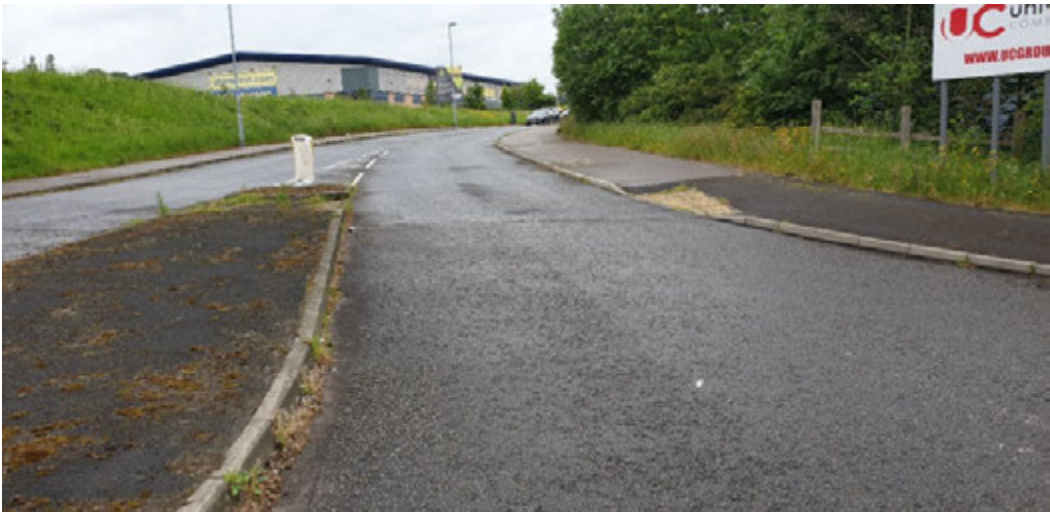
*Figure 5 - View west of outbound lane. Some minor chipping loss in surface course.*

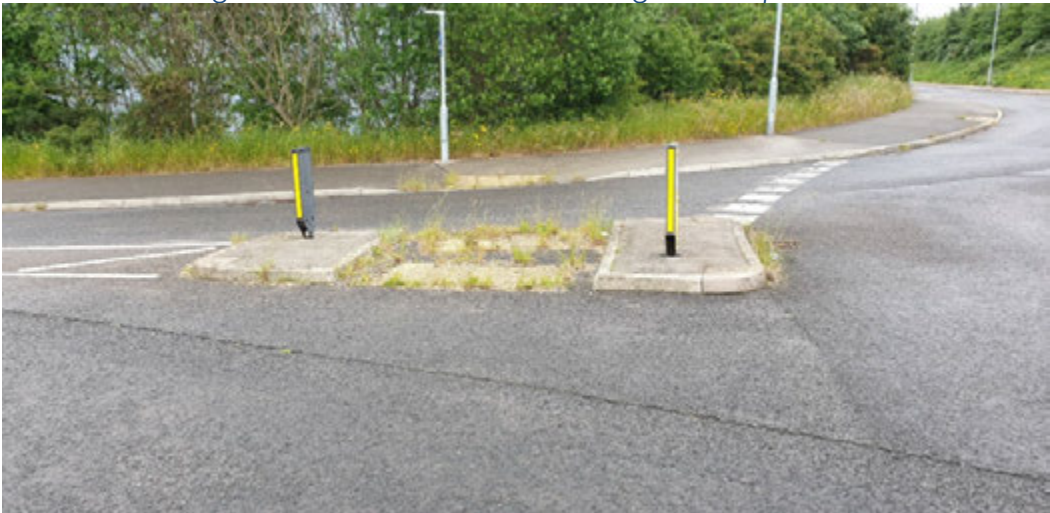
*Figure 31 - Island on northern leg. Overgrown with weeds and vegetation etc.*

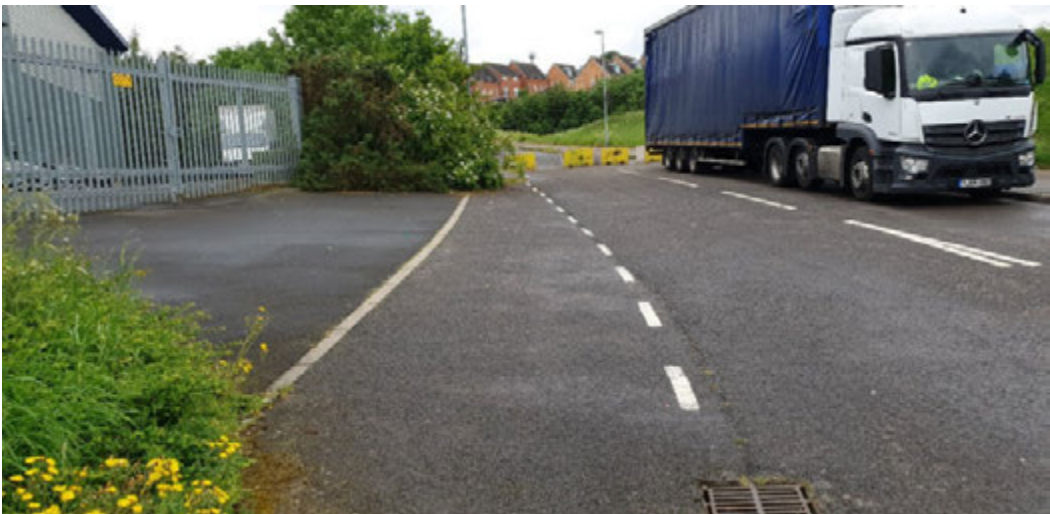
*Figure 34 - Looking south on eastern side footway. Second access into Self Store unit.*

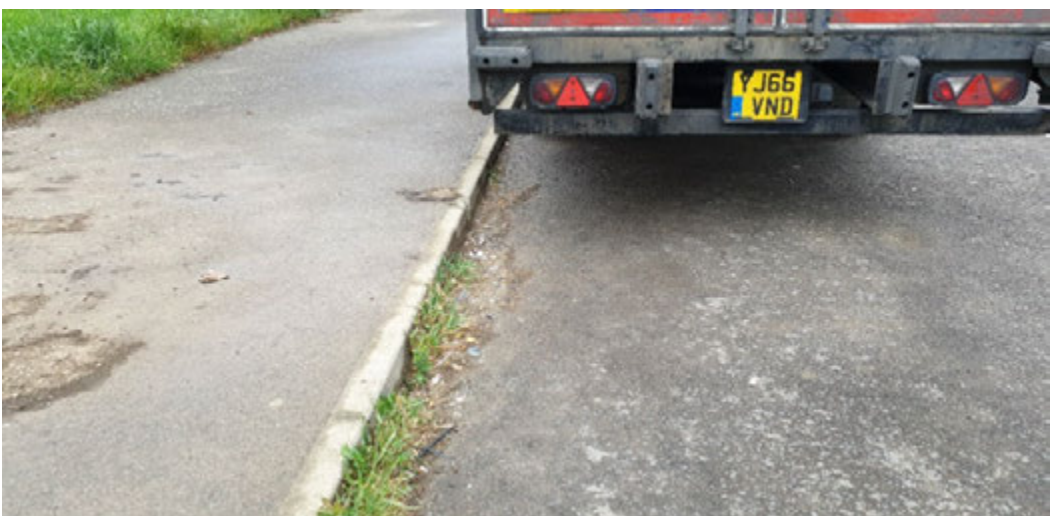
*Figure 35 - Western channel of southern leg.*

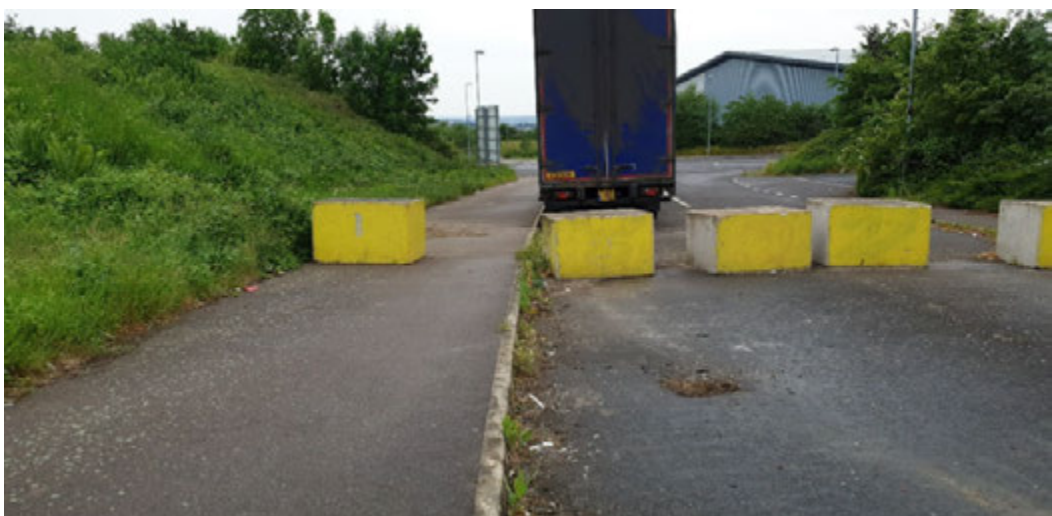
*Figure 38 - Looking north through concrete blocks. Carriageway south of the blocks is not finished with surface course.*

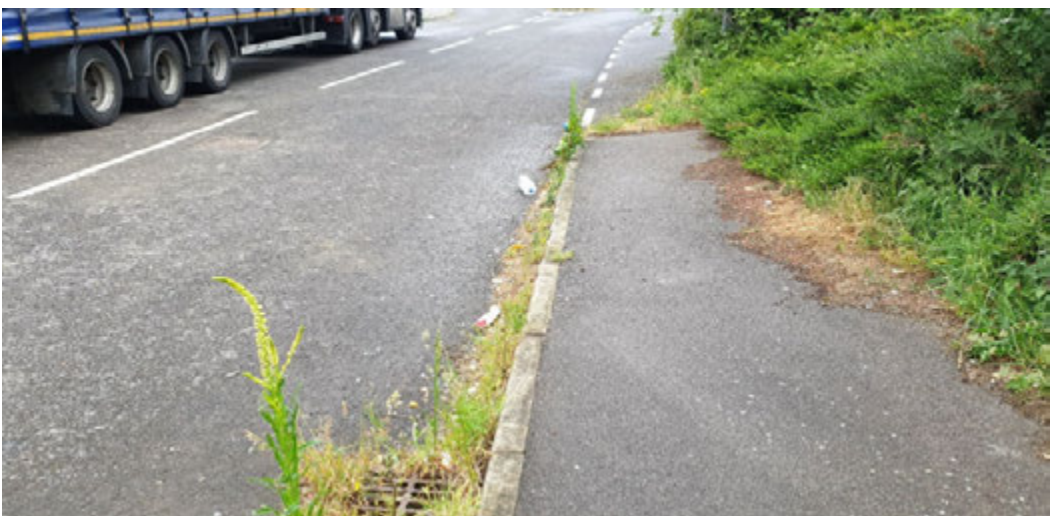
*Figure 41 - Growth in channel linem encroaching back of footway and over tactiles.*

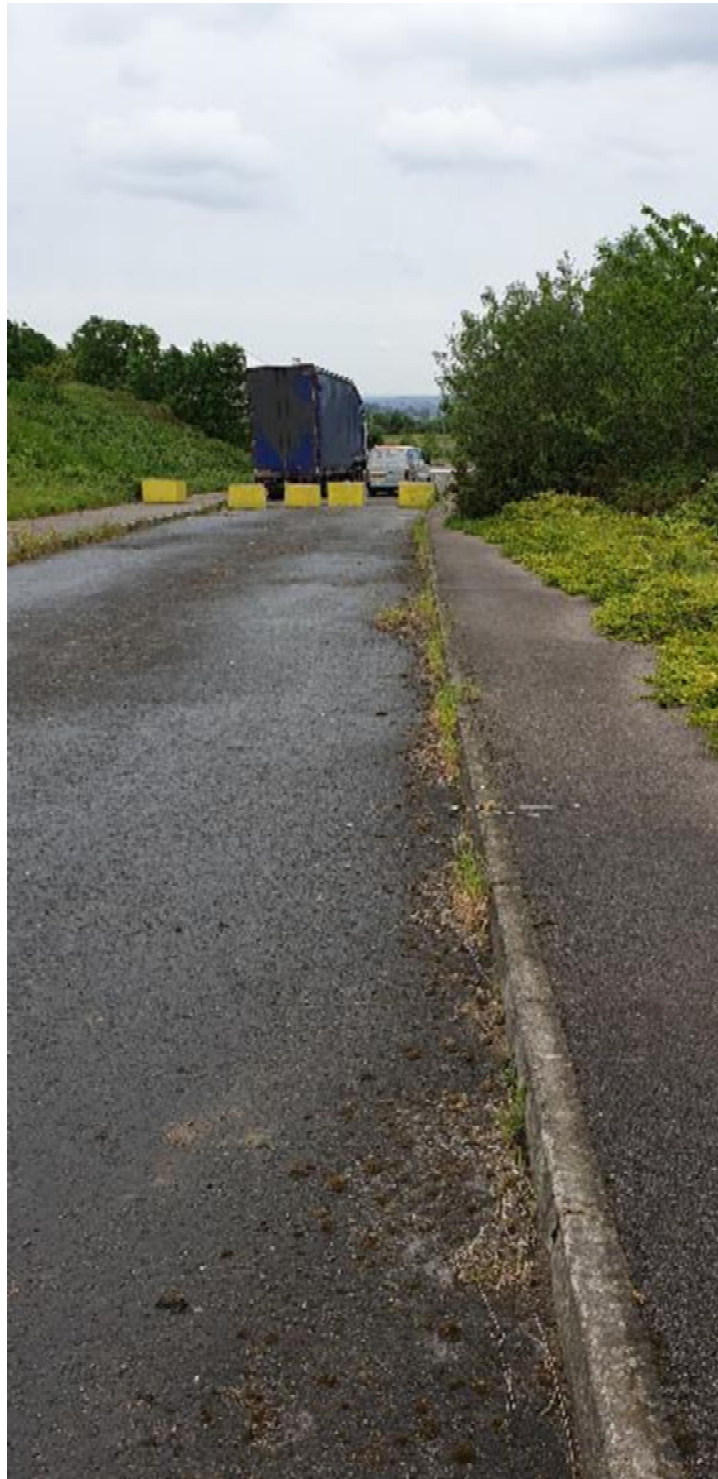
*Figure 43 - Eastern channel looking north.*

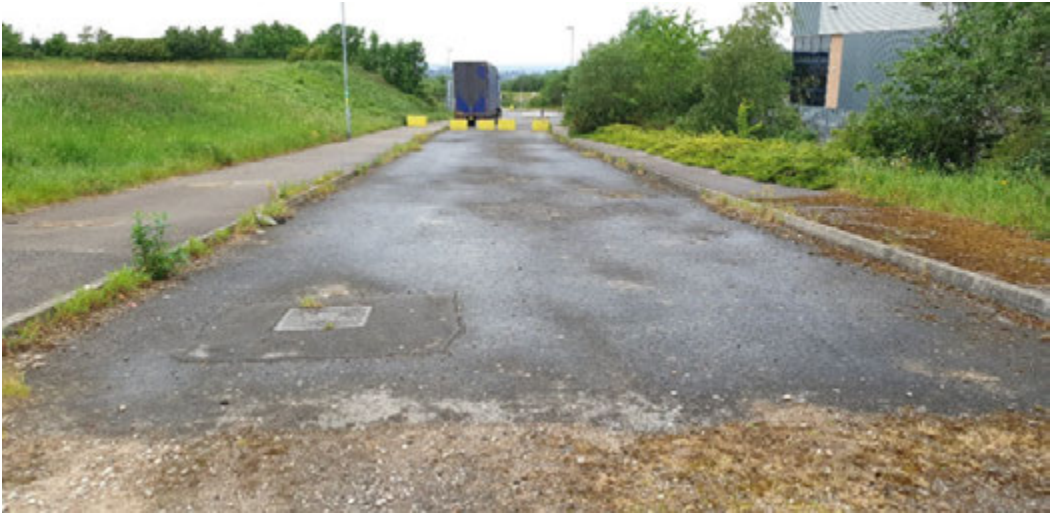
*Figure 46 - View north from end of macadam binder course.*

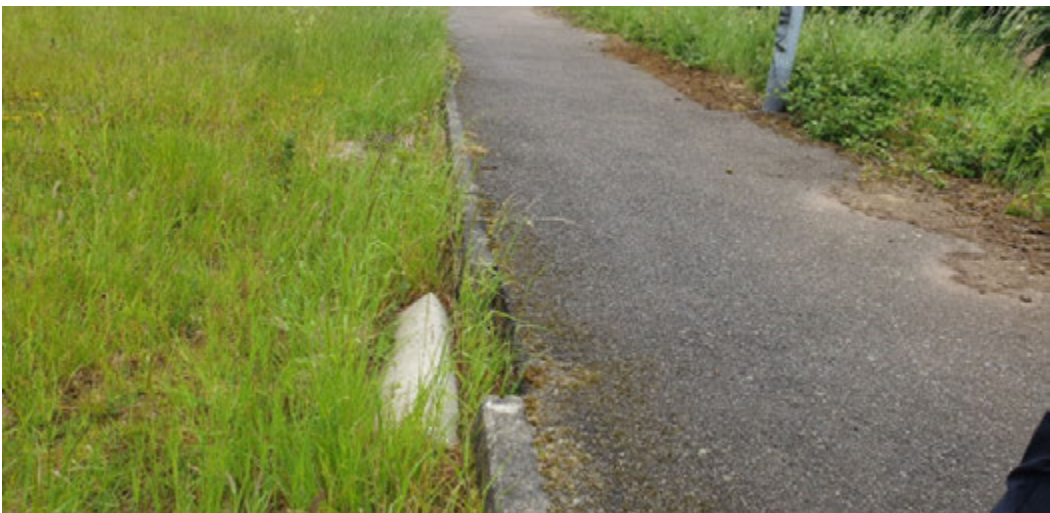
*Figure 51 - One kerb has dislodged. To be replaced in S38 works.*
