Project Name: Gleeson - Off Wakefield Road	Project number:	Date: 17/12/2024	Contact:	
---	-----------------	---------------------	----------	--

Profile Report	1
Inspection: 1	
Project Information	2
Section: 1, S1 --- Outfall	5
Section: 2, F1 --- F2	6
Section: 3, F2 --- F3	11
Section: 4, F3 --- F4	16
Section: 5, F4 --- F5	20
Section: 6, F4 --- Boundary	24
Section: 7, F6 --- F3	26
Section: 8, F7 --- F5	31
Section: 9, F7 --- F5	38
Section: 10, F7 --- F5	41
Section: 11, F5 --- F8	45
Section: 12, F8 --- F9	50
Section: 13, F8 --- F9	58
Section: 14, F9 --- F10	62

Project name :
Gleeson - Off Wakefield Road - Ather

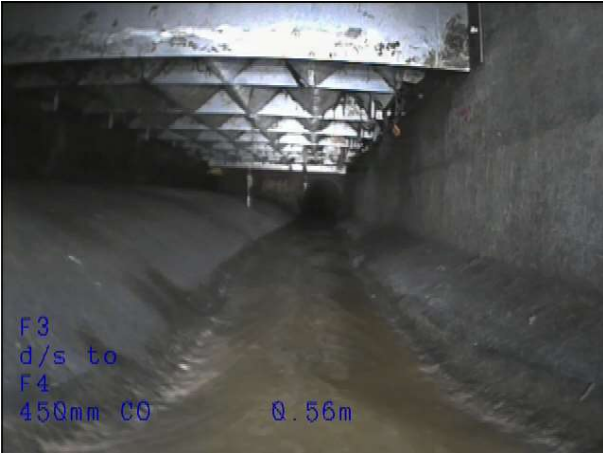
Photo: 4_3A
0.56m, Finish node type, manhole reference number: F4
Remarks: Sewer Overflow
