## Proposed Drainage Strategy

PERSEVERANCE STREET, BARNSELEY

CAIRNWELL DEVELOPMENTS LTD

**48063-ECE-XX-XX-RP-C-0005**

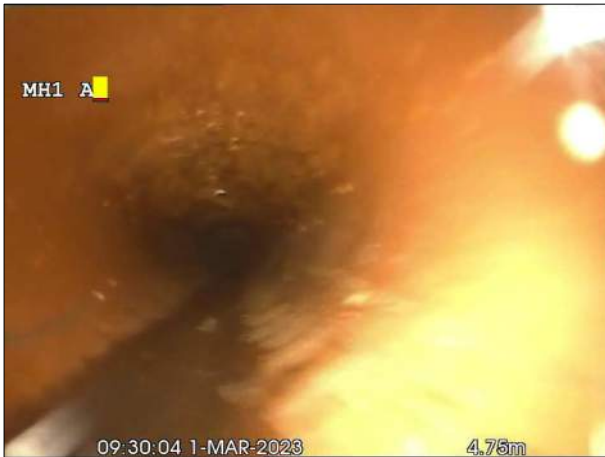
Photo: 5\_5a, 00:00:00  
5m, General Condition photograph

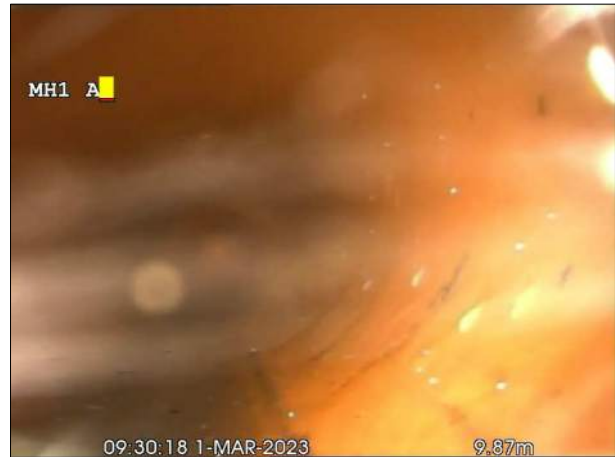
Photo: 6\_6a, 00:00:00  
10m, General Condition photograph

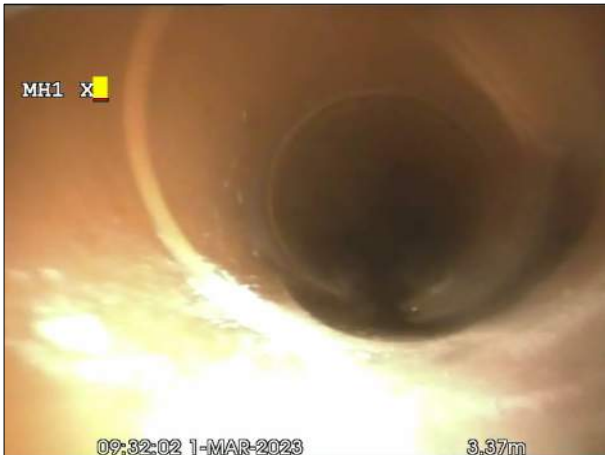
Photo: 12\_4a, 00:00:00  
 3.4m, Junction at 02 o'clock, dia 100 mm

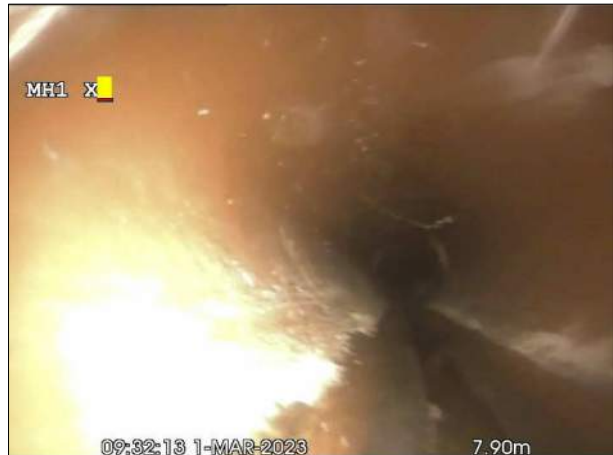
Photo: 13\_5a, 00:00:00  
 8m, General Condition photograph

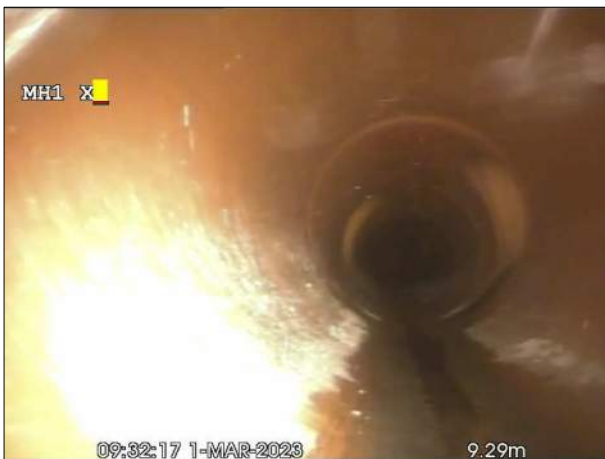
Photo: 14\_6a, 00:00:00  
 9.7m, Junction at 03 o'clock, dia 100 mm

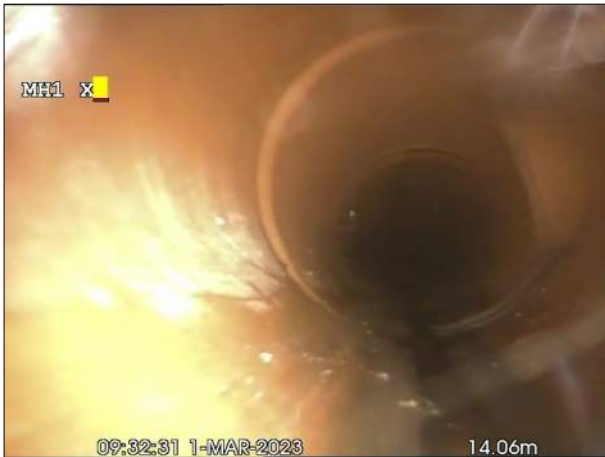
Photo: 16\_8a, 00:00:00  
14.1m, Junction at 03 o'clock, dia 100 mm

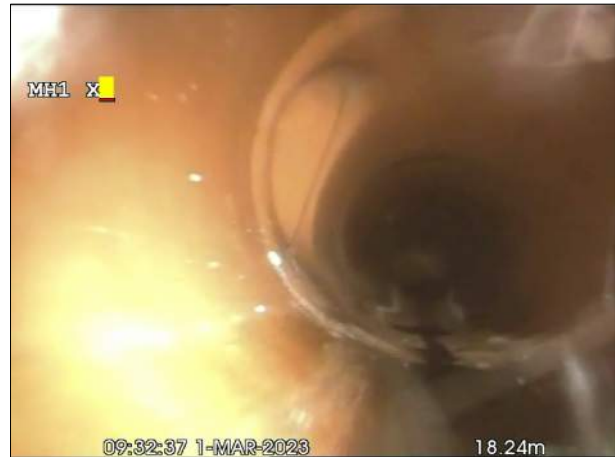
Photo: 17\_9a, 00:00:00  
19m, Junction at 09 o'clock, dia 100 mm

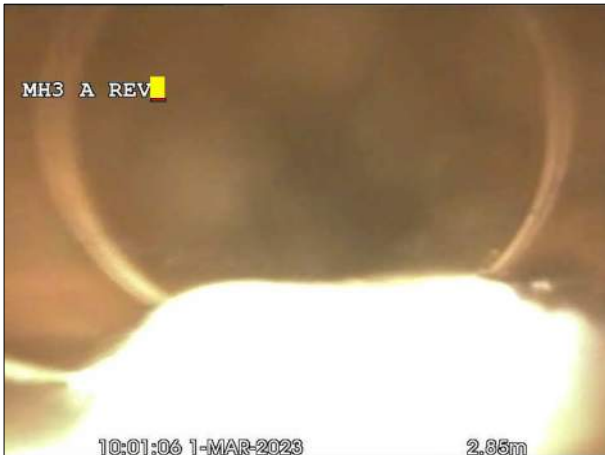
Photo: 24\_4a, 00:00:00  
2.5m, General Condition photograph

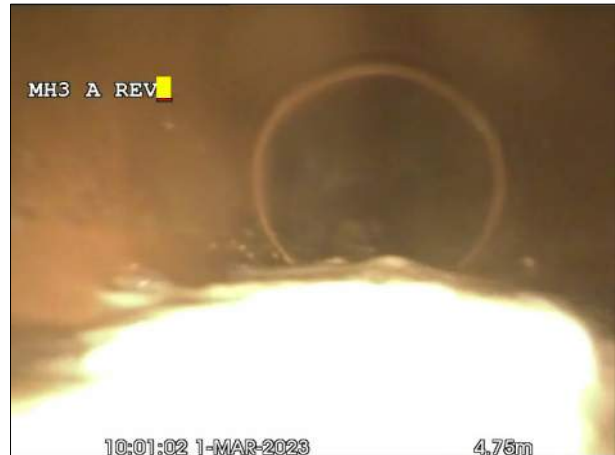
Photo: 3\_5a, 00:00:00  
5m, General Condition photograph

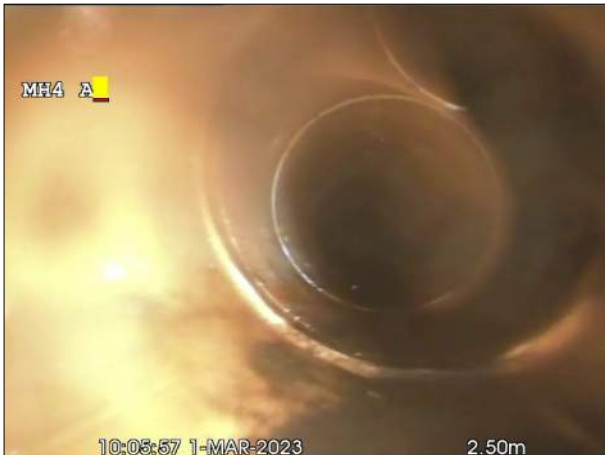
Photo: 31\_4a, 00:00:00  
2.5m, Junction at 12 o'clock, dia 100 mm

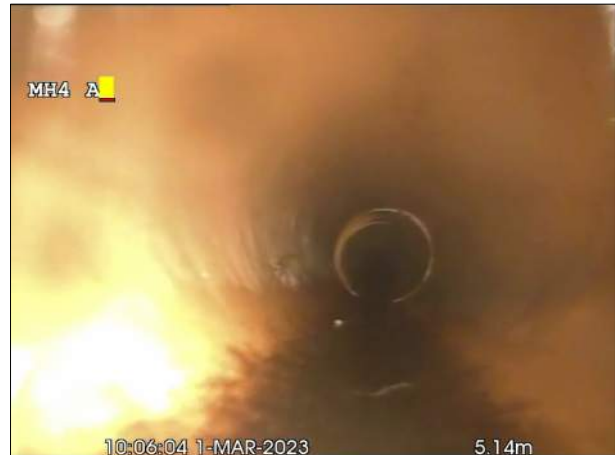
Photo: 32\_5a, 00:00:00  
5m, General Condition photograph

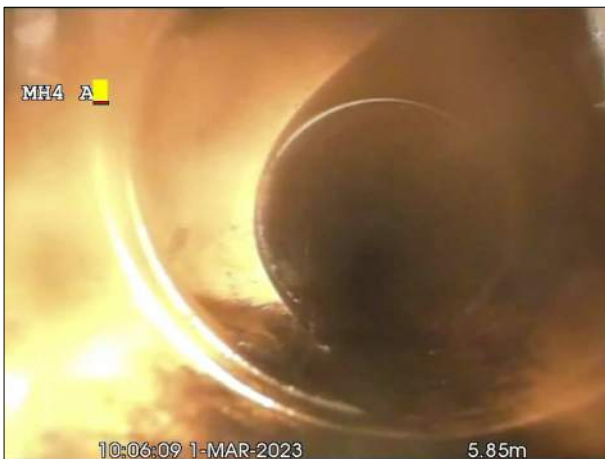
Photo: 33\_6a, 00:00:00  
5.85m, Junction at 09 o'clock, dia 100 mm

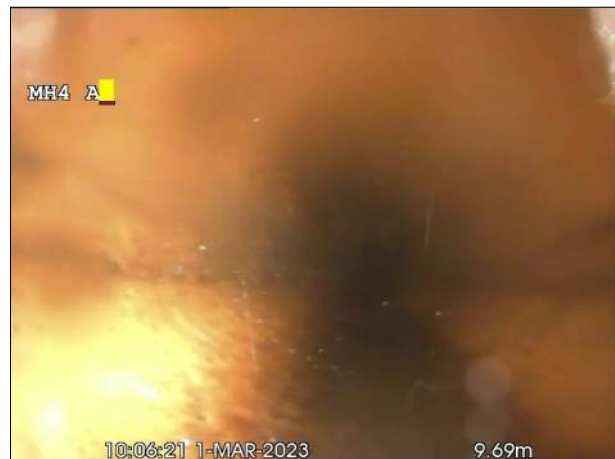
Photo: 34\_7a, 00:00:00  
10m, General Condition photograph

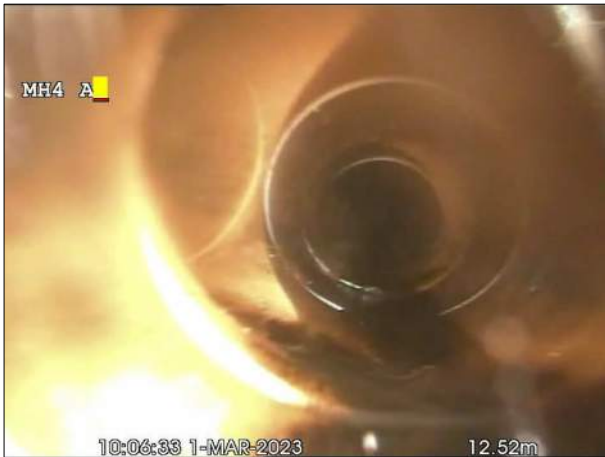
Photo: 35\_8a, 00:00:00  
12.5m, Junction at 09 o'clock, dia 100 mm

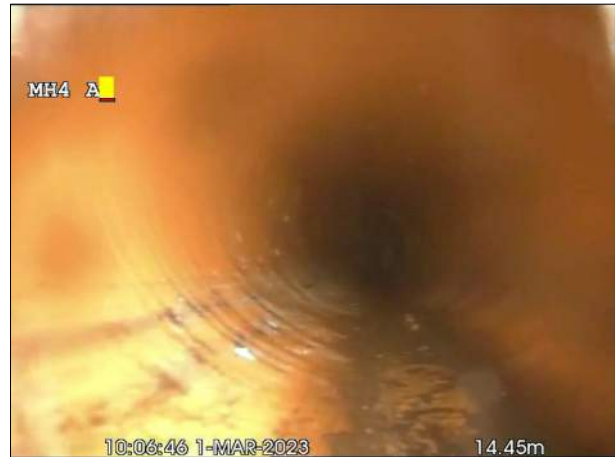
Photo: 36\_9a, 00:00:00  
15m, General Condition photograph
