## STRUCTURAL REPORT

| Location | Knabbs Hall Farm, Silkstone Common, Nr Barnsley, S75 4RD |
| application | Re-development, Reinstatement of Dwelling and Conversion of Agricultural Buildings to form 4 dwellings |
| job number | 16/372 |

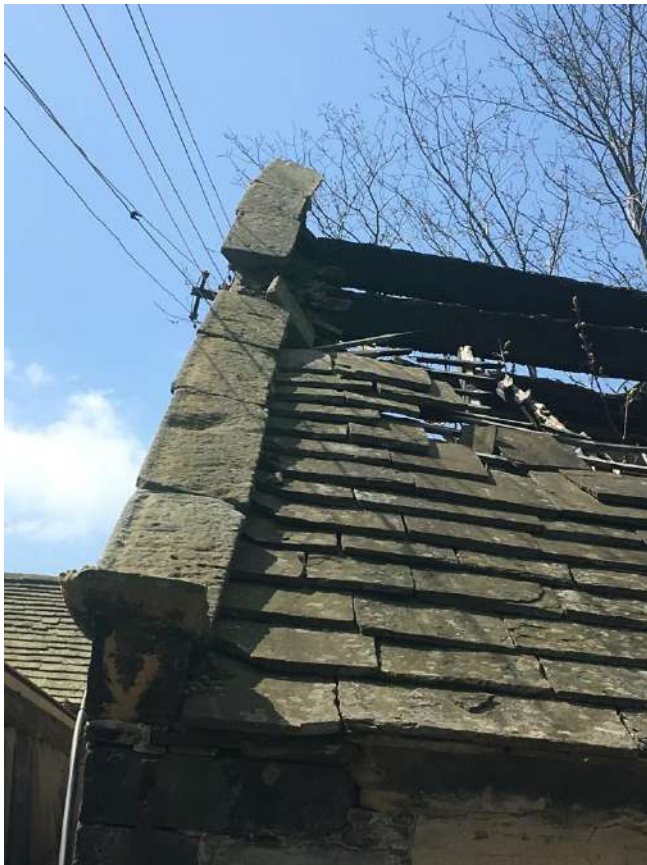
Water tabling to south gable of Unit 1. Note service cables providing stability to leaning gable peak.

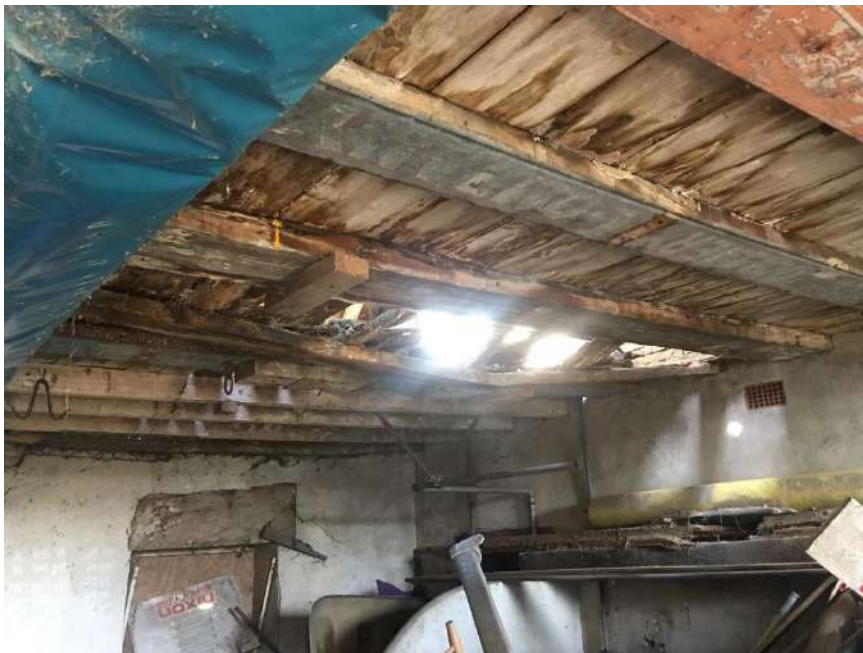
Original First  
Floor/Ceiling to right  
hand side of Unit 2

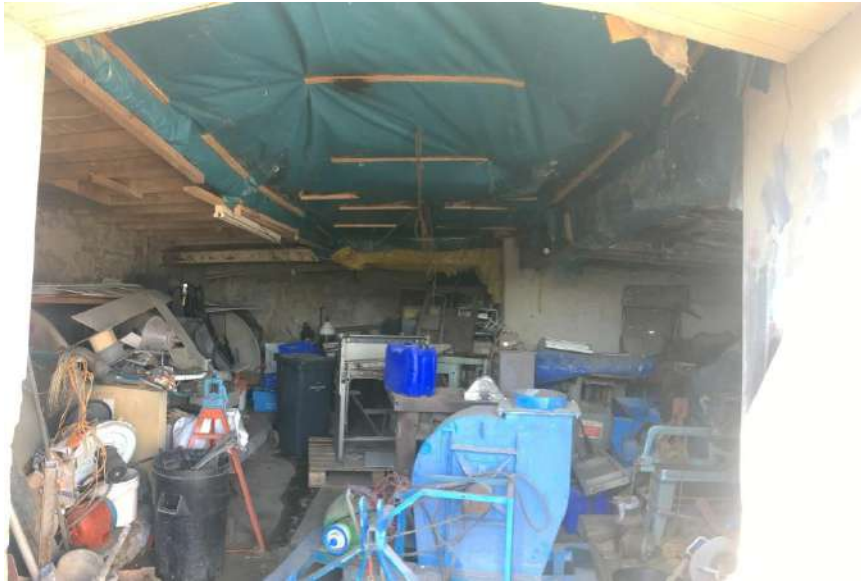
Plastic sheeting to  
underside of Unit 2  
first floor

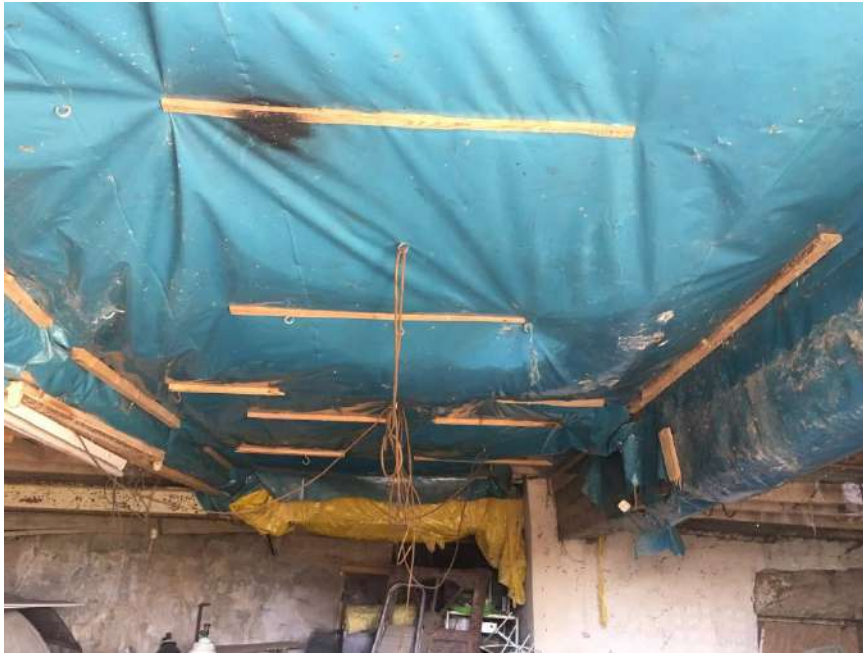
Plastic sheeting to  
underside of Unit 2  
first floor

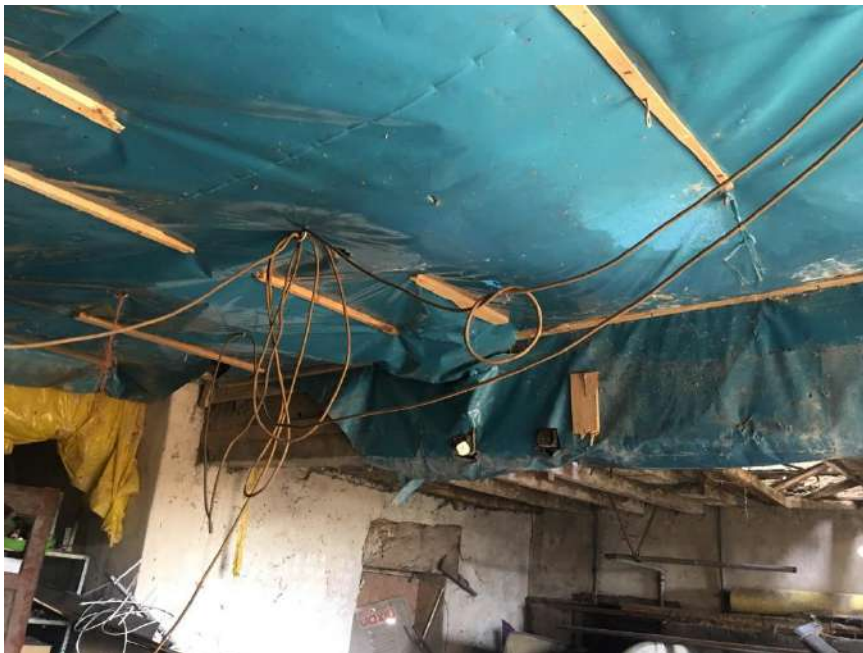
Plastic sheeting to  
underside of Unit 2 first  
floor (Electric cables to  
underside)

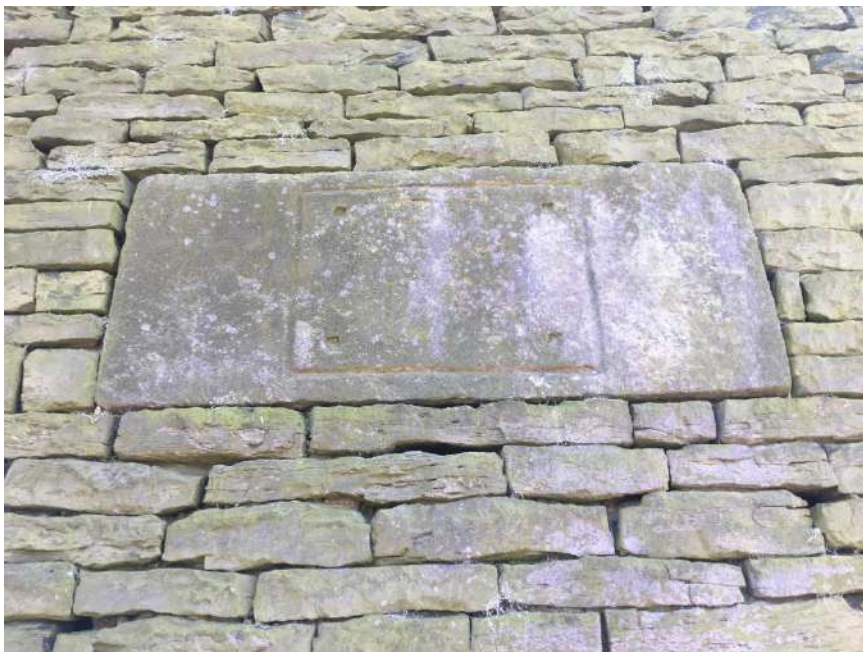
Weathered date  
stone (1633) within  
gable of Unit 3

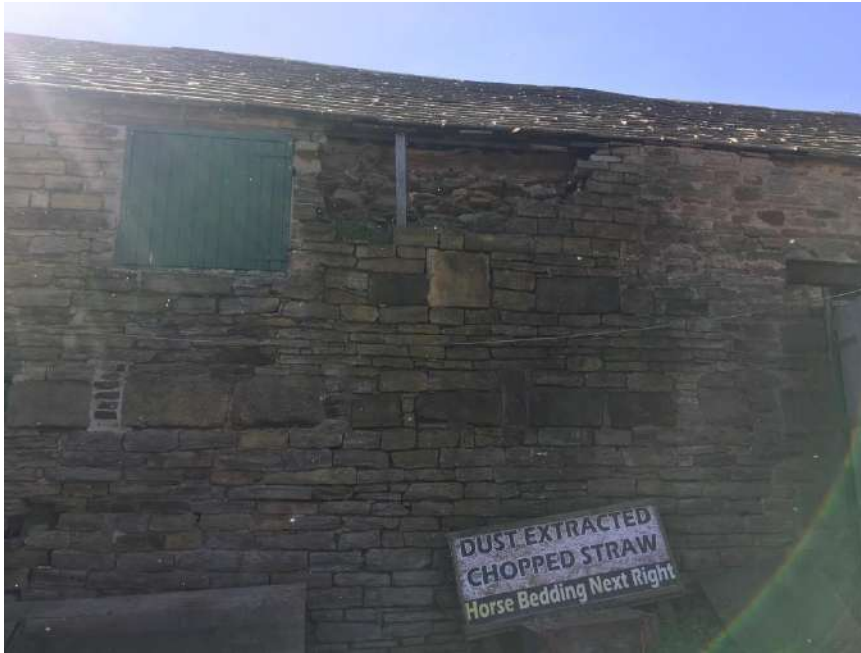
- Front elevation, just left of the principle opening
- Eaves level to front where tin roof covering abuts stone slate roof covering
- Masonry above opening to LHS of front elevation (far left hand side). The original timber lintel has dropped causing the masonry above to also dislodge. It may be the end bearing to this timber lintel has failed, this is currently covered by a stack of pallets that prop the roof of the adjacent/perpendicular building.

Masonry displacement at  
eaves level to LHS of  
principle opening to Unit 3

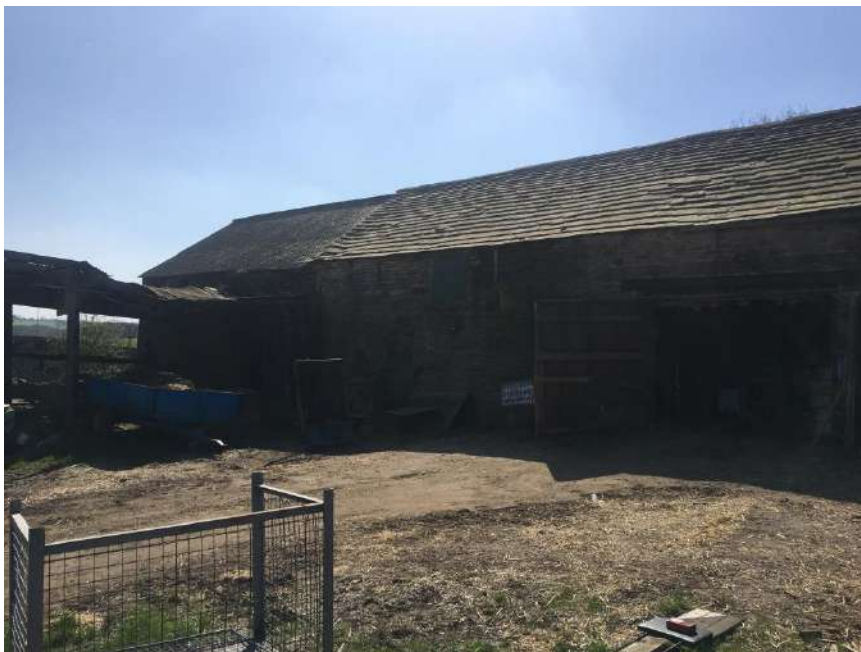
Unit 3 Viewed from  
North East

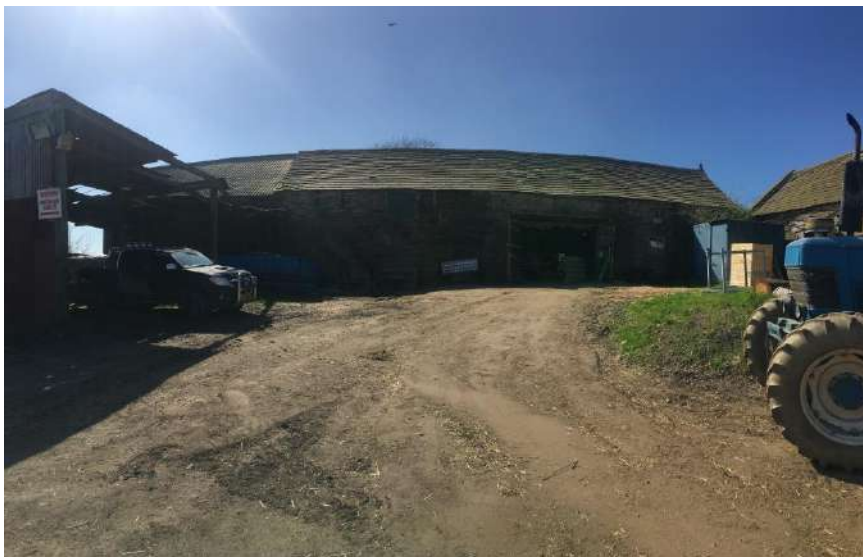
Unit 3 Viewed from  
East

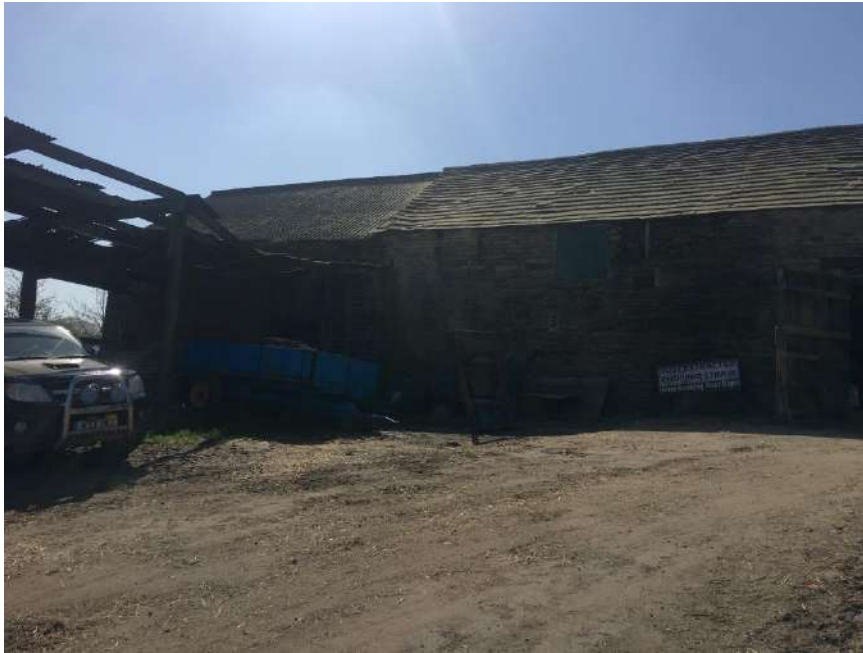
Unit 3 Viewed from  
North East

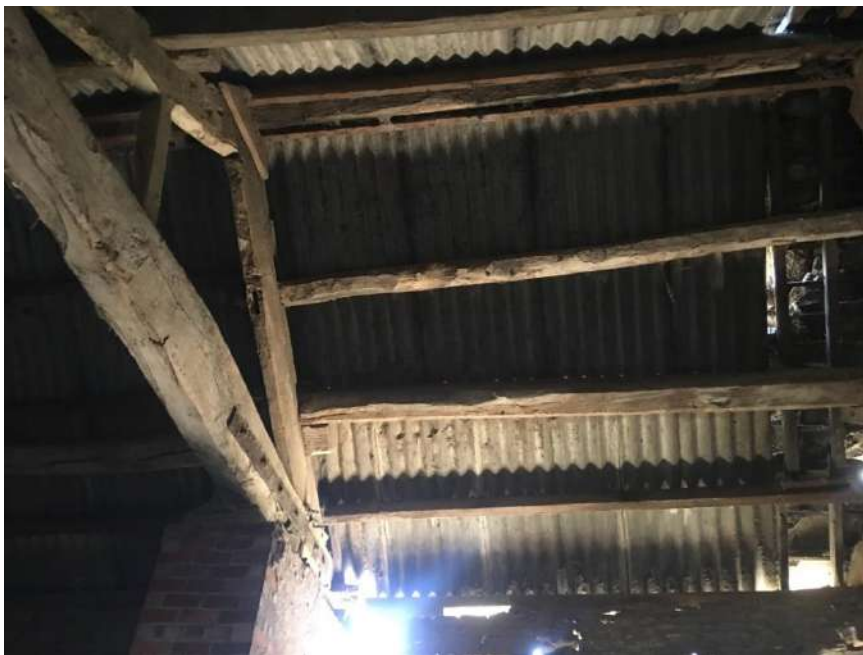
The westerly one third (left hand side viewed from the front) of unit 3 has had its original roof covering removed at some point with corrugated sheeting replacing the stone slate. Additional timber purlins have been incorporated to support this more modern roof covering. This roof covering is to be removed with Yorkshire stone slate re-laid on the roof. It is acknowledged the original roof covering will most likely have been stone slate. The original roof structure is predominantly intact to this area so the reinstatement of a Yorkshire stone slate roof should not have cause for concern with regards to loading.

Underside of  
profiled sheeted  
roof to Unit 3

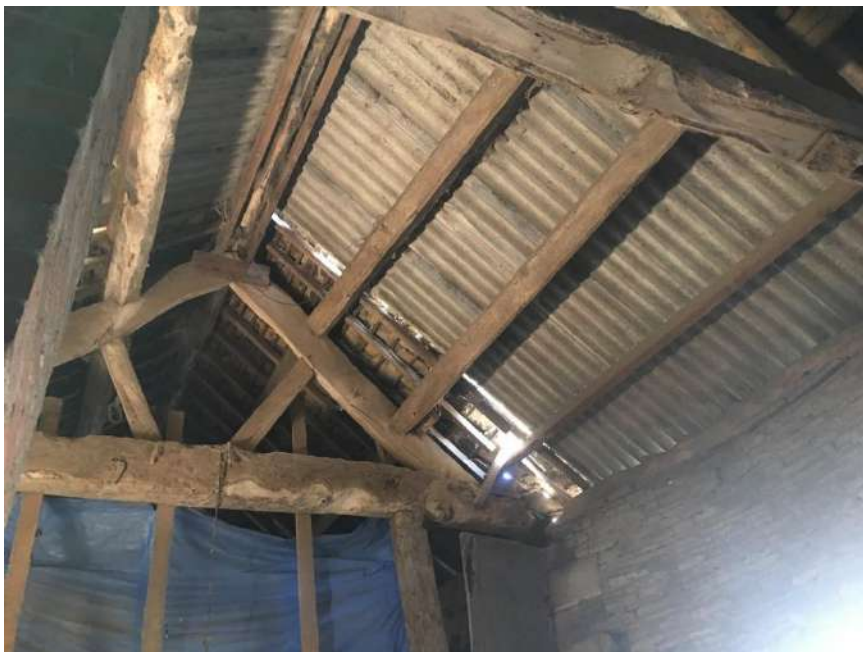
Underside of  
profiled sheeted  
roof to Unit 3

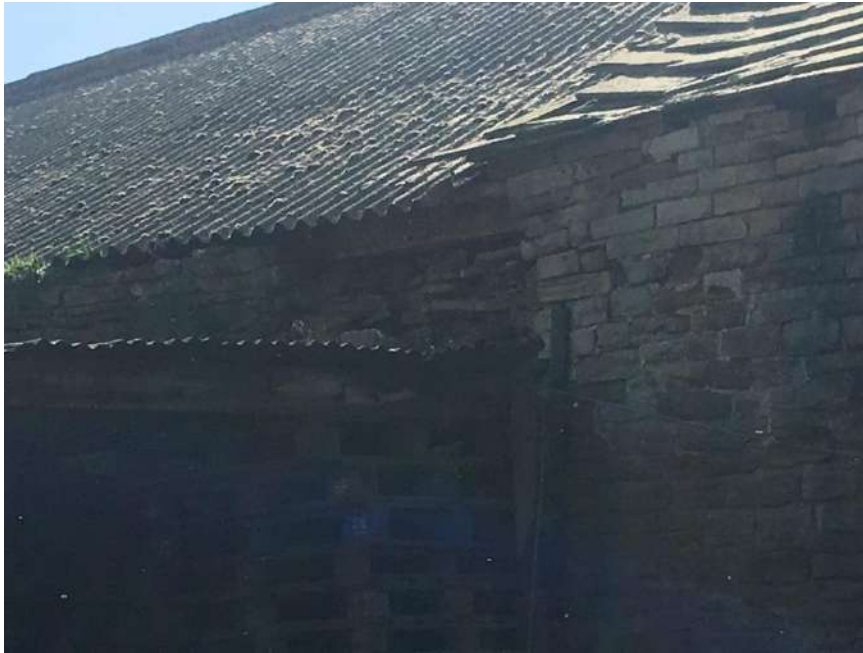
Abutment of stone  
slate and profiled  
sheeting to Unit 3

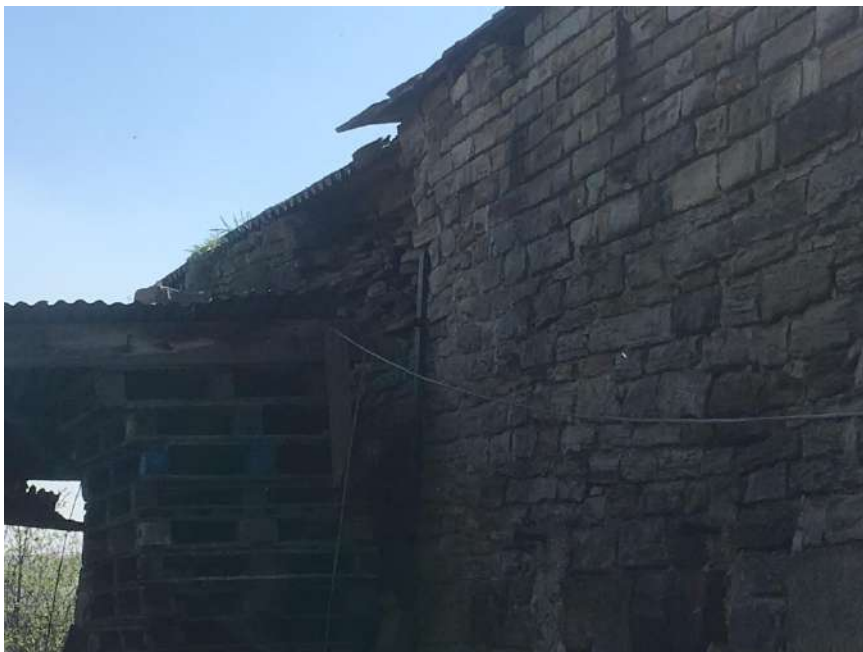
Masonry displacement to  
Unit 3 above location of  
adjacent pallet props

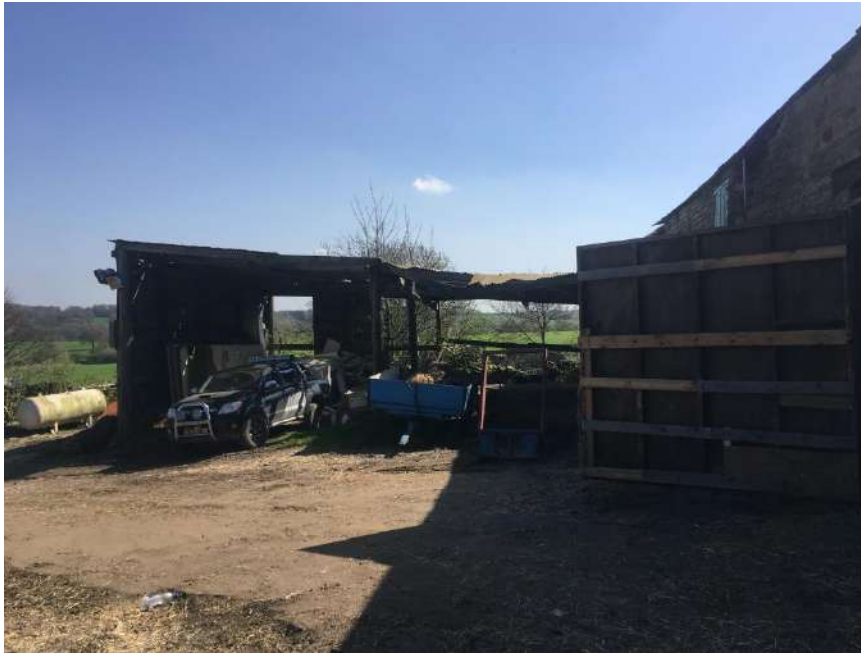
Perpendicular pole  
building to East of Unit 3  
(to be removed)

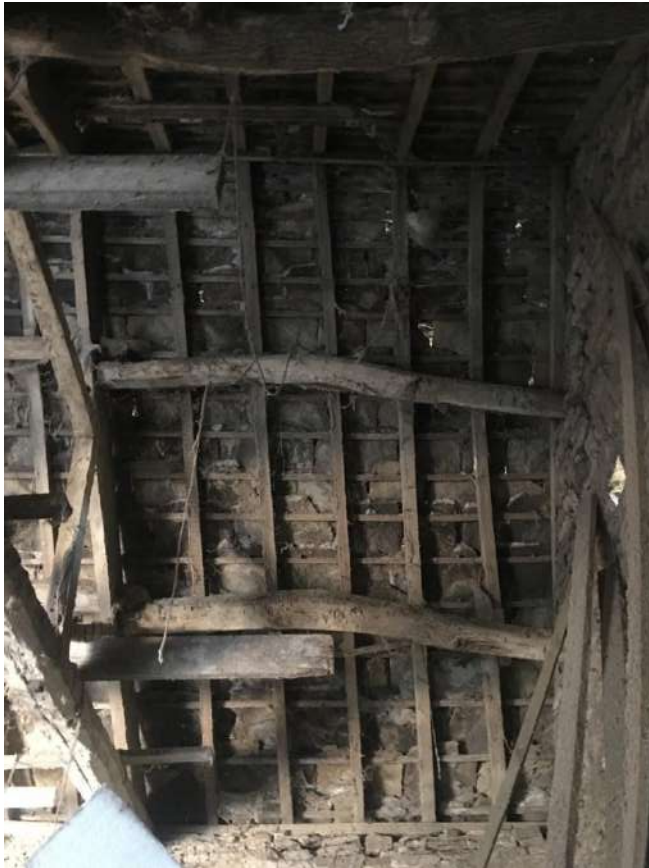
Underside of roof  
to Unit 3.

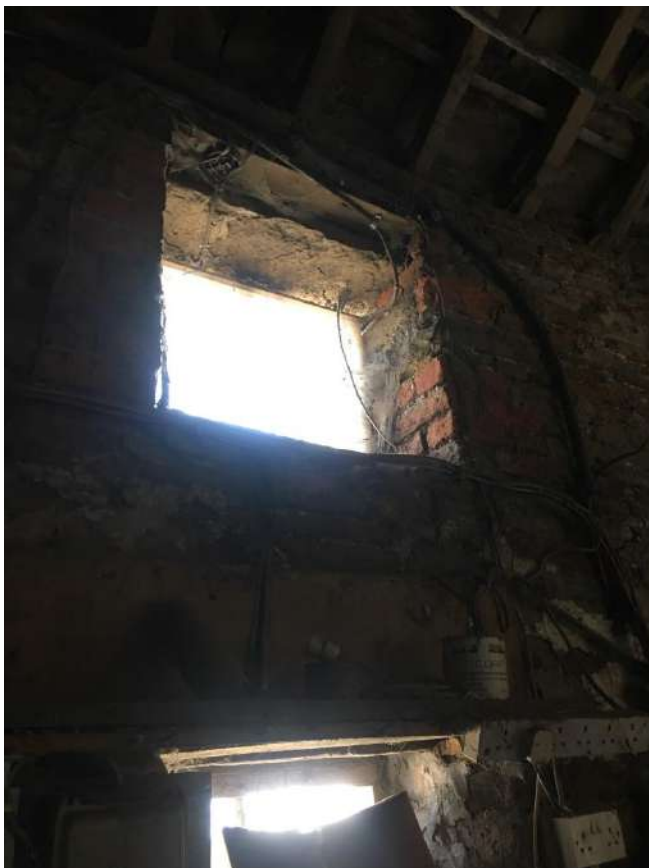
High level opening  
within Unit 3.

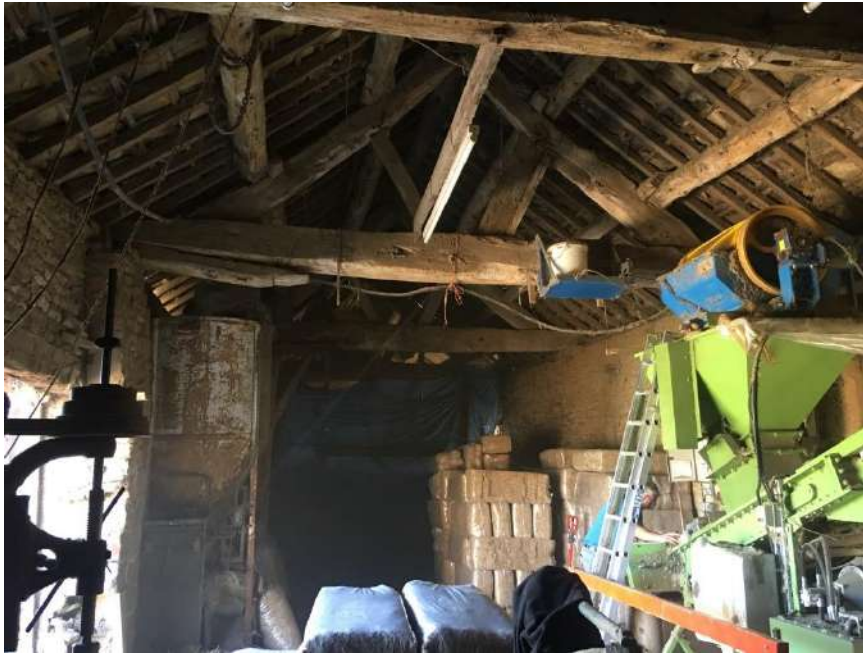
Roof trusses/straw  
chopping plant within  
Unit 3.

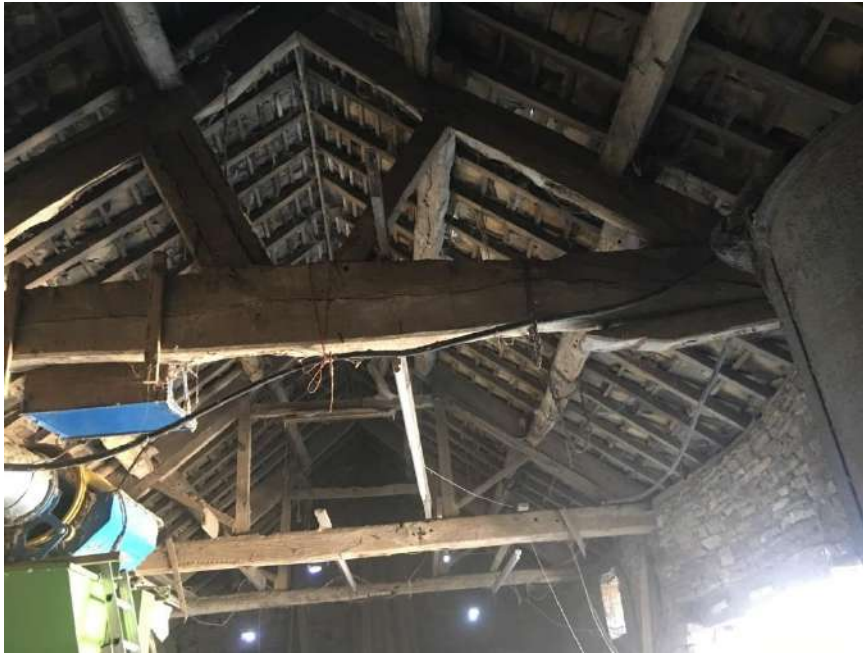
Roof trusses within  
Unit 3.

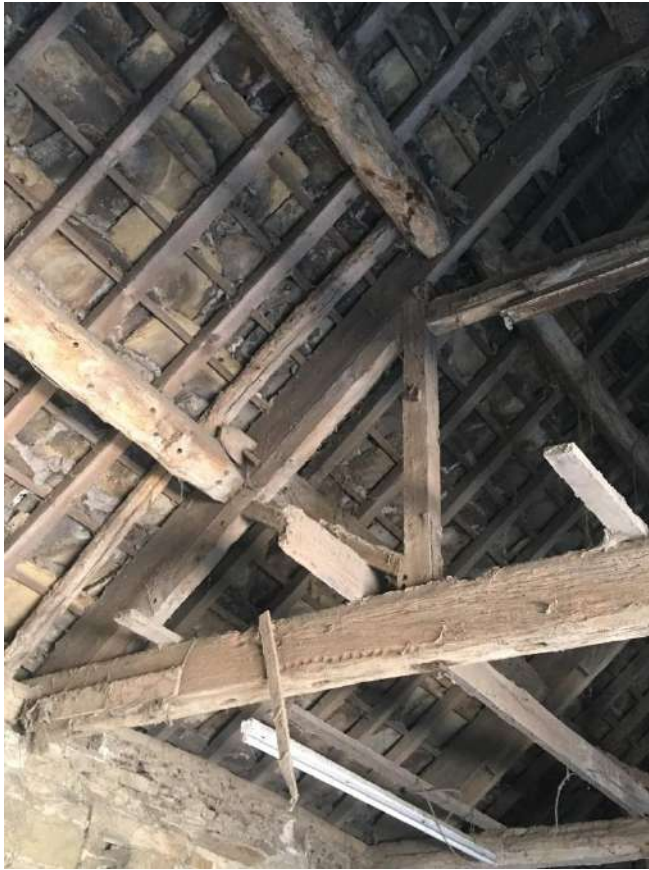
Purlins/Roof trusses  
within Unit 3.
